Schedule of Compliance Submittal - Basic

Site name:
Ingham CDC MS4

INGHAM COUNTY DRAINS MS4 PROGRESS REPORT

APRIL 1, 2021

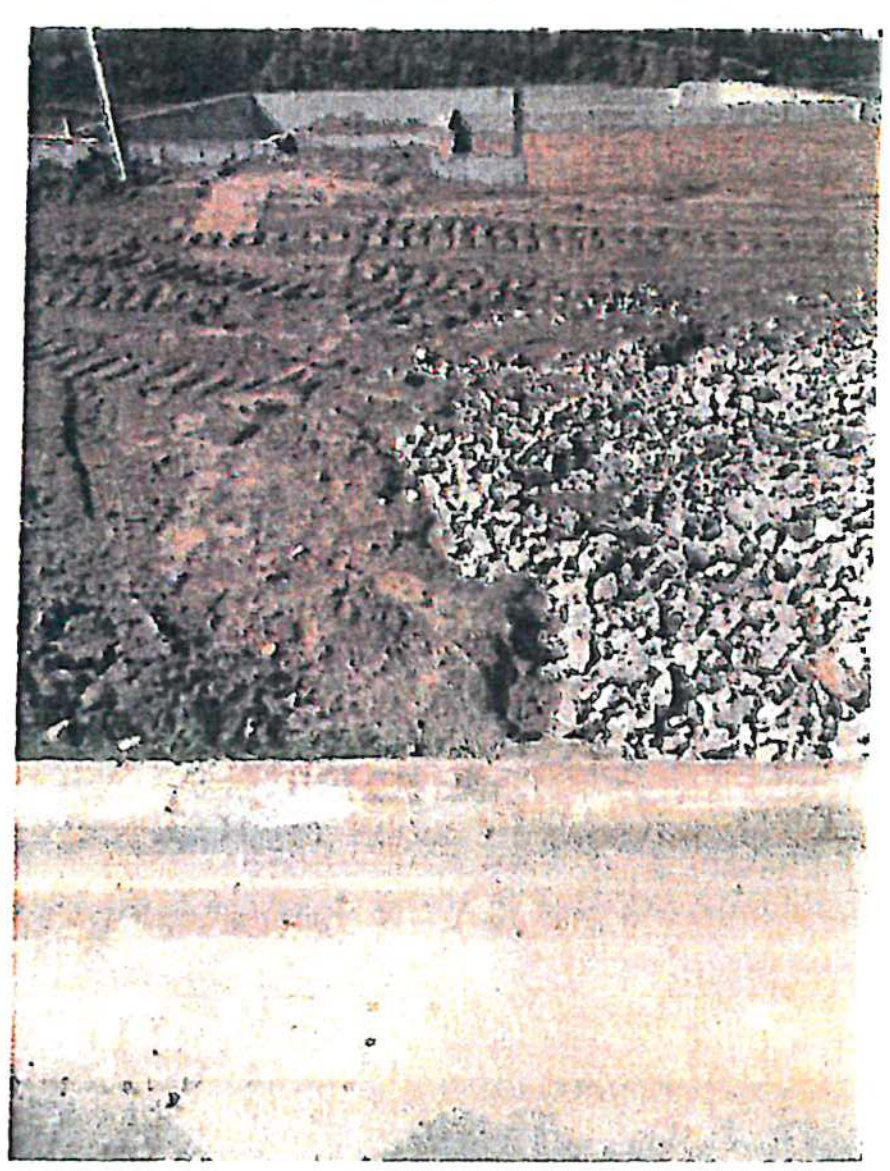
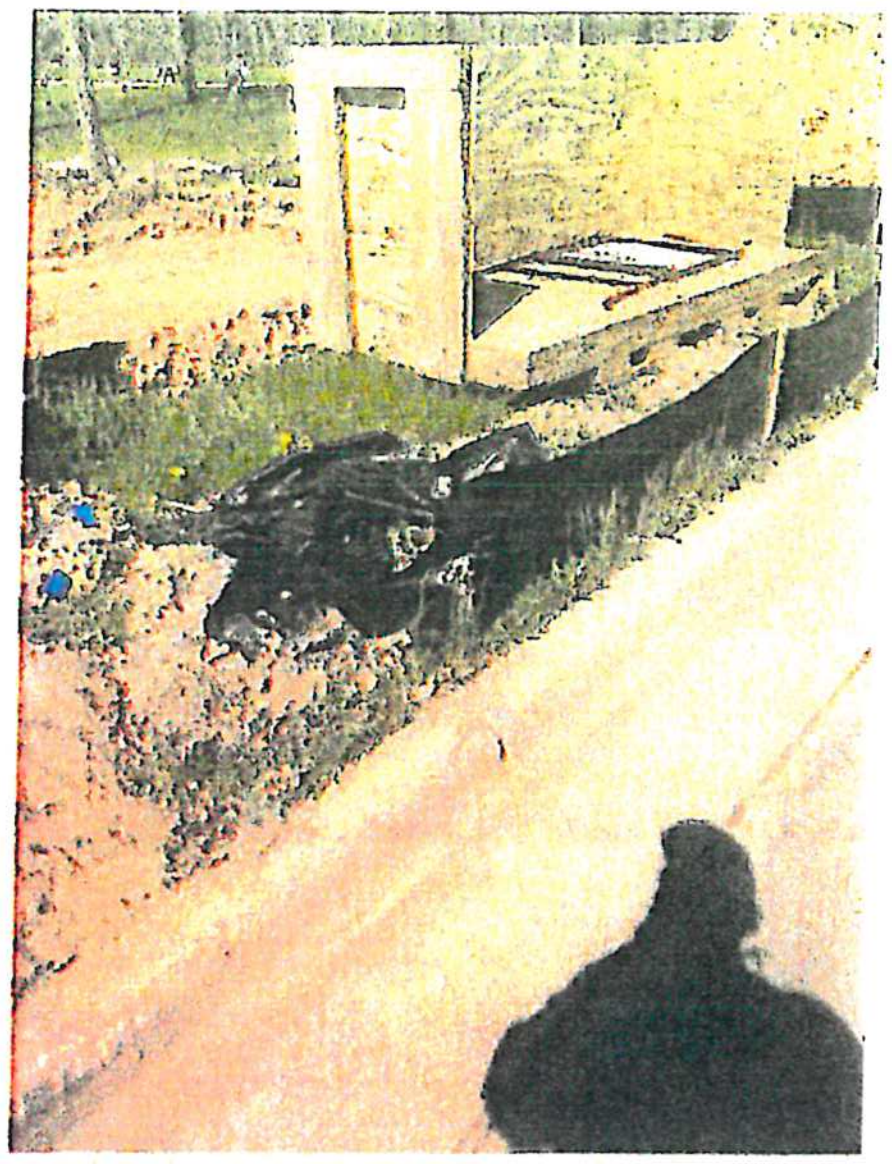
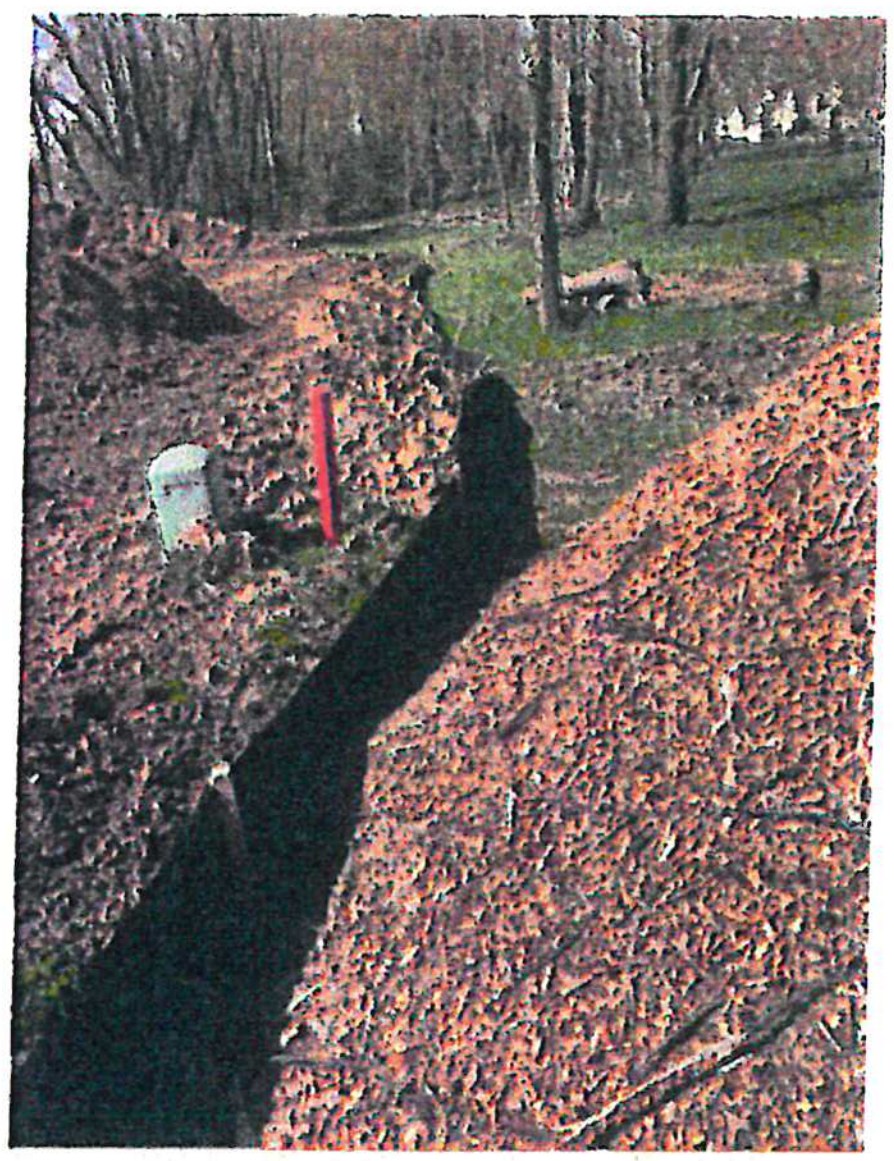
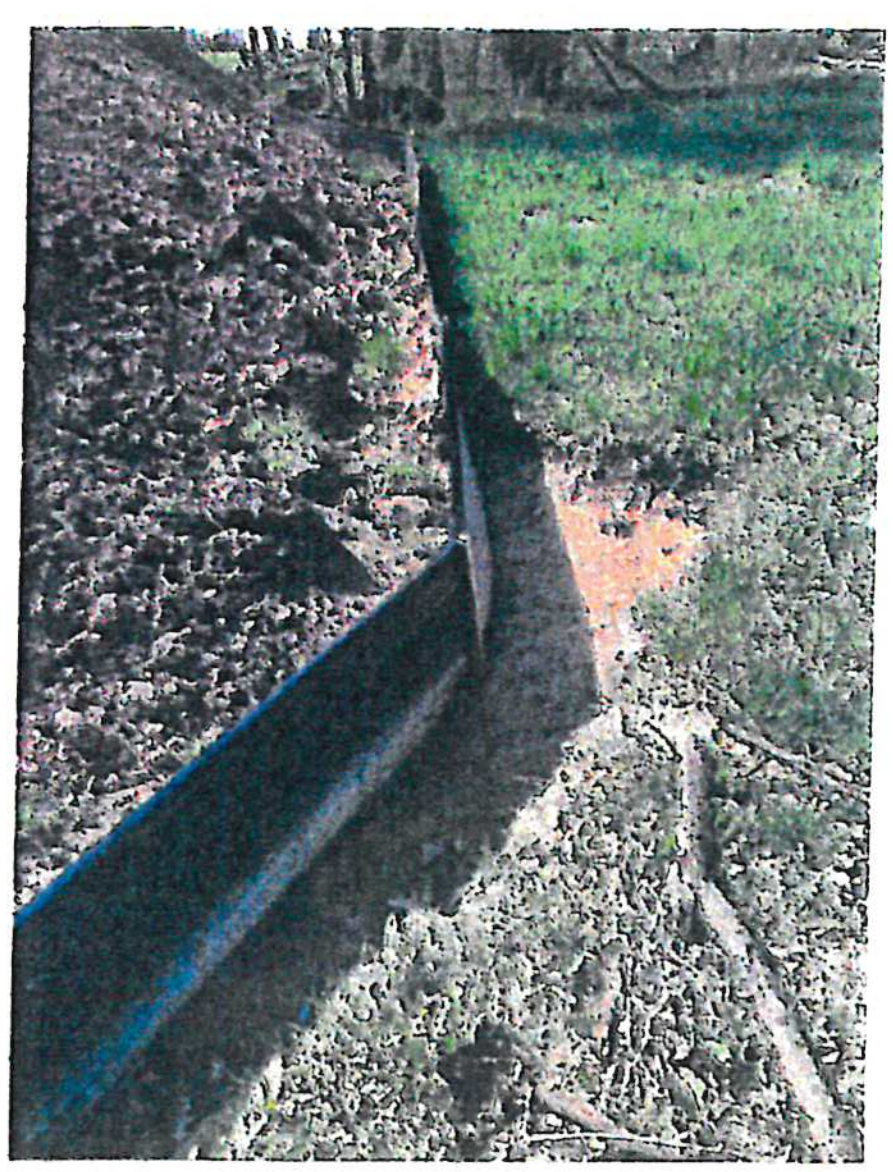
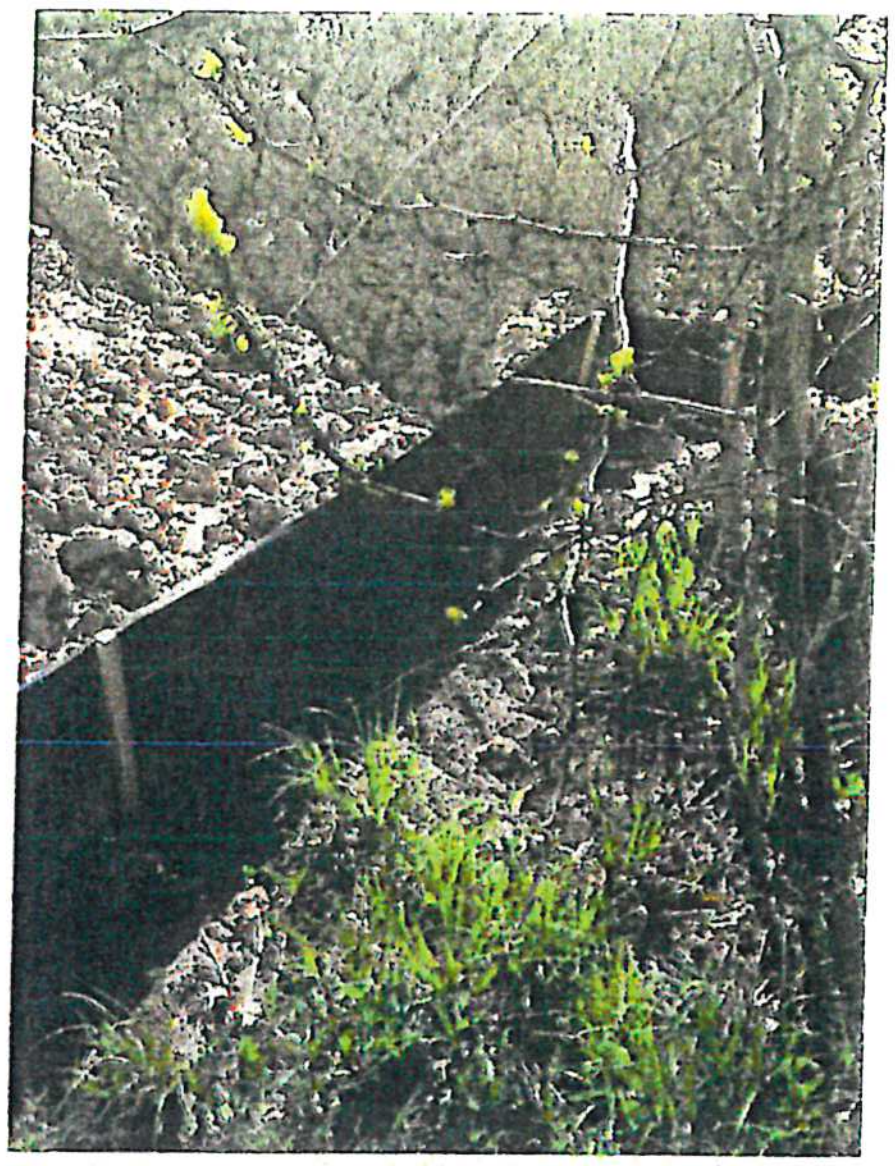
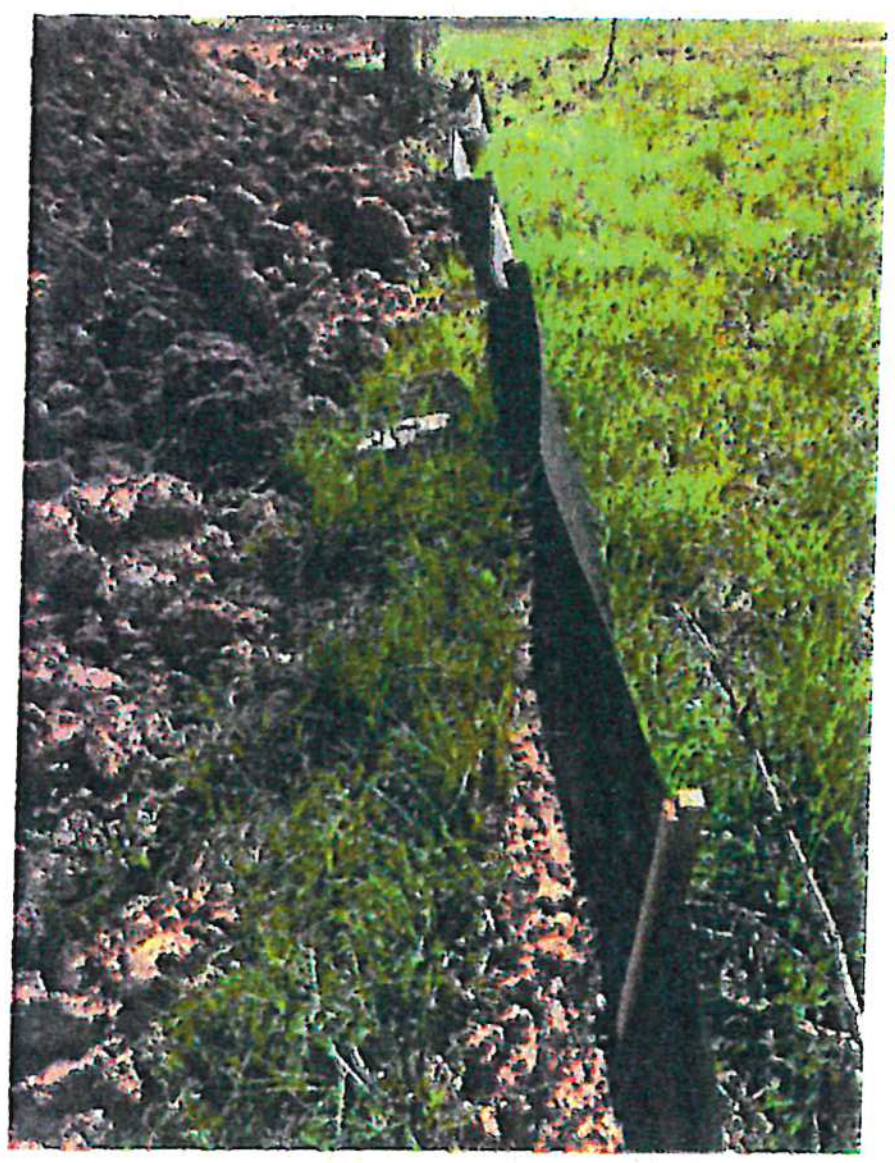
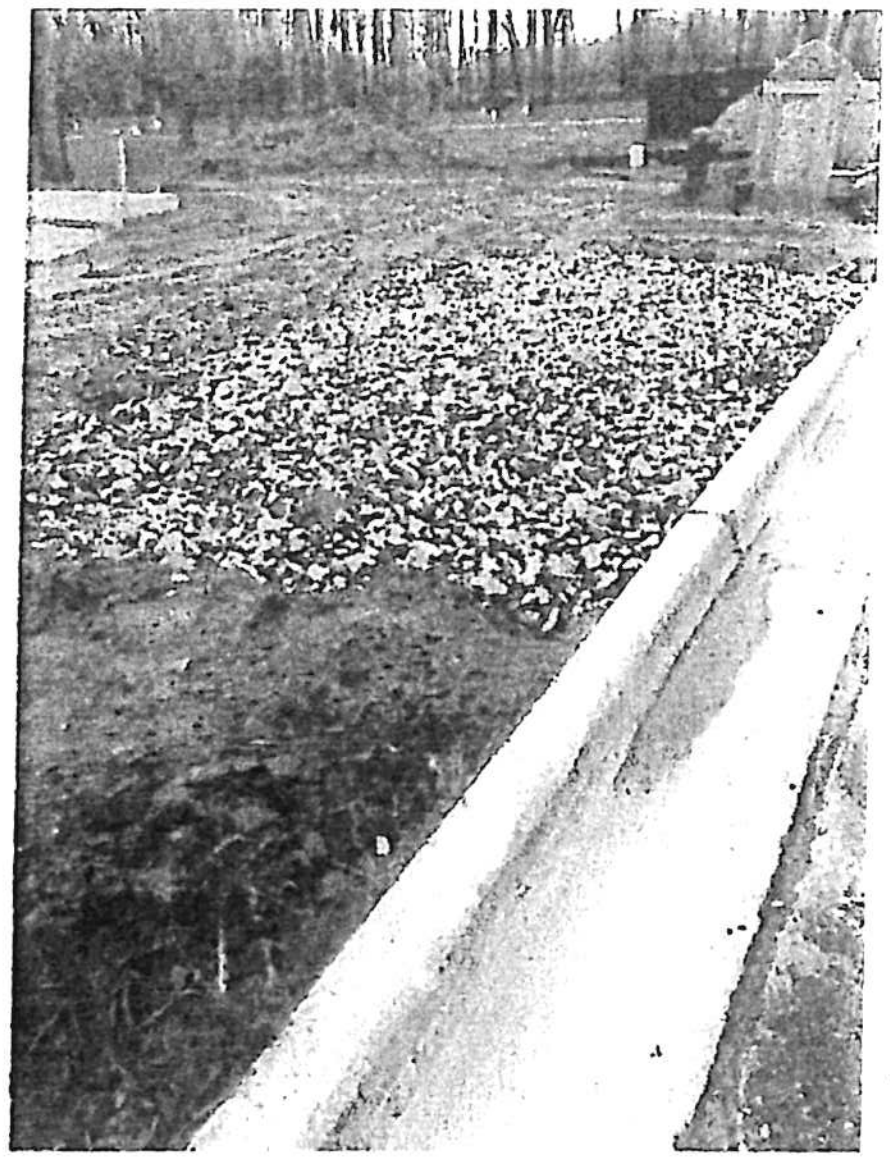
5/11/20 Recheck

Specific site conditions Arrived on 8 May to check work from earlier inspection. Talked with Derek Lisabeth of Forte Builders and he confirmed that he would be correcting the earlier request for fixes on Friday the eighth they did not do site and work done to repair silt fence is and sweep the roads have not been done.

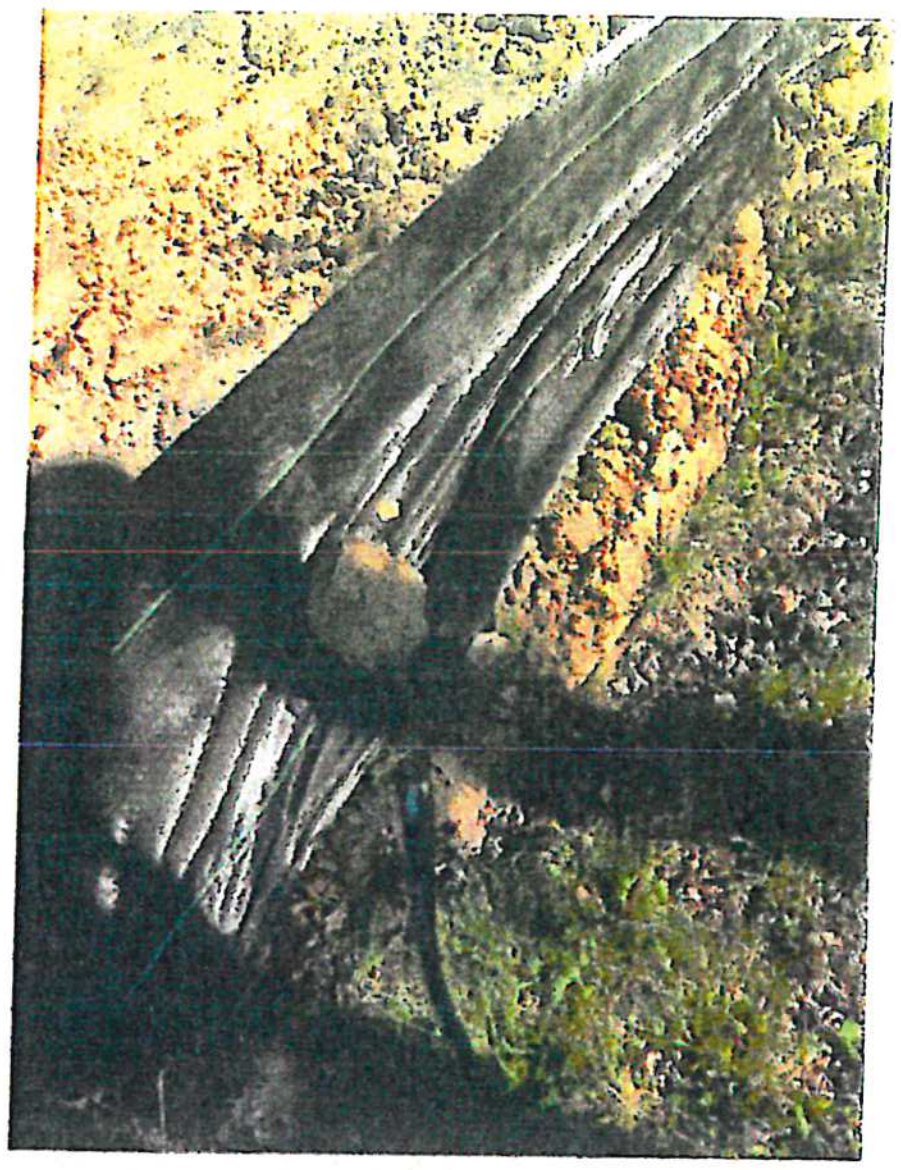
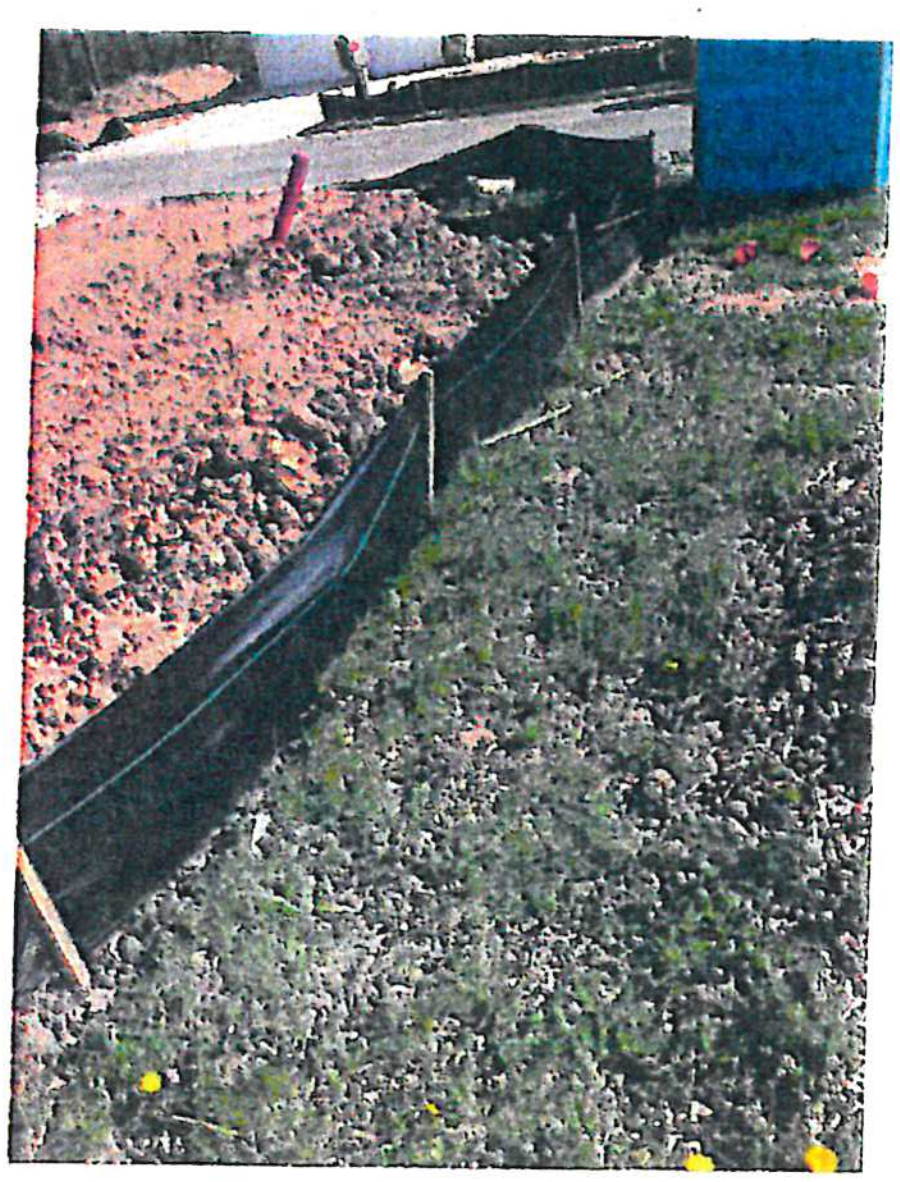
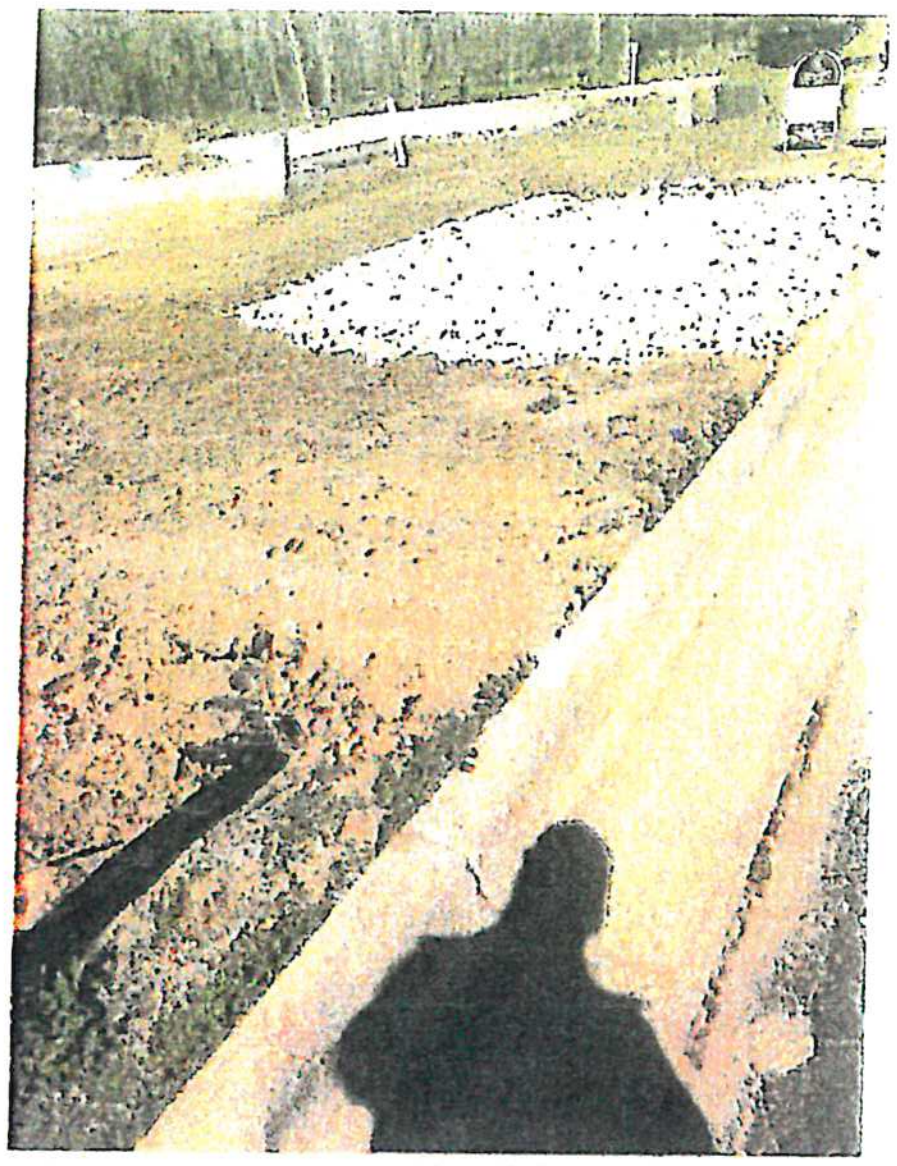
5/11/20 Recheck

Specific site conditions Silt fence still not anchored in places where mentioned earlier reports. Silt Fence has not been replaced per approved plan. Talked with Derek Lisabeth of Forte BuildersAnd he confirmed that he would be cracking the early request for fixes on Friday the eighth they did not do the site and work done to repair silt fence and sweep the roads have not been done

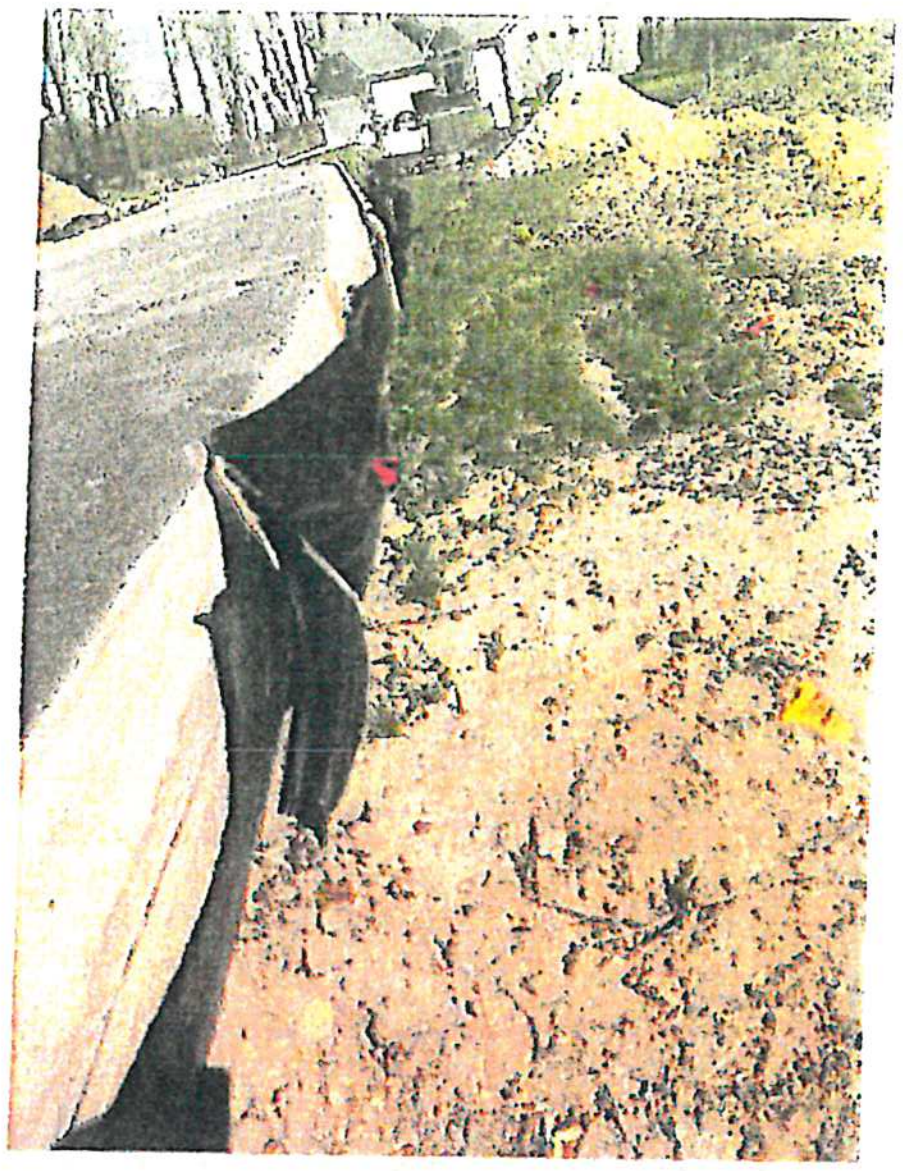
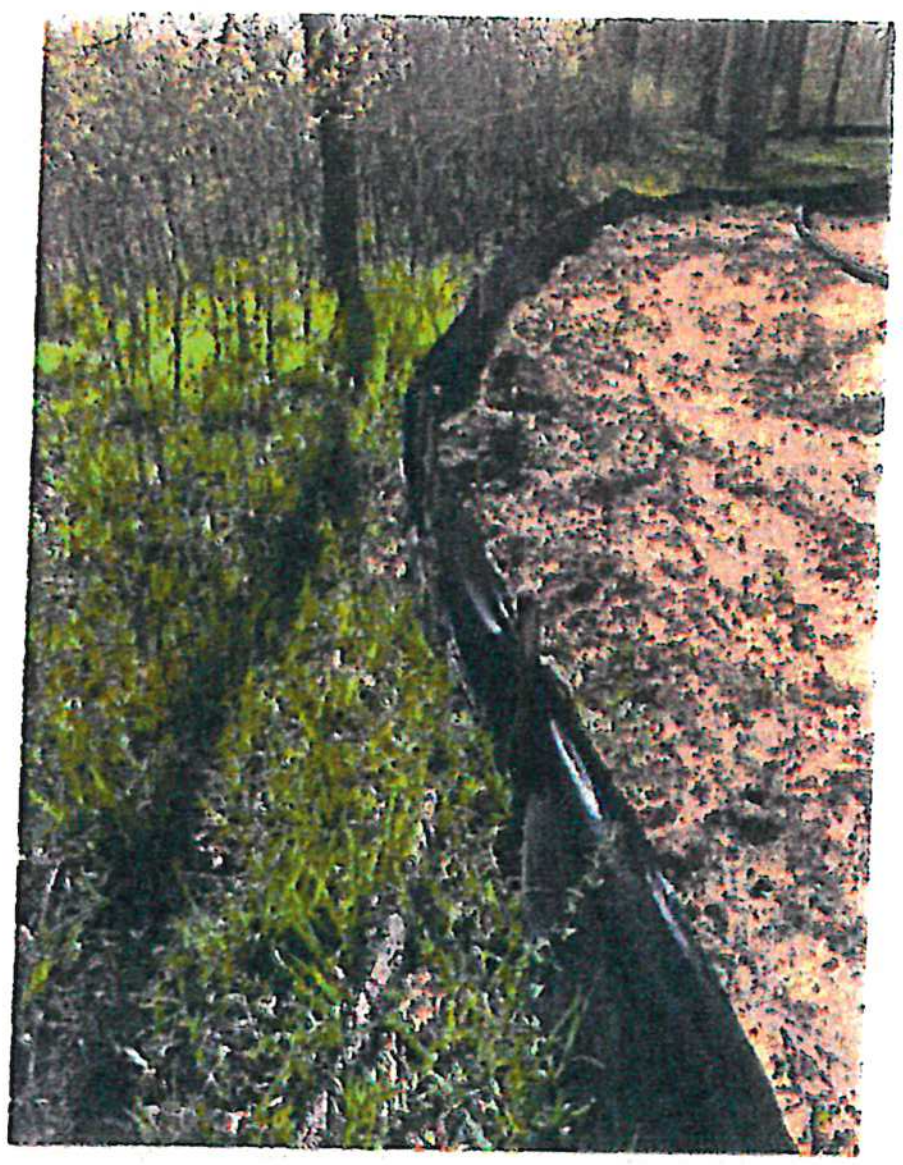
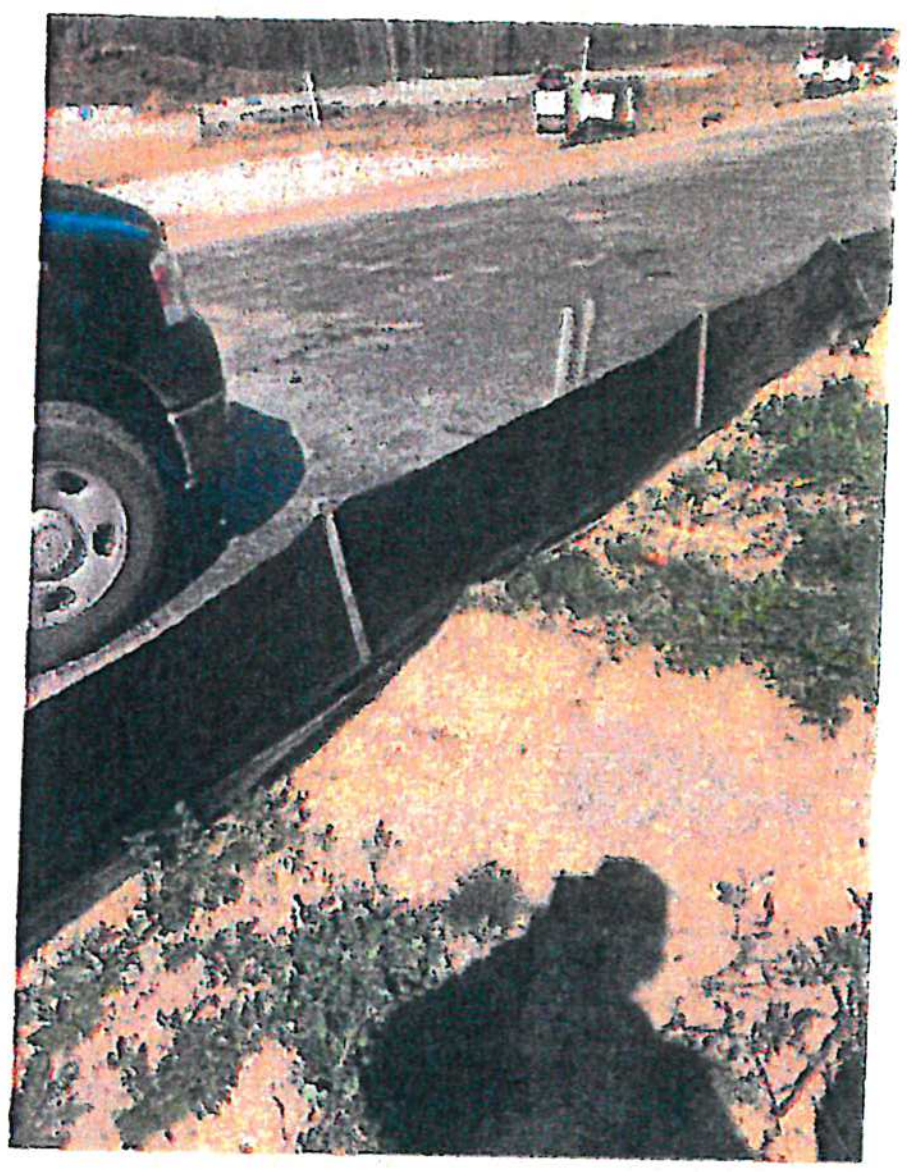
5/11/20 Recheck

1) **Silt fence was not properly anchored and needed to be repaired.**

1) **Repair and properly anchor all silt fence.**

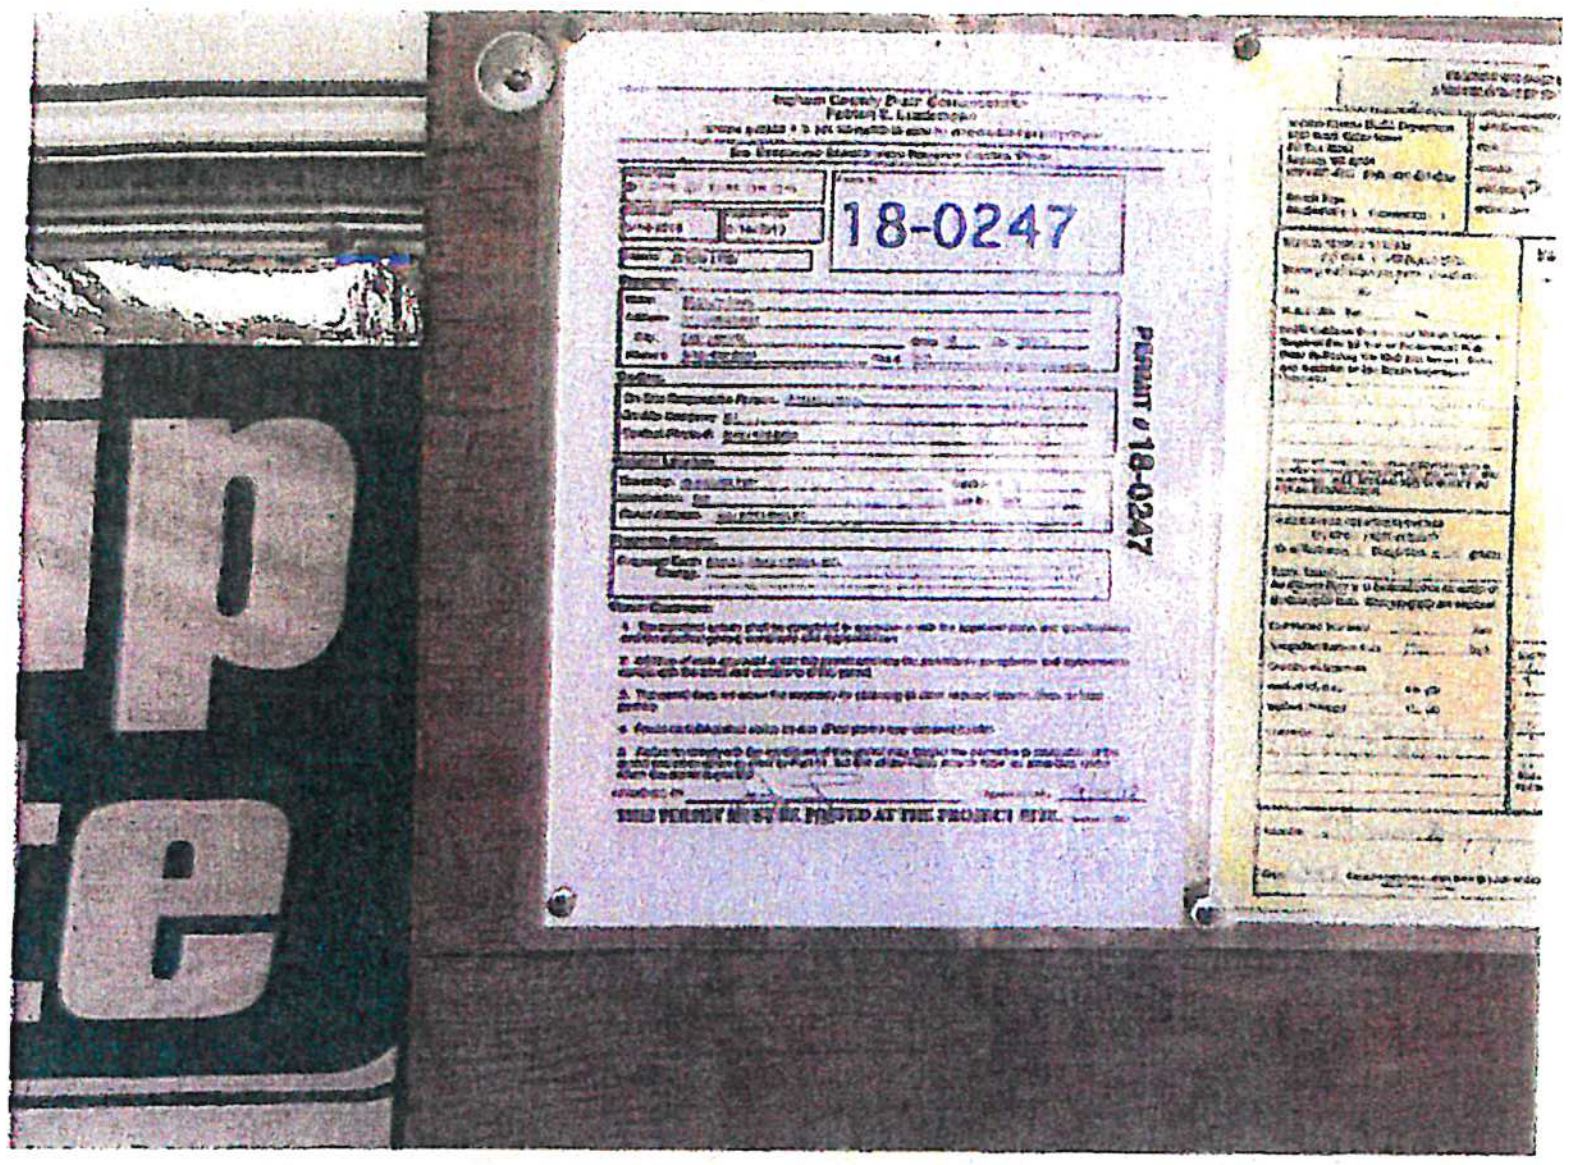
Permit posted, is visible from Stillman Road.

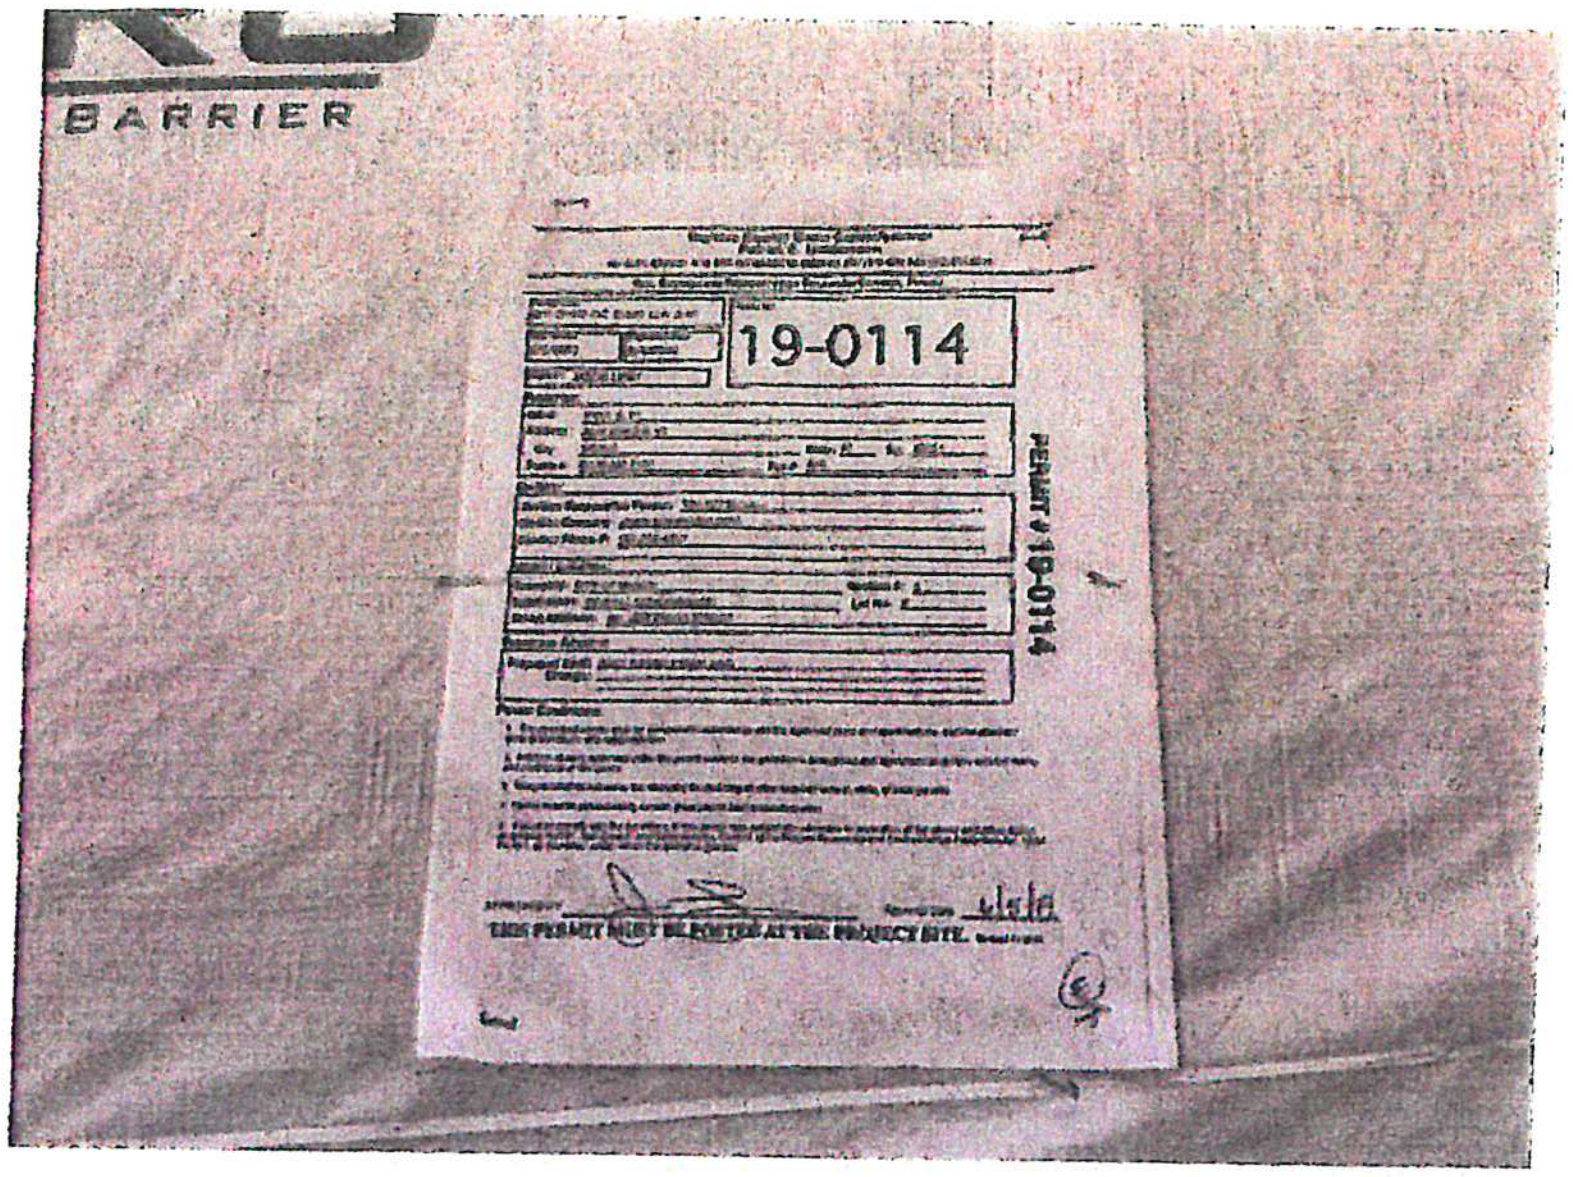
Permit posted at project site.

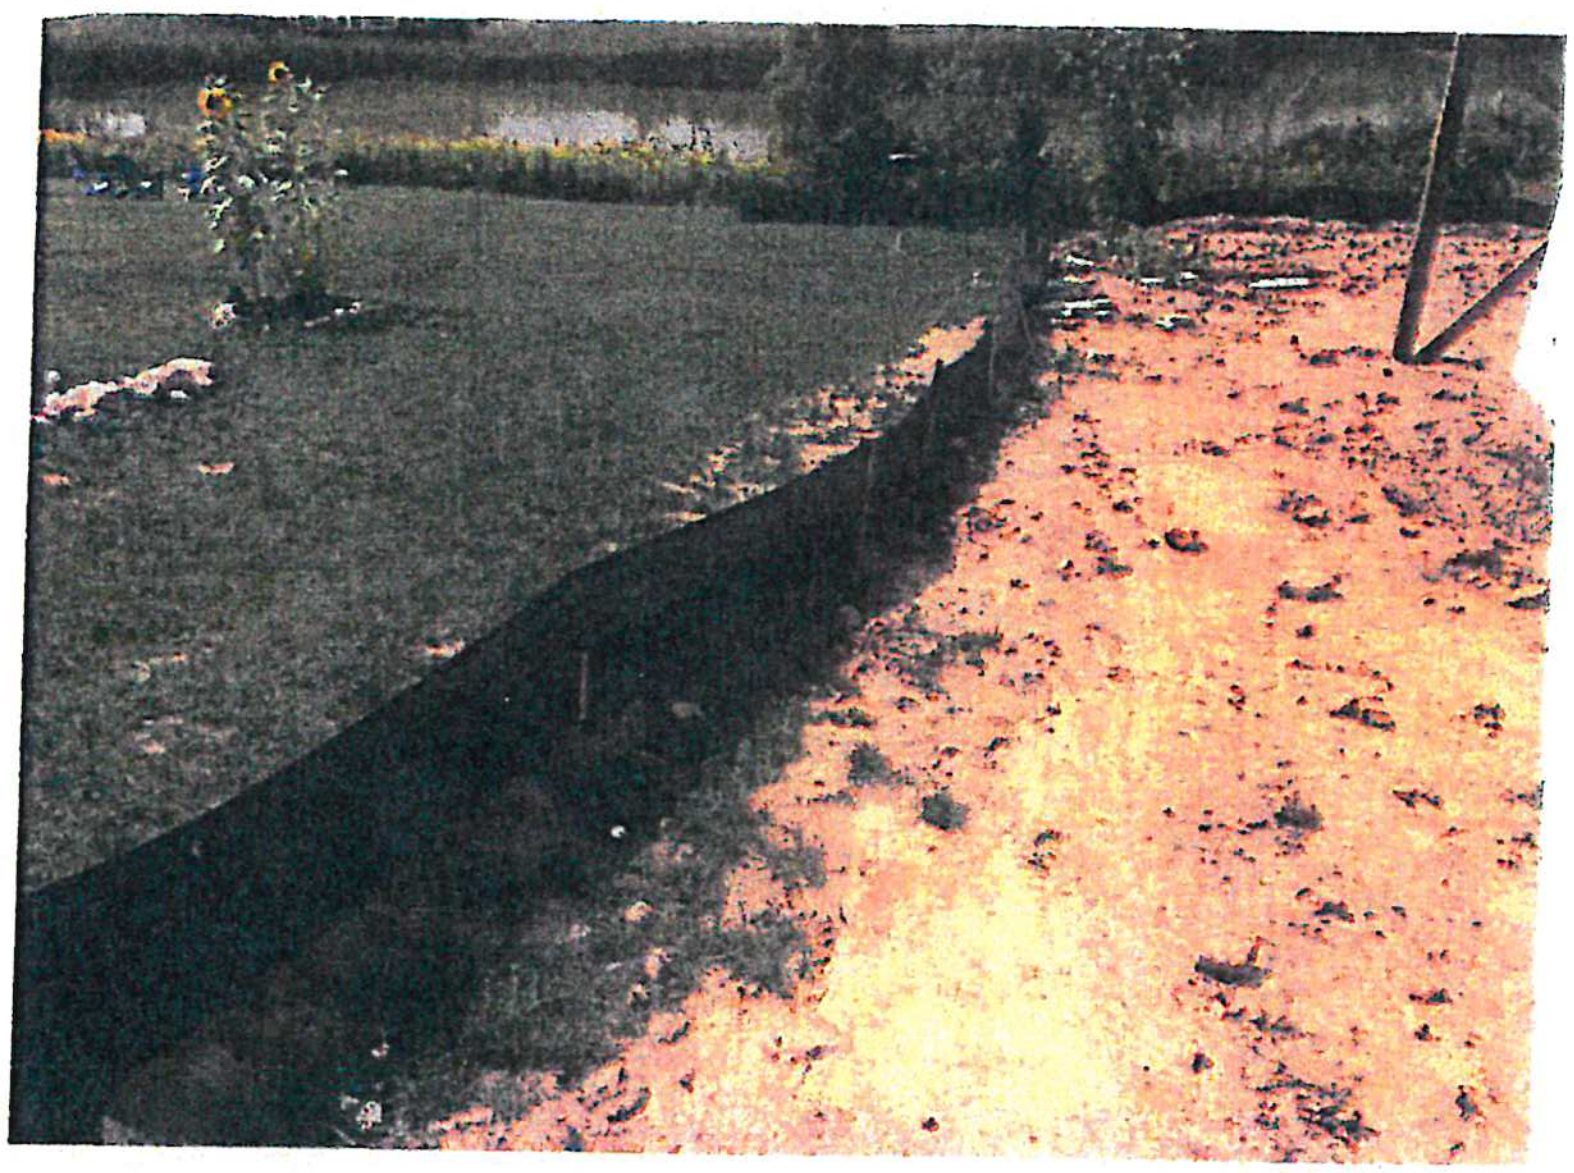
South side silt fence properly installed.

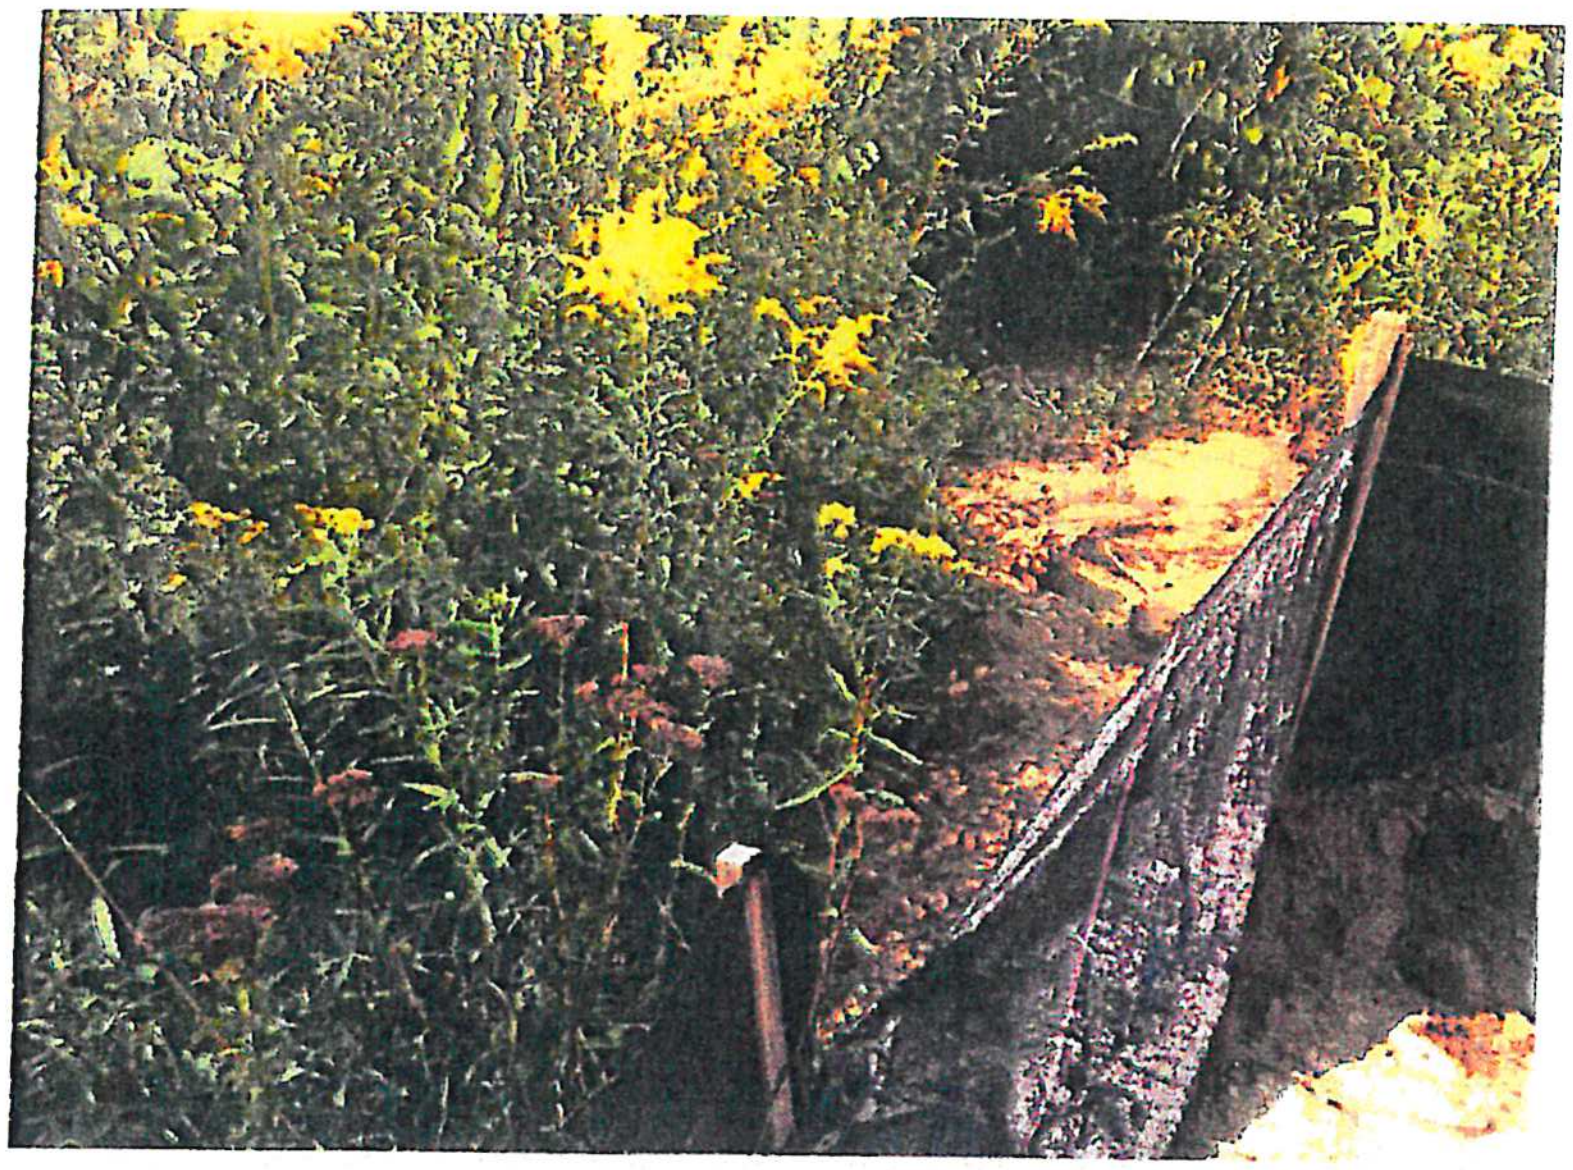
Sediment traveled under silt fence during last rain event. (West side of project site.)

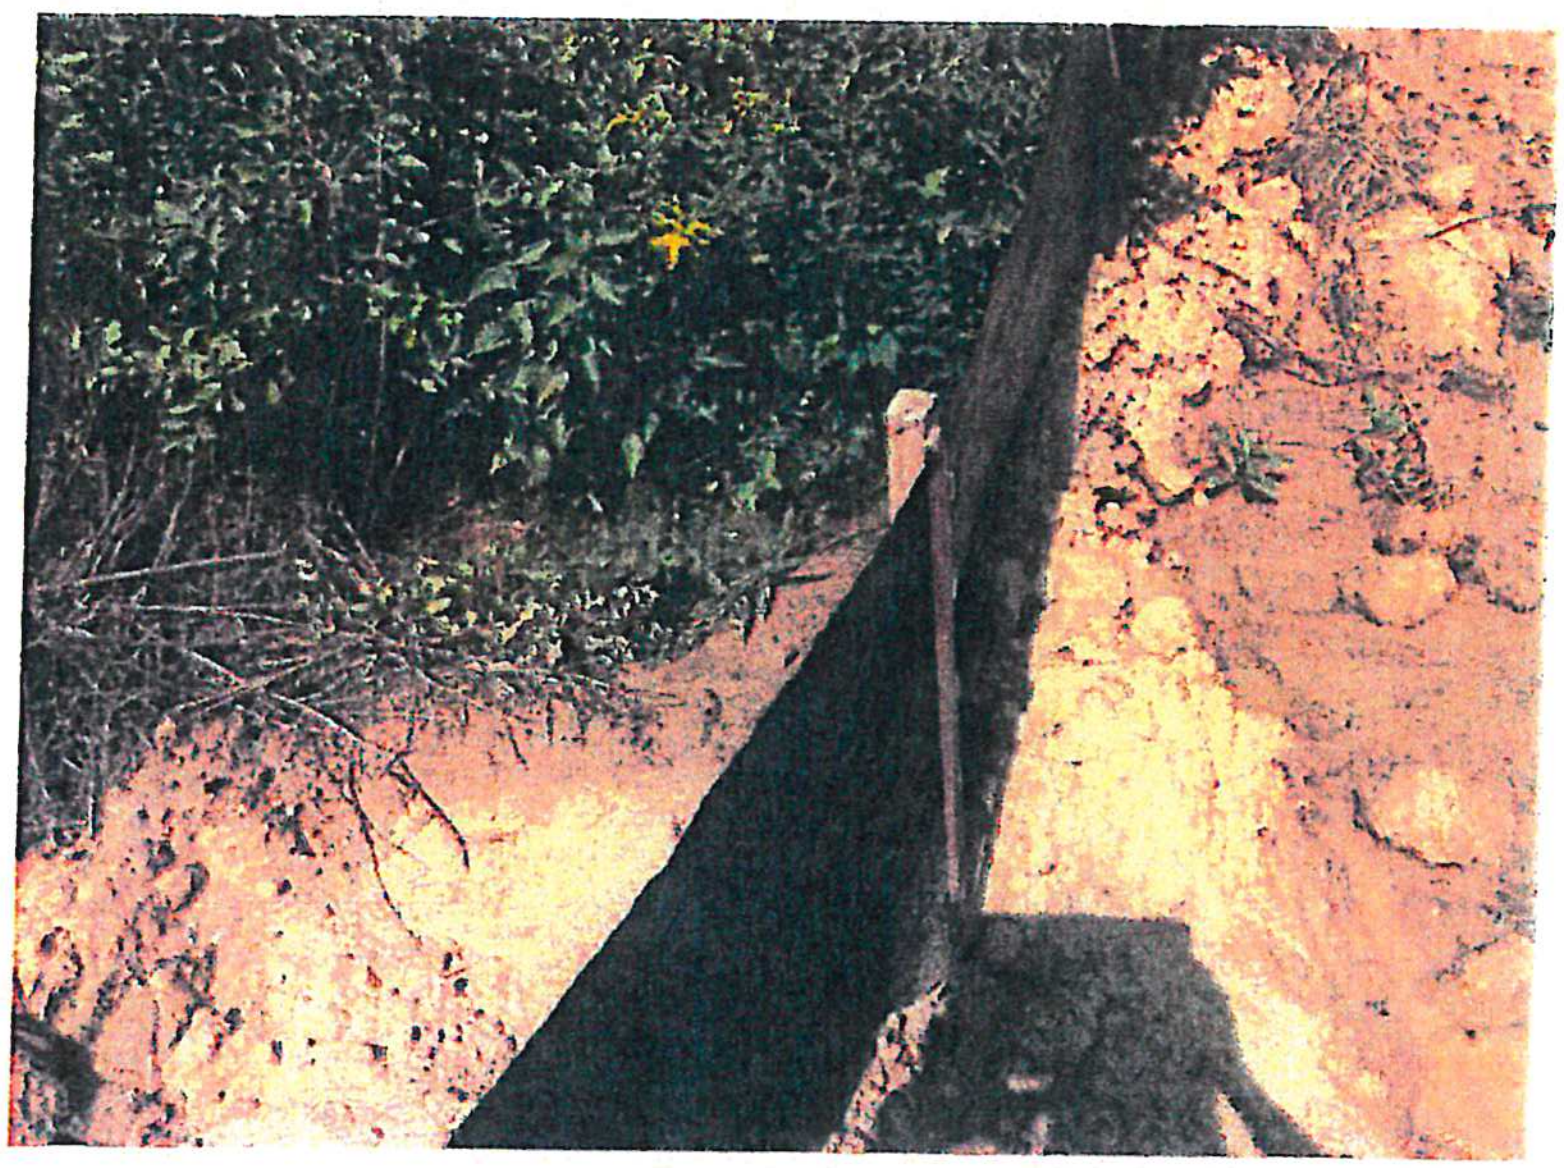
Sediment traveled under silt fence during last rain event. (West side of project site.)
