Schedule of Compliance Submittal - Basic

Site name:
Ingham CDC MS4

INGHAM COUNTY DRAINS MS4 PROGRESS REPORT

APRIL 1, 2021

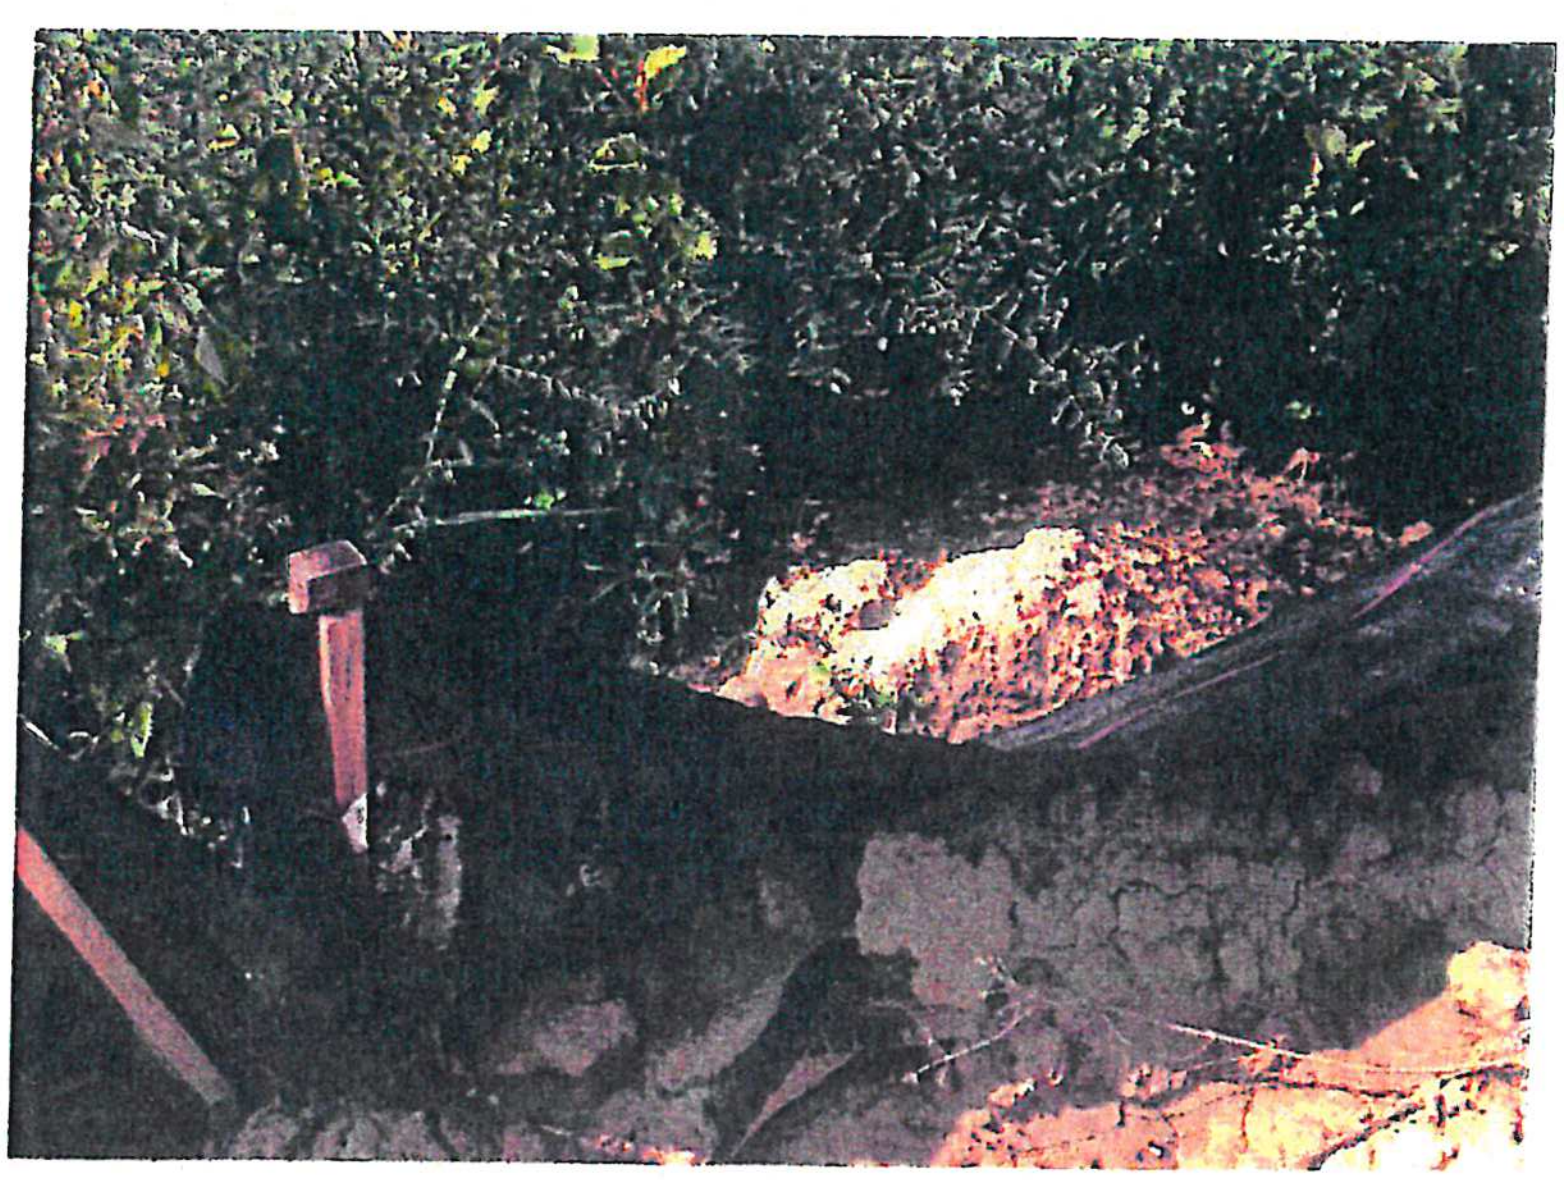
Space in silt fence that needs to be fully closed.

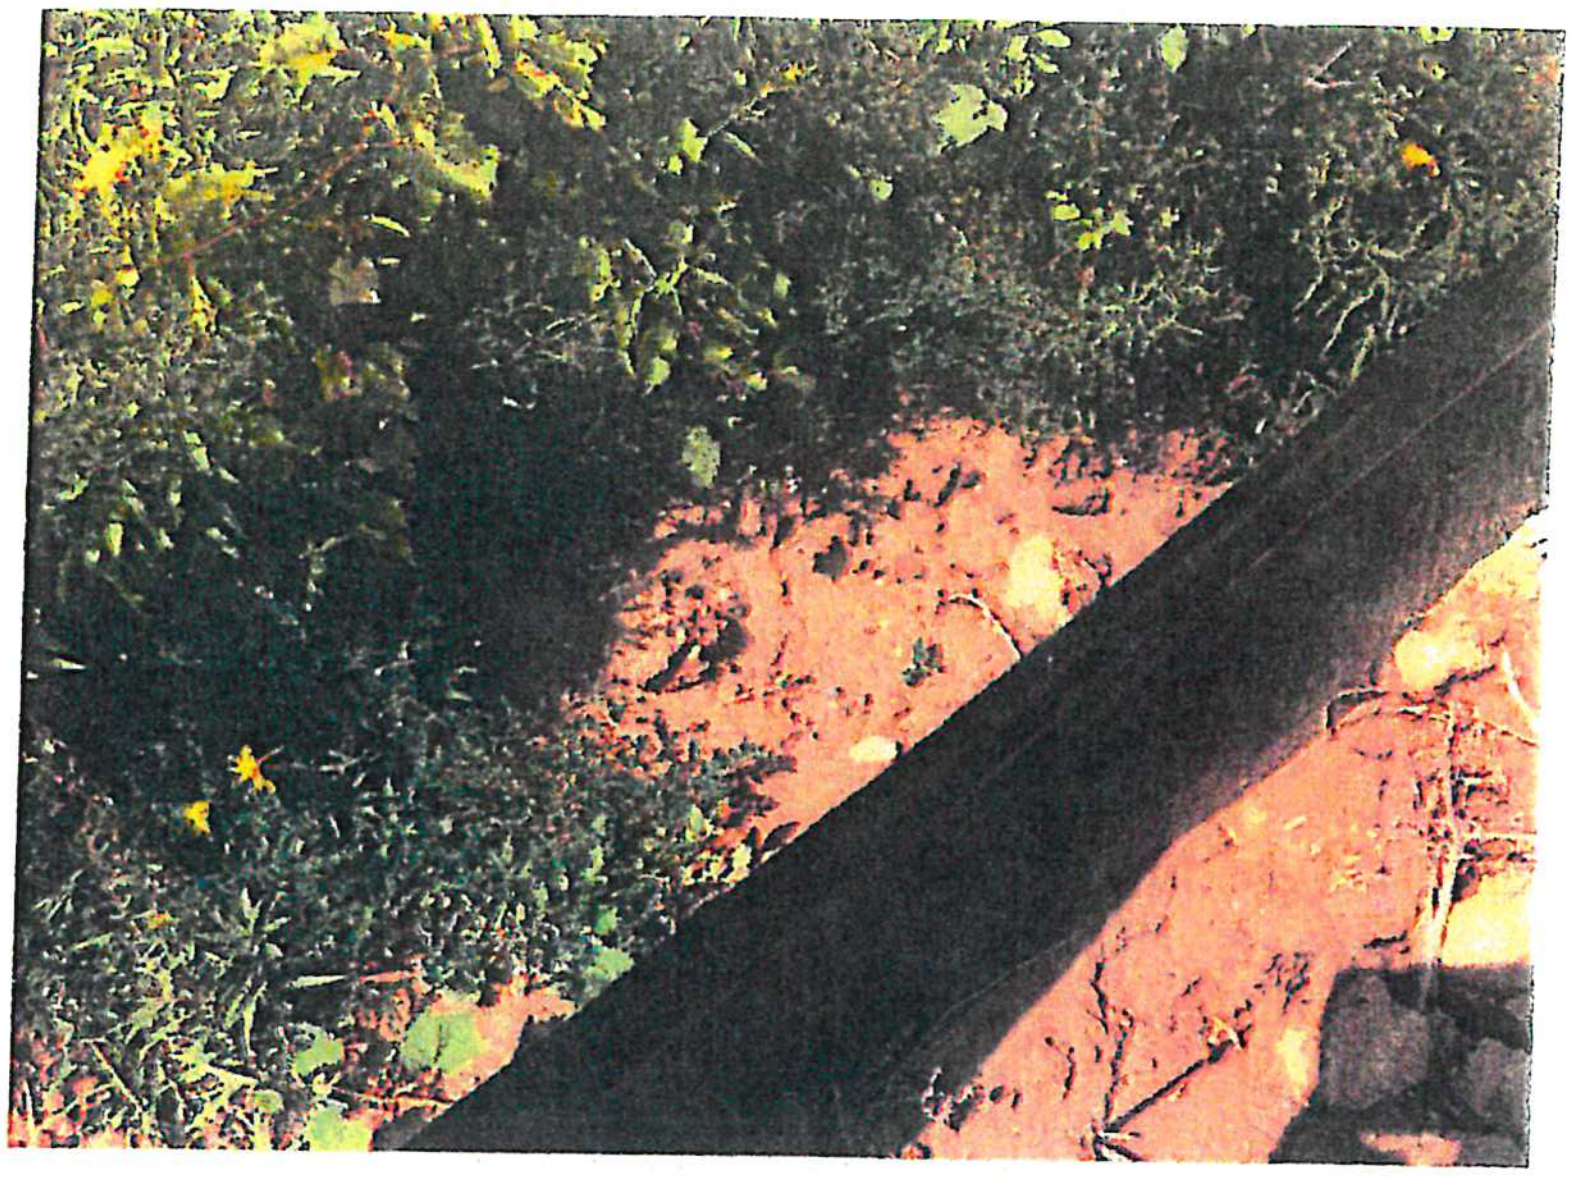
Sediment traveling under silt fence.

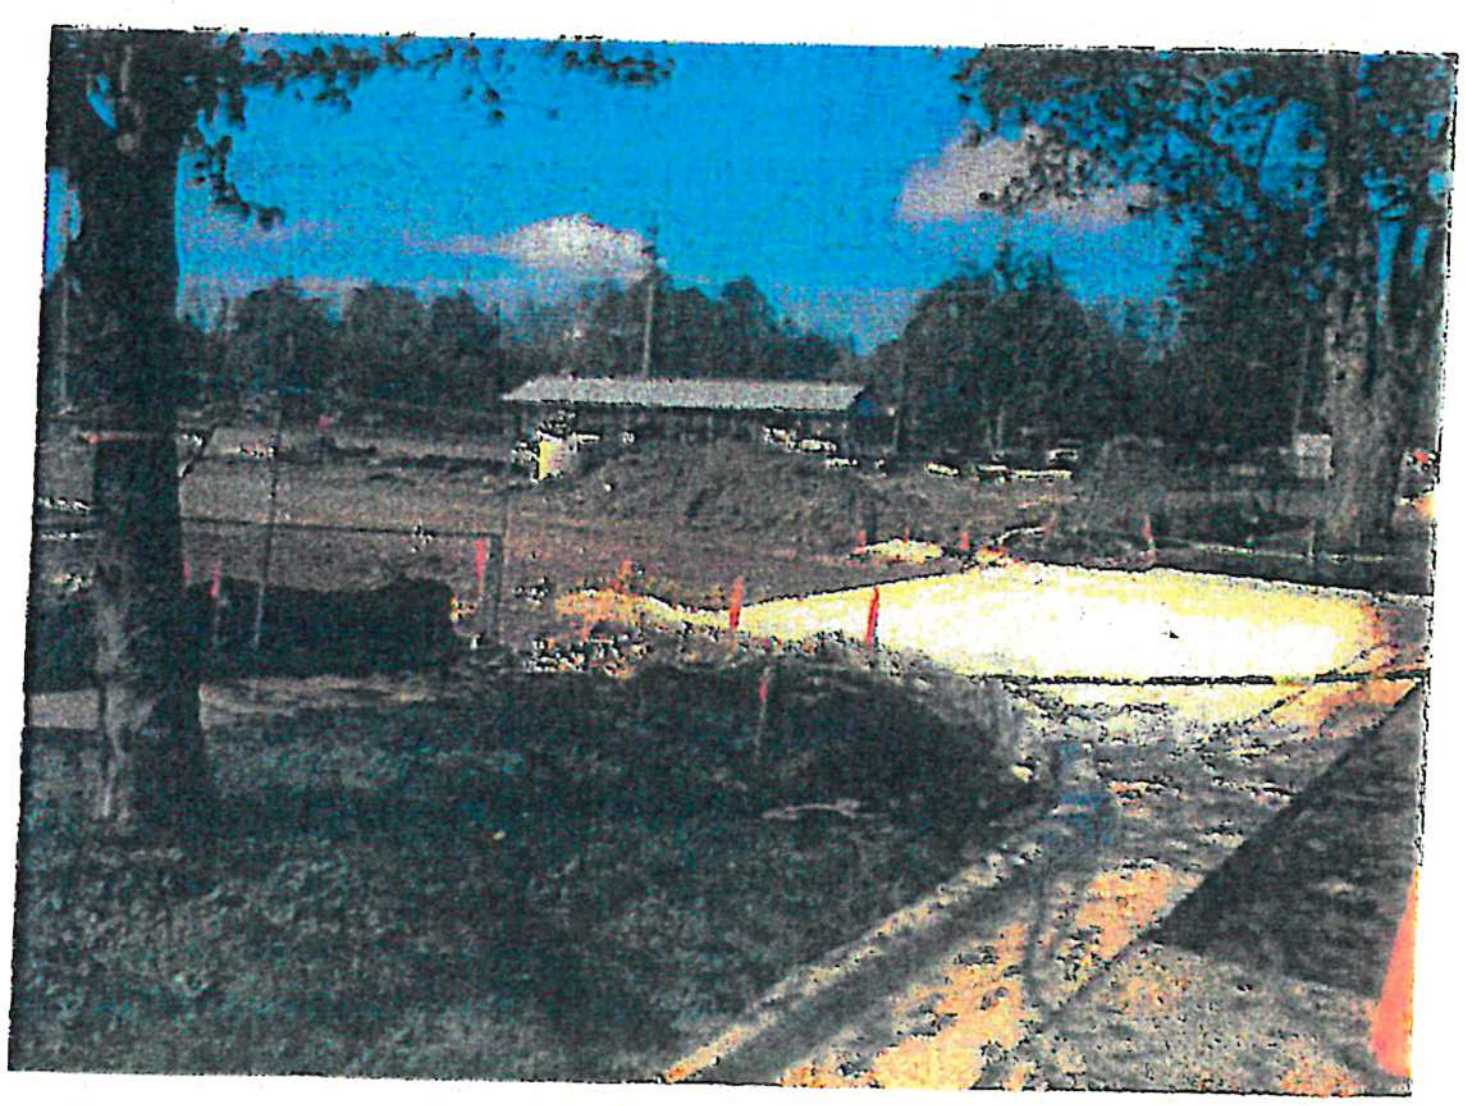
Construction drive on Maple St

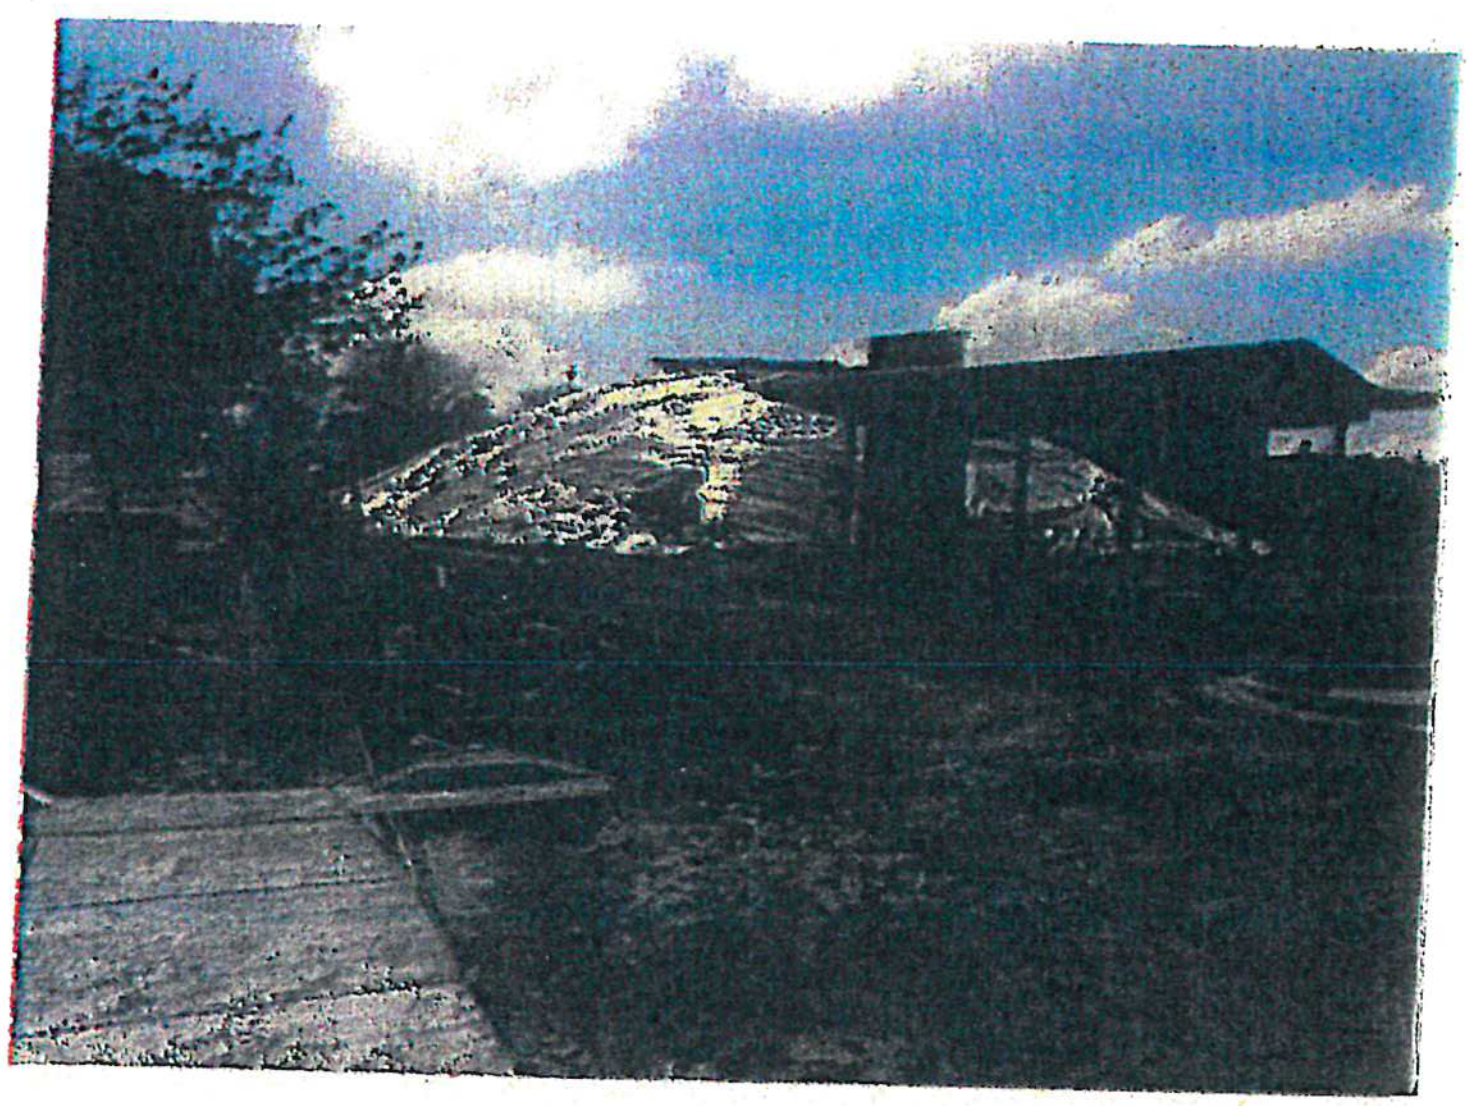
Inside site just south of construction drive on Maple St

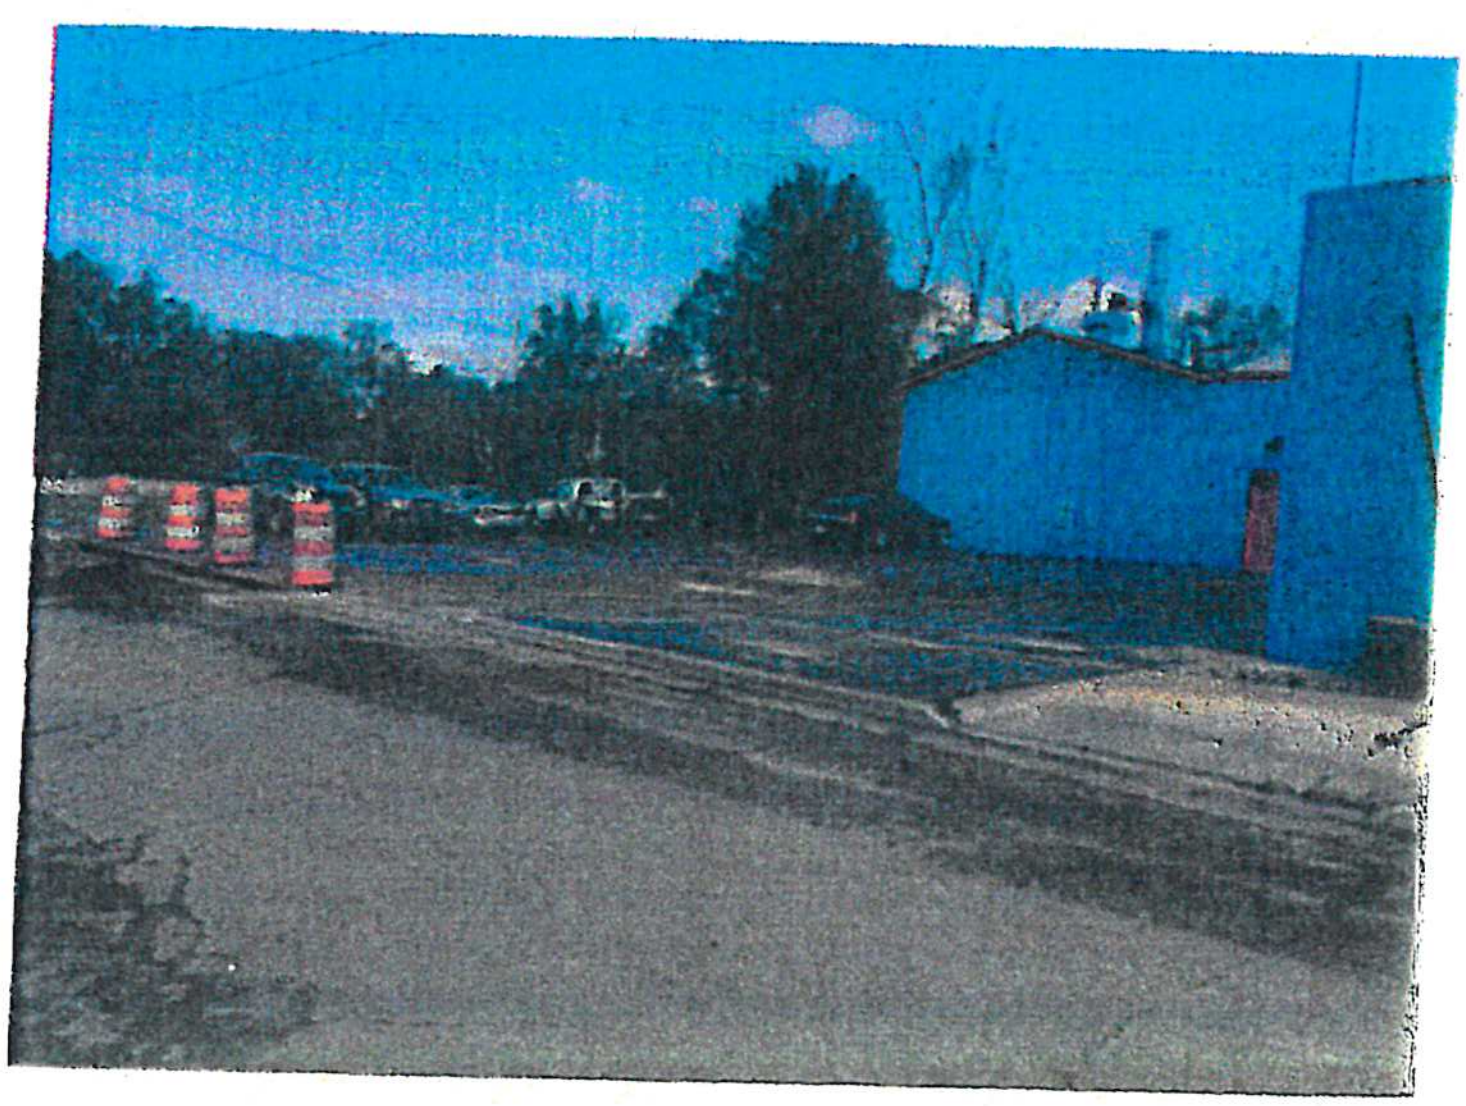
Benedict Auto Body parking lot

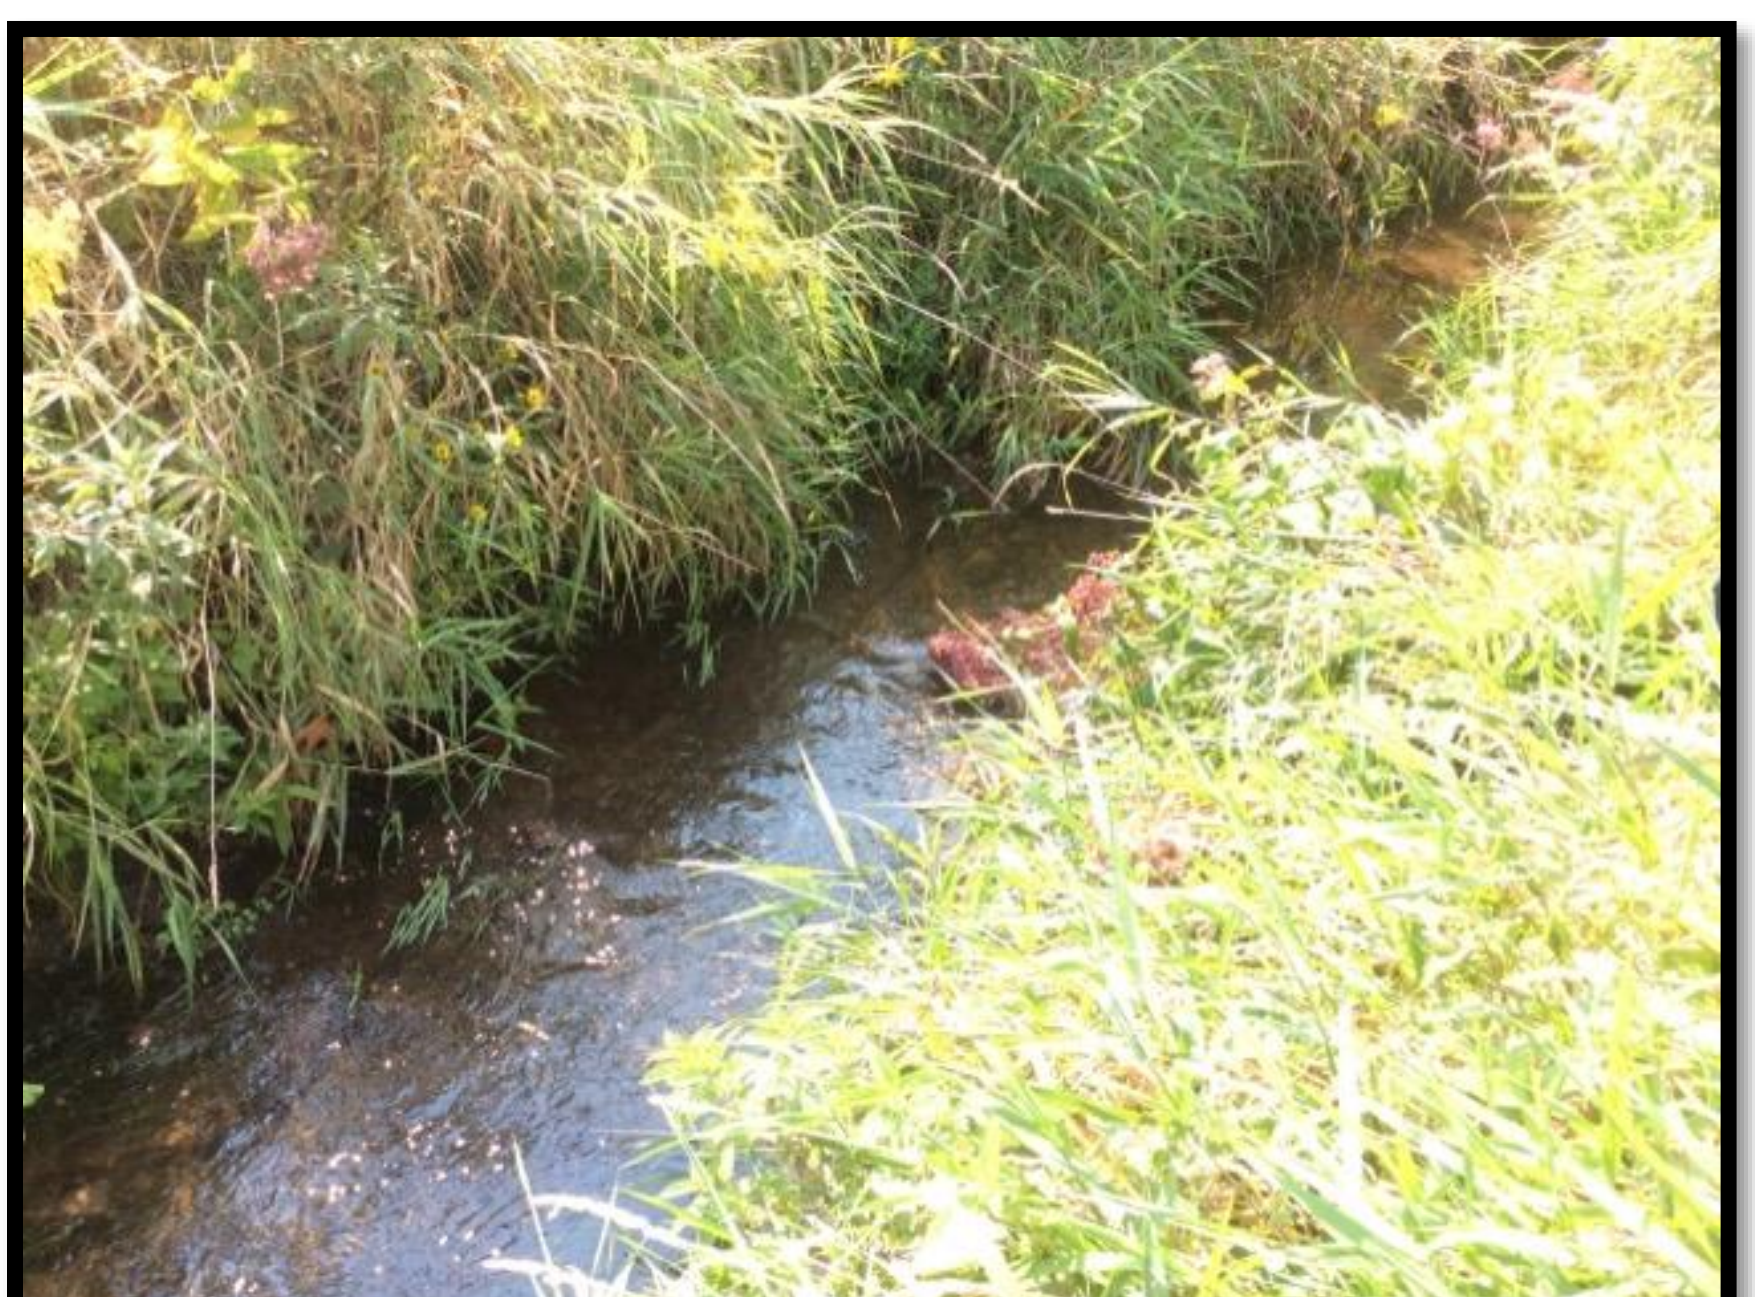
Discharge Point Details	POINT NUMBER	**A18-00**
	DRAIN NAME	**ALTON DRAIN**
	LAND USE/AREA	RESIDENTIAL - MULTI
	NO. OF DAYS SINCE RUN OFF	2
	RISE X SPAN (IN)	NA
	MATERIAL/TYPE	NA
	VEGETATION CONDITION	NORMAL
	OUTFALL DAMAGE	NONE
	FLOW DEPTH (IN)	0
	FLOW PRESENT (Y/N)	NO
	SUBMERGED (Y/N)	N/A
Observations	COLOR	NONE
	DEPOSITS/STAINS	NONE
	FLOATABLES	NONE
	TURBIDITY	NONE
	ODOR	NONE
	NOTES	Open drain with no water in it. Filled with cattails.
IDEP Parameters	AMMONIA (mg/L)	0
	PH	0
	SURFACTANT (mg/L LAS)	0
	TEMPERATURE (F)	0
	TURBIDITY (NTU)	0
	SPECIFIC CONDUCTIVITY (mS/cm)	0
Data Collection Detail	STAFF	ERS/KRZ
	GPS	
	TIMESTAMP	09/12/2017 08:53:21

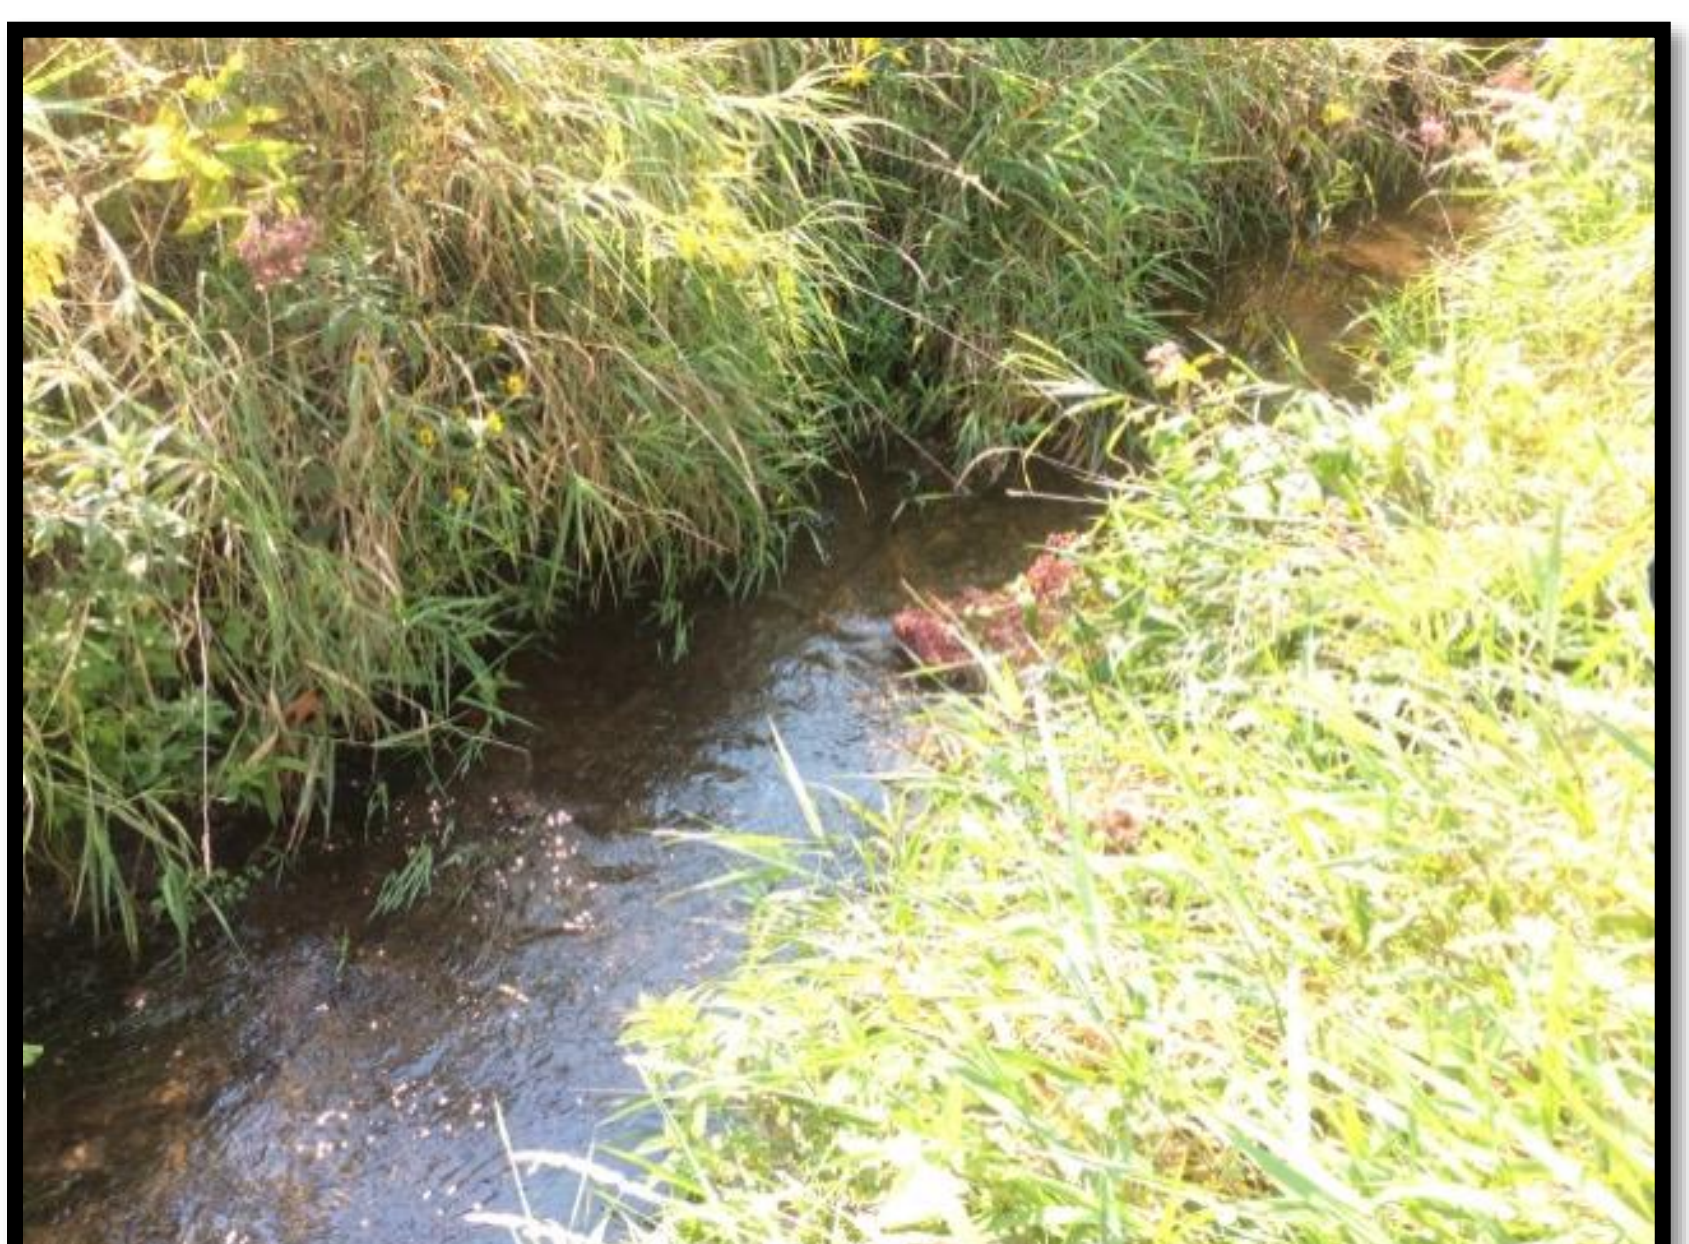
Discharge Point Details	POINT NUMBER	**B22-00**
	DRAIN NAME	**BULLETT LAKE DRAIN**
	LAND USE/AREA	AGRICULTURAL
	NO. OF DAYS SINCE RUN OFF	2
	RISE X SPAN (IN)	NA
	MATERIAL/TYPE	open drain
	VEGETATION CONDITION	NORMAL
	OUTFALL DAMAGE	NONE
	FLOW DEPTH (IN)	3
	FLOW PRESENT (Y/N)	YES
	SUBMERGED (Y/N)	NO
Observations	COLOR	NONE
	DEPOSITS/STAINS	NONE
	FLOATABLES	SHEEN
	TURBIDITY	NONE
	ODOR	NONE
	NOTES	slight bacterial sheen on surface of the water
IDEP Parameters	AMMONIA (mg/L)	0
	PH	0
	SURFACTANT (mg/L LAS)	0
	TEMPERATURE (F)	0
	TURBIDITY (NTU)	0
	SPECIFIC CONDUCTIVITY (mS/cm)	0
Data Collection Detail	STAFF	ERS/KRZ
	GPS	+42.710781, -84.239080, +10.000000
	TIMESTAMP	09/13/2017 09:10:13

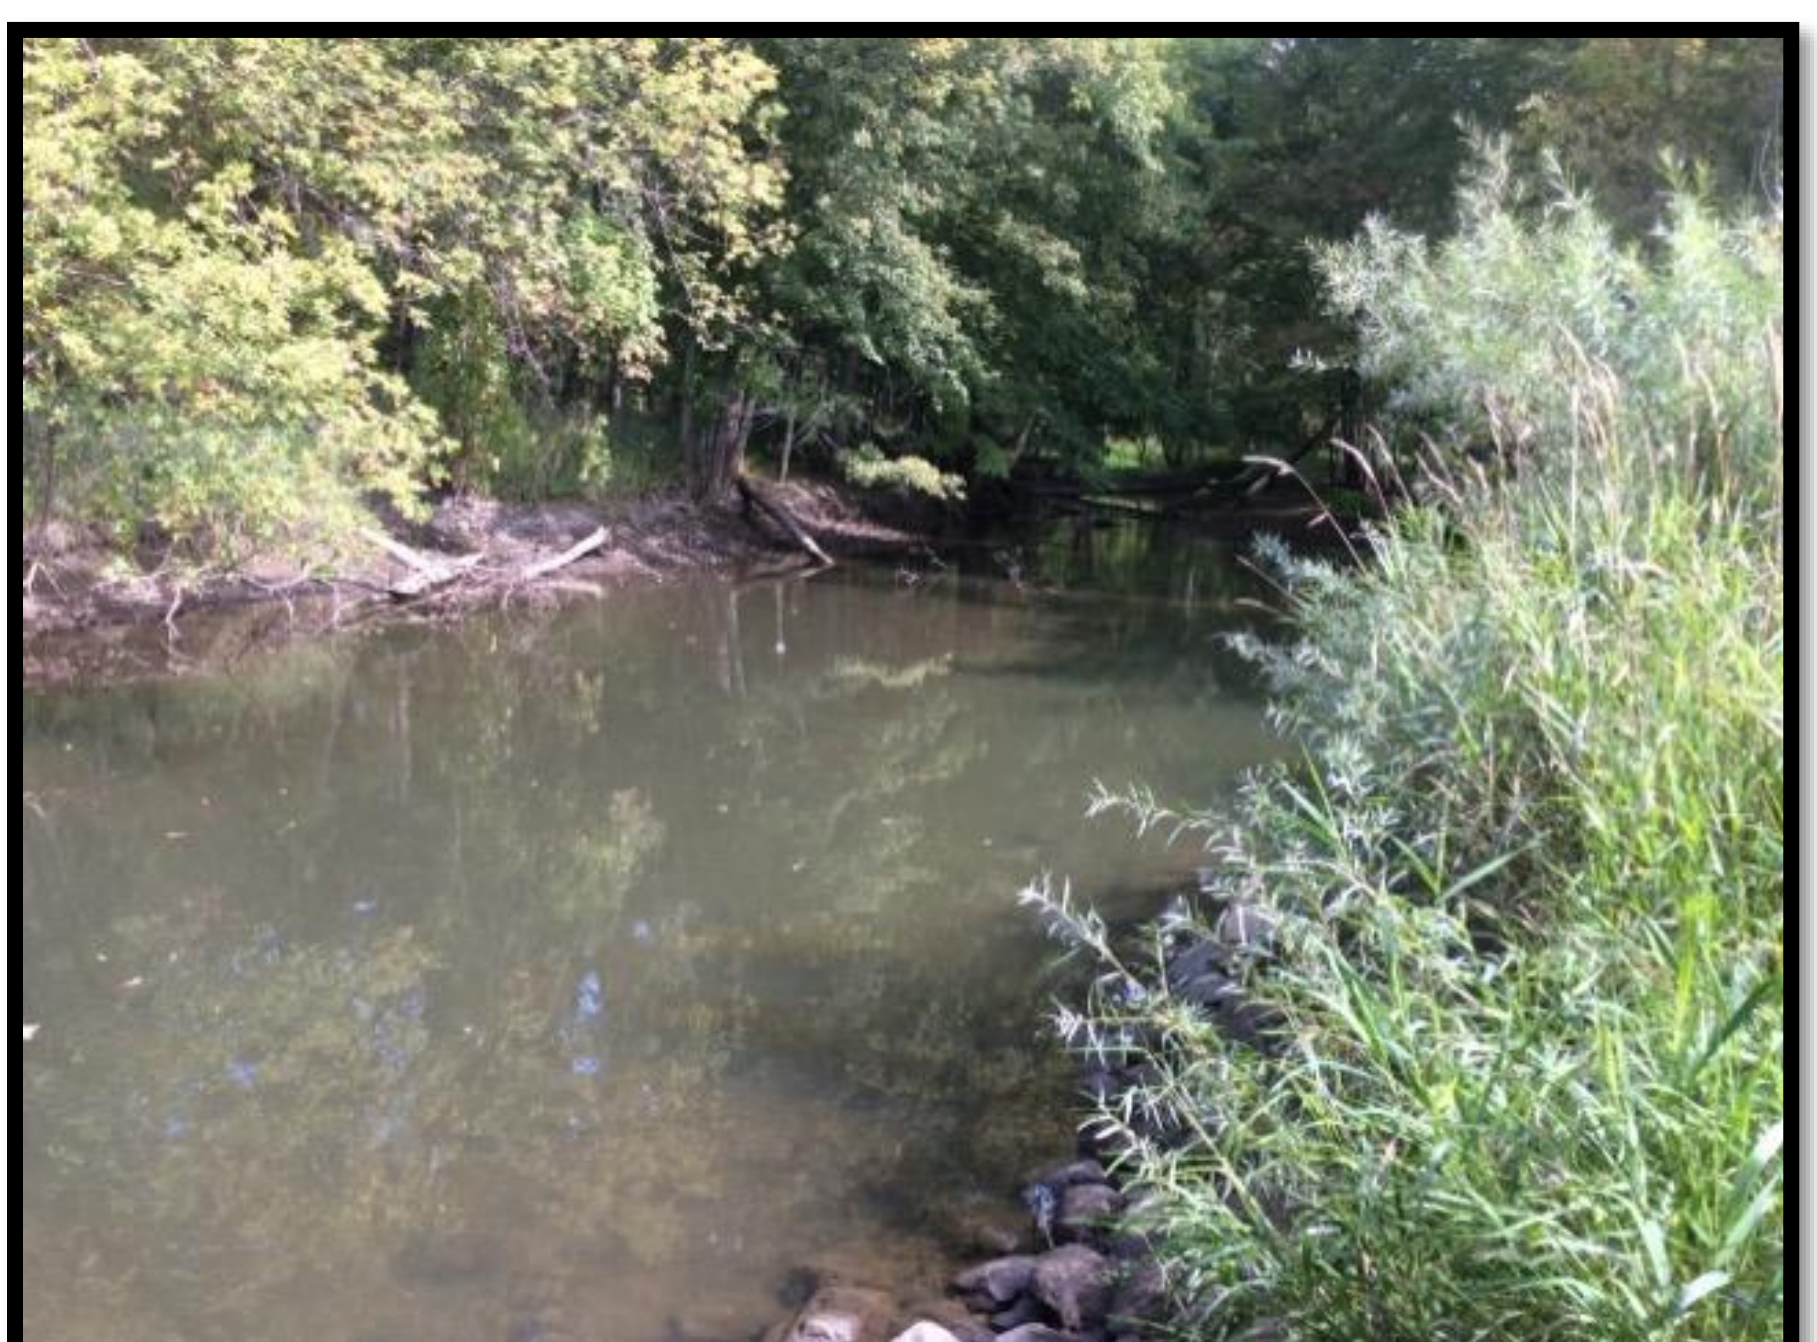
Discharge Point Details	POINT NUMBER	**C32-00**
	DRAIN NAME	**COUNTRY CROSSROADS DRAIN**
	LAND USE/AREA	AGRICULTURAL
	NO. OF DAYS SINCE RUN OFF	2
	RISE X SPAN (IN)	12
	MATERIAL/TYPE	DUAL WALL HDPE
	VEGETATION CONDITION	NORMAL
	OUTFALL DAMAGE	NONE
	FLOW DEPTH (IN)	0
	FLOW PRESENT (Y/N)	NO
	SUBMERGED (Y/N)	NO
Observations	COLOR	NONE
	DEPOSITS/STAINS	NONE
	FLOATABLES	NONE
	TURBIDITY	NONE
	ODOR	NONE
	NOTES	Pipe leads to nearby open drain.
IDEP Parameters	AMMONIA (mg/L)	0
	PH	0
	SURFACTANT (mg/L LAS)	0
	TEMPERATURE (F)	0
	TURBIDITY (NTU)	0
	SPECIFIC CONDUCTIVITY (mS/cm)	0
Data Collection Detail	STAFF	ERS/KRZ
	GPS	+42.639646, -84.602733, +10.000000
	TIMESTAMP	09/12/2017 09:58:48

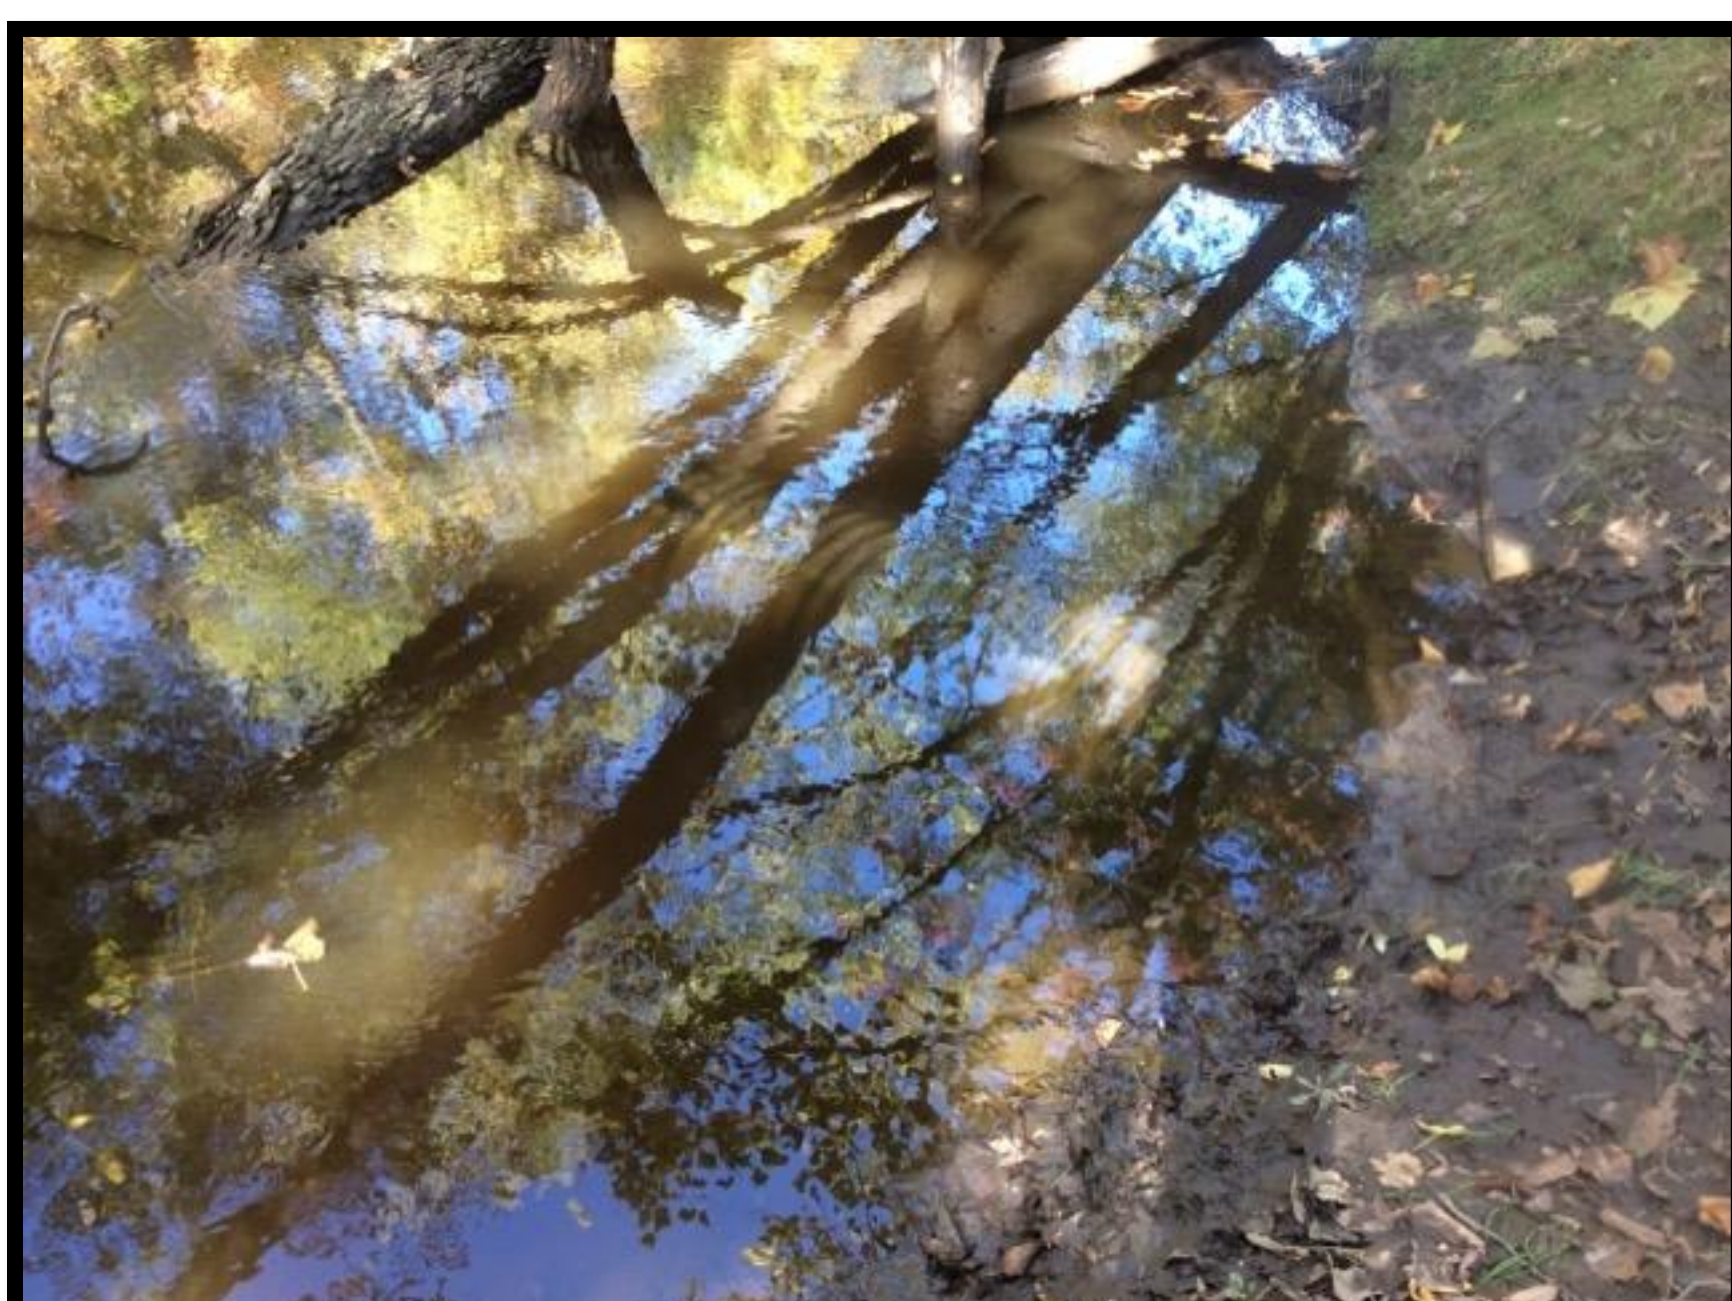
Discharge Point Details	POINT NUMBER	**F06-00**
	DRAIN NAME	**FOREST HILLS DRAIN**
	LAND USE/AREA	RESIDENTIAL - MULTI
	NO. OF DAYS SINCE RUN OFF	2
	RISE X SPAN (IN)	15
	MATERIAL/TYPE	DUAL WALL HDPE
	VEGETATION CONDITION	NORMAL
	OUTFALL DAMAGE	NONE
	FLOW DEPTH (IN)	1
	FLOW PRESENT (Y/N)	YES
	SUBMERGED (Y/N)	NO
Observations	COLOR	NONE
	DEPOSITS/STAINS	NONE
	FLOATABLES	NONE
	TURBIDITY	NONE
	ODOR	NONE
	NOTES	flow is likely due to sprinklers in drainage area
IDEP Parameters	AMMONIA (mg/L)	0
	PH	0
	SURFACTANT (mg/L LAS)	0
	TEMPERATURE (F)	0
	TURBIDITY (NTU)	0
	SPECIFIC CONDUCTIVITY (mS/cm)	0
Data Collection Detail	STAFF	ERS/KRZ
	GPS	+42.705231, -84.421682, +10.000000
	TIMESTAMP	10/19/2017 12:00:11

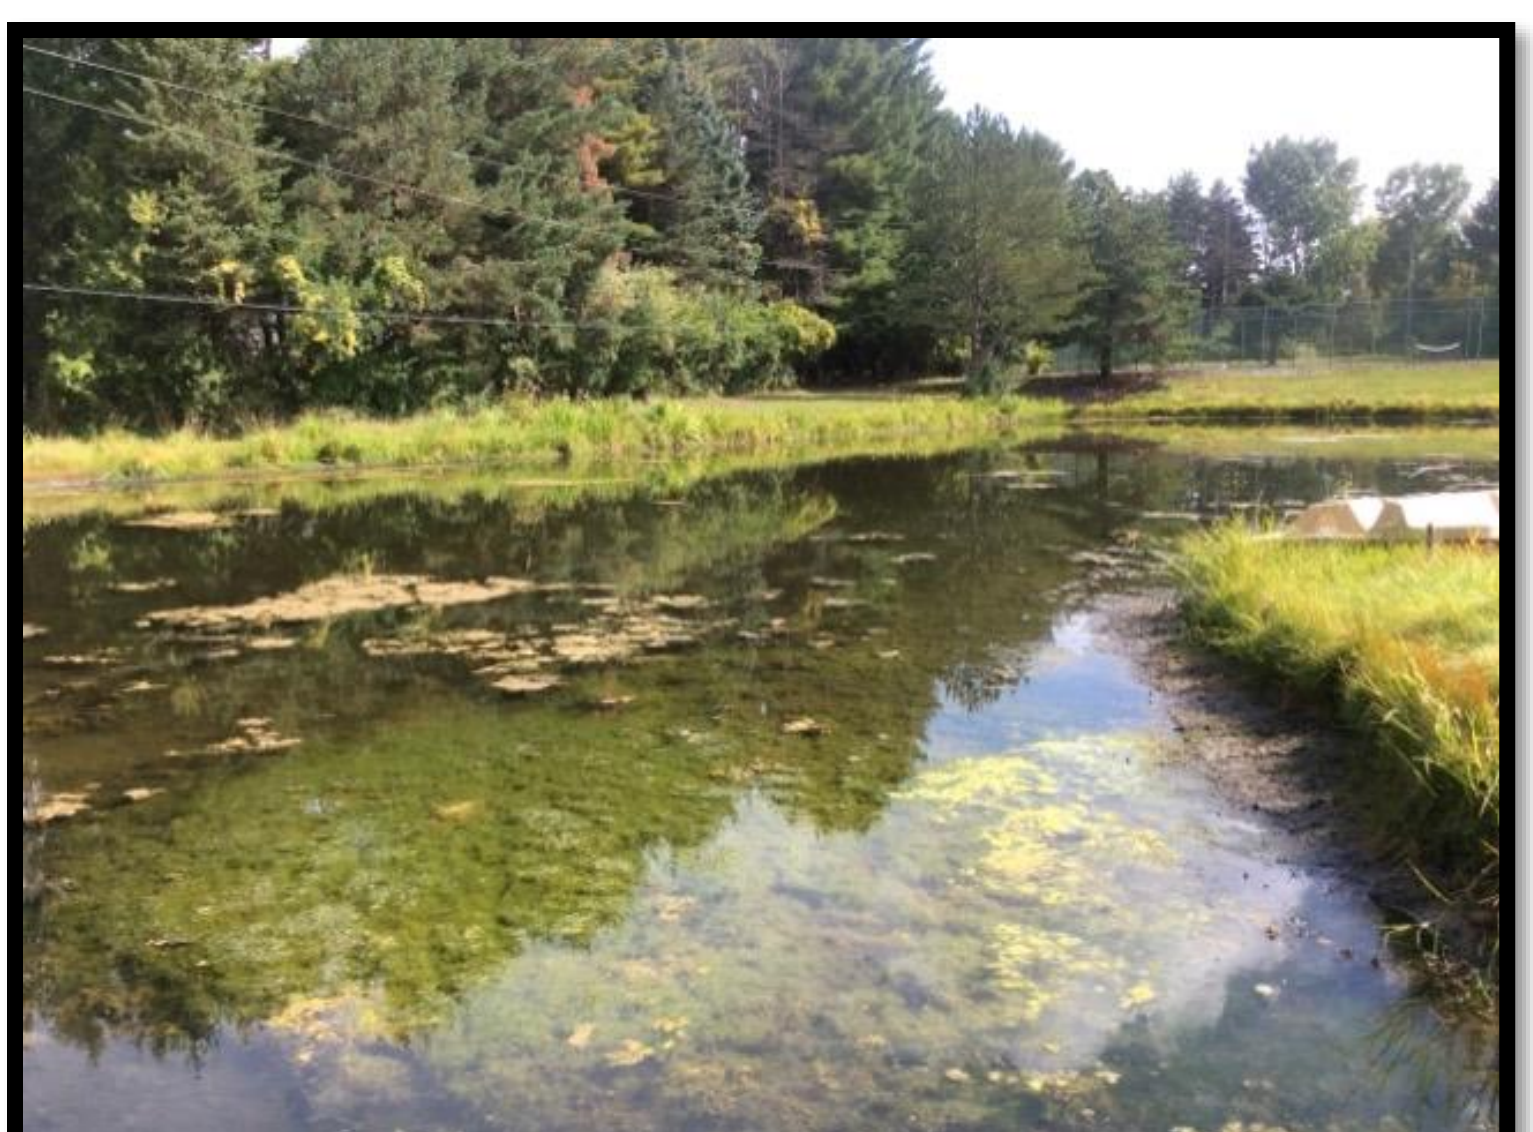
Discharge Point Details	**POINT NUMBER**	**F07-11**
	DRAIN NAME	**FOSTER, GEORGETOWN BRANCH DRAIN**
	LAND USE/AREA	MEADOW
	NO. OF DAYS SINCE RUN OFF	2
	RISE X SPAN (IN)	NA
	MATERIAL/TYPE	NA
	VEGETATION CONDITION	NORMAL
	OUTFALL DAMAGE	NONE
	FLOW DEPTH (IN)	0
	FLOW PRESENT (Y/N)	NO
	SUBMERGED (Y/N)	N/A
Observations	**COLOR**	NONE
	DEPOSITS/STAINS	NONE
	FLOATABLES	NONE
	TURBIDITY	NONE
	ODOR	NONE
	NOTES	Wetland, no pipe observed at point.
IDEP Parameters	**AMMONIA (mg/L)**	0
	PH	0
	SURFACTANT (mg/L LAS)	0
	TEMPERATURE (F)	0
	TURBIDITY (NTU)	0
	SPECIFIC CONDUCTIVITY (mS/cm)	0
Data Collection Detail	**STAFF**	ERS/KRZ
	GPS	+42.731329, -84.397457, +10.000000
	TIMESTAMP	09/14/2017 11:40:25

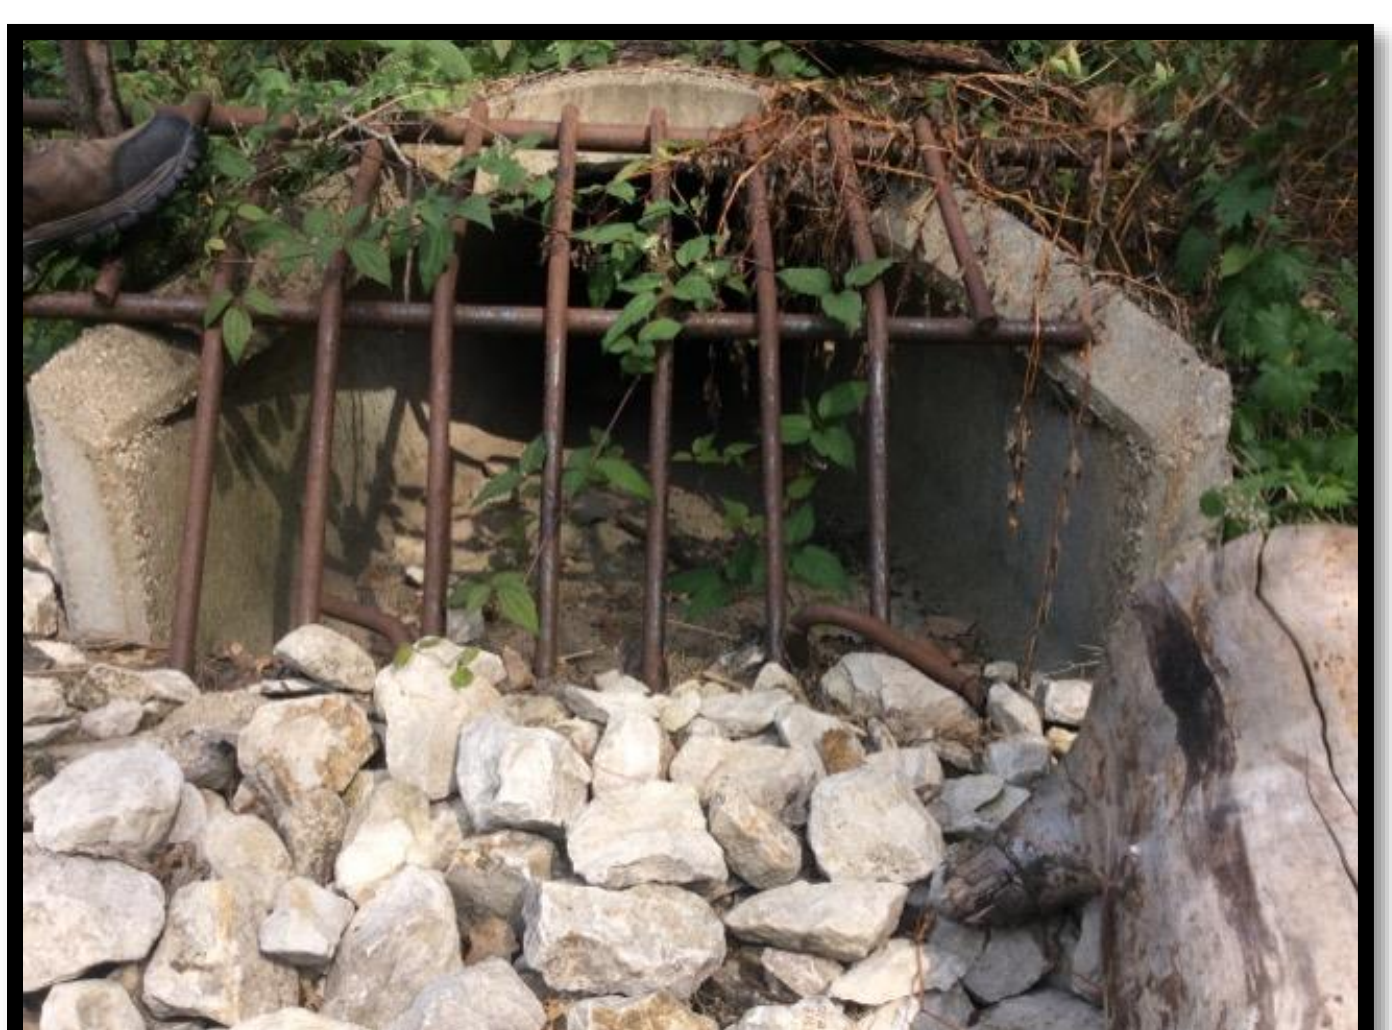
Discharge Point Details	**POINT NUMBER**	**G03-12**
	DRAIN NAME	**GILBERT, HOUGHTON HOLLOW BRANCH DRAIN**
	LAND USE/AREA	RESIDENTIAL - MULTI
	NO. OF DAYS SINCE RUN OFF	2
	RISE X SPAN (IN)	15
	MATERIAL/TYPE	ROUND CONCRETE
	VEGETATION CONDITION	NORMAL
	OUTFALL DAMAGE	NONE
	FLOW DEPTH (IN)	0
	FLOW PRESENT (Y/N)	NO
	SUBMERGED (Y/N)	N/A
Observations	**COLOR**	NONE
	DEPOSITS/STAINS	NONE
	FLOATABLES	NONE
	TURBIDITY	NONE
	ODOR	NONE
	NOTES	Outfalls into a low-lying backyard.
IDEP Parameters	**AMMONIA (mg/L)**	0
	PH	0
	SURFACTANT (mg/L LAS)	0
	TEMPERATURE (F)	0
	TURBIDITY (NTU)	0
	SPECIFIC CONDUCTIVITY (mS/cm)	0
Data Collection Detail	**STAFF**	ERS/KRZ
	GPS	+42.653179, -84.580195, +10.000000
	TIMESTAMP	09/11/2017 14:29:24
