Schedule of Compliance Submittal - Basic

Site name:
Ingham CDC MS4

INGHAM COUNTY DRAINS MS4 PROGRESS REPORT

APRIL 1, 2021

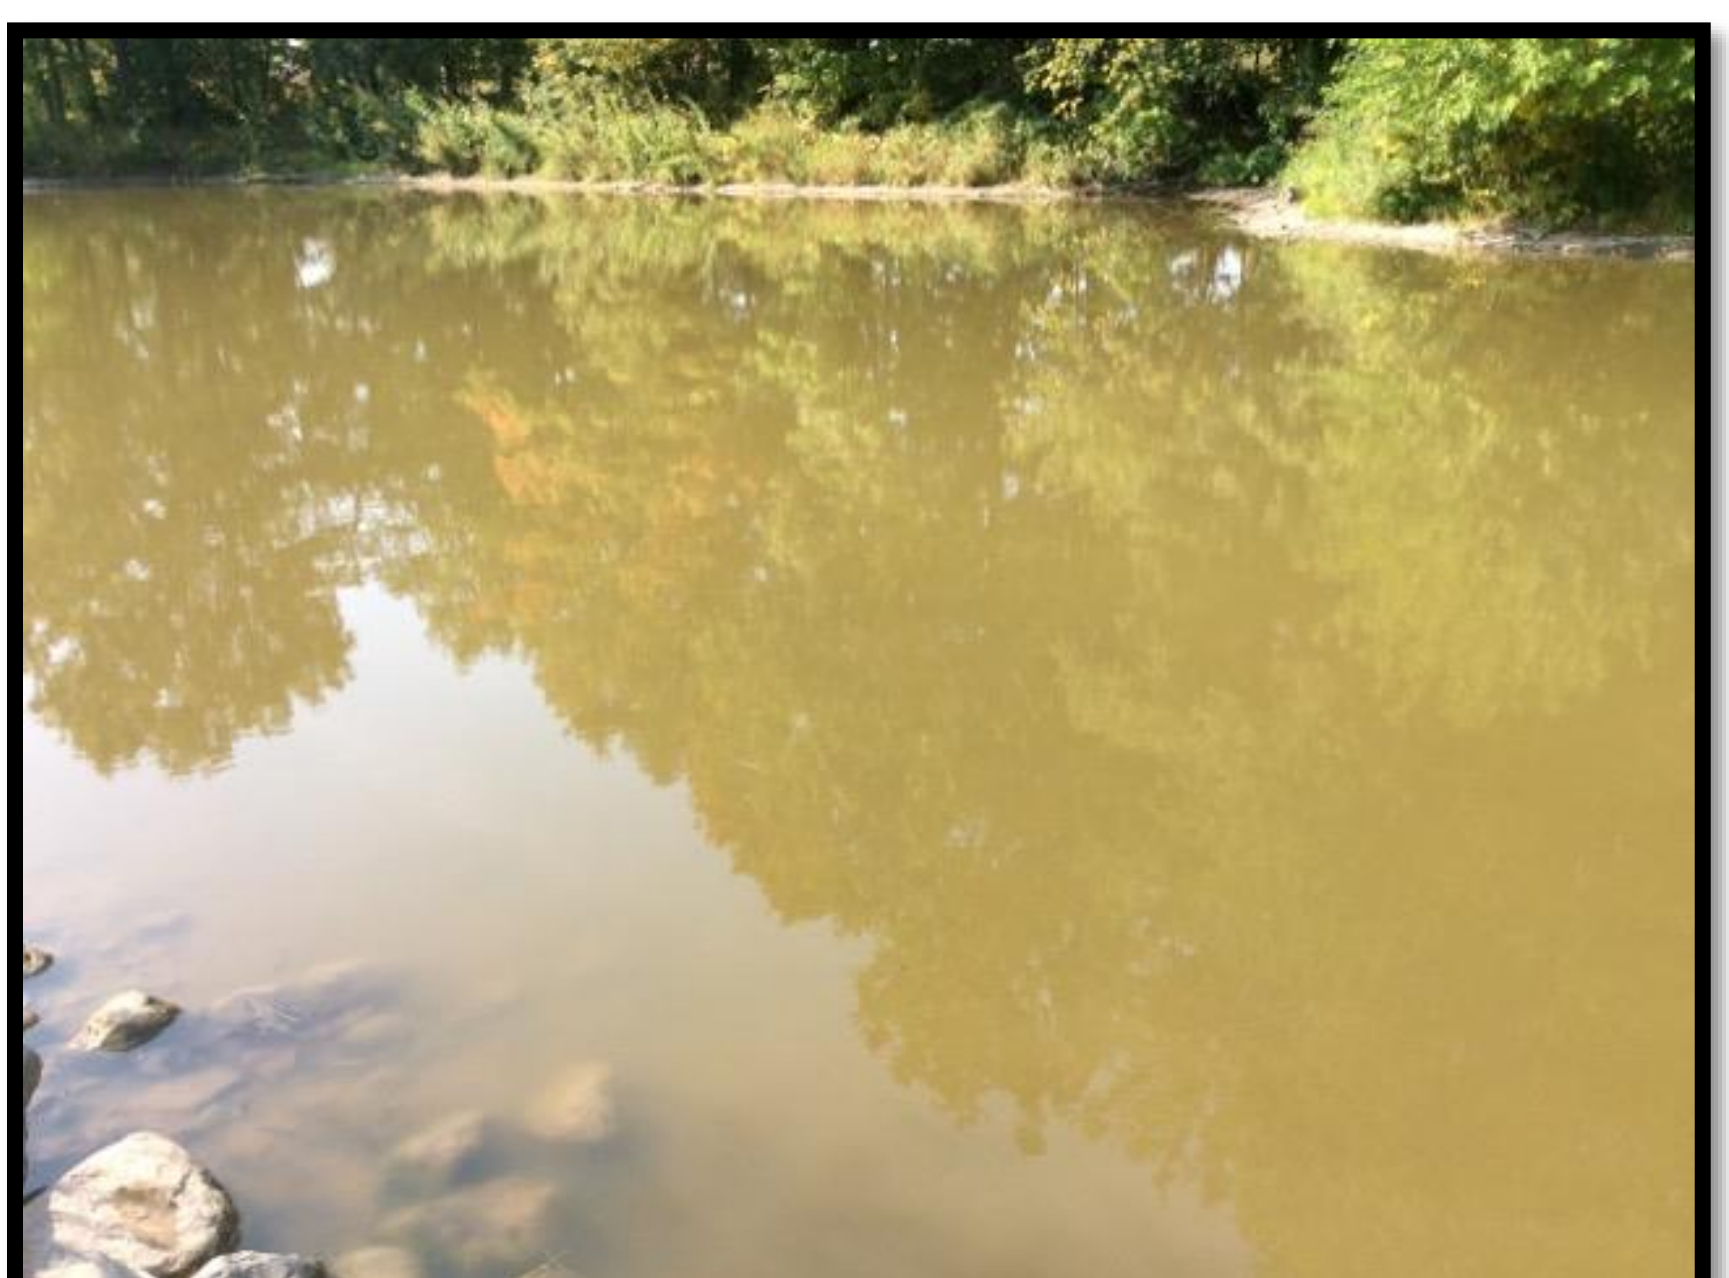
Discharge Point Details	POINT NUMBER	**G10-00**
	DRAIN NAME	**GRAHAM AND BRANCH NO. 1 DRAIN**
	LAND USE/AREA	RESIDENTIAL - MULTI
	NO. OF DAYS SINCE RUN OFF	2
	RISE X SPAN (IN)	NA
	MATERIAL/TYPE	NA
	VEGETATION CONDITION	NORMAL
	OUTFALL DAMAGE	NONE
	FLOW DEPTH (IN)	0
	FLOW PRESENT (Y/N)	NO
	SUBMERGED (Y/N)	NO
Observations	COLOR	NONE
	DEPOSITS/STAINS	NONE
	FLOATABLES	NONE
	TURBIDITY	NONE
	ODOR	NONE
	NOTES	Supposed to be a tile to tile connection point. No structures present. May be an old, collapsed clay pipe as there's a wet area.
IDEP Parameters	AMMONIA (mg/L)	0
	pH	0
	SURFACTANT (mg/L LAS)	0
	TEMPERATURE (F)	0
	TURBIDITY (NTU)	0
	SPECIFIC CONDUCTIVITY (mS/cm)	0
Data Collection Detail	STAFF	ERS/KRZ
	GPS	+42.598388, -84.501841, +10.000000
	TIMESTAMP	09/11/2017 12:08:21

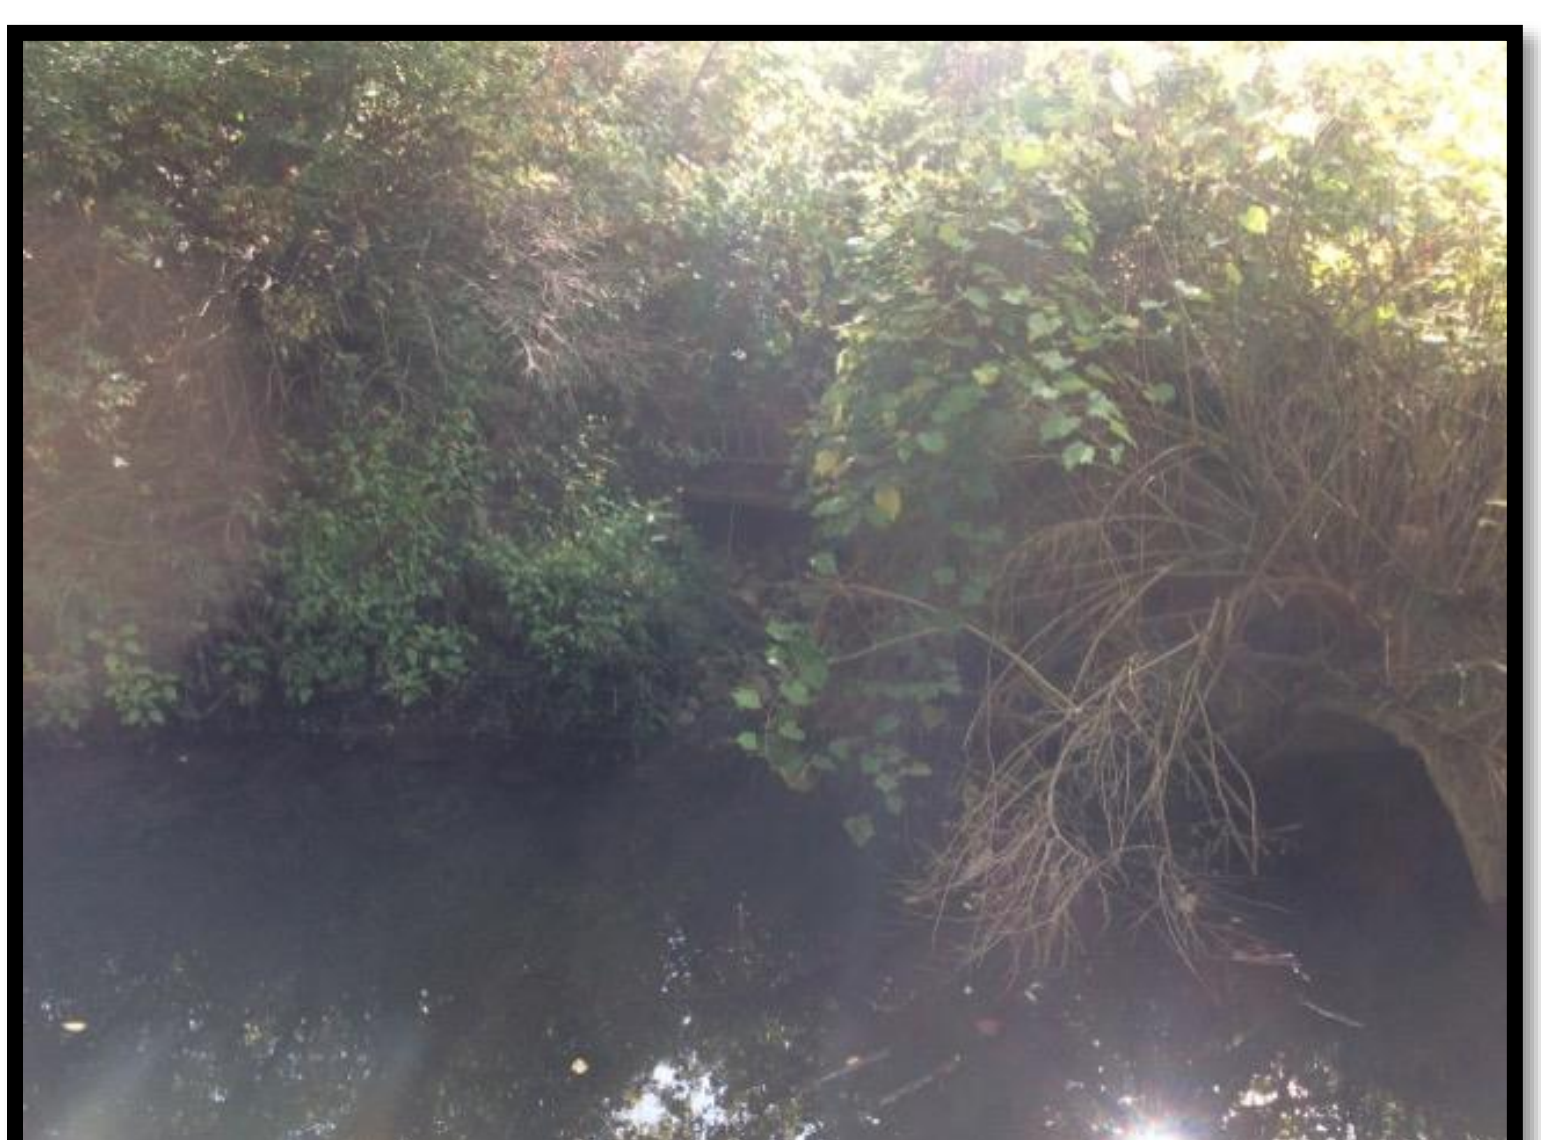
Discharge Point Details	**POINT NUMBER**	**G16-00**
	DRAIN NAME	**GREENCREST RELIEF DRAIN**
	LAND USE/AREA	WOODED AREA
	NO. OF DAYS SINCE RUN OFF	2
	RISE X SPAN (IN)	27
	MATERIAL/TYPE	CONCRETE ELEPTICAL
	VEGETATION CONDITION	NORMAL
	OUTFALL DAMAGE	NONE
	FLOW DEPTH (IN)	0
	FLOW PRESENT (Y/N)	NO
	SUBMERGED (Y/N)	NO
Observations	**COLOR**	NONE
	DEPOSITS/STAINS	NONE
	FLOATABLES	NONE
	TURBIDITY	CLOUDY
	ODOR	NONE
	NOTES	Standing water, somewhat cloudy.
IDEP Parameters	**AMMONIA (mg/L)**	0
	pH	0
	SURFACTANT (mg/L LAS)	0
	TEMPERATURE (F)	0
	TURBIDITY (NTU)	0
	SPECIFIC CONDUCTIVITY (mS/cm)	0
Data Collection Detail	**STAFF**	ERS/KRZ
	GPS	+42.746629, -84.442149, +10.000000
	TIMESTAMP	09/13/2017 13:39:13

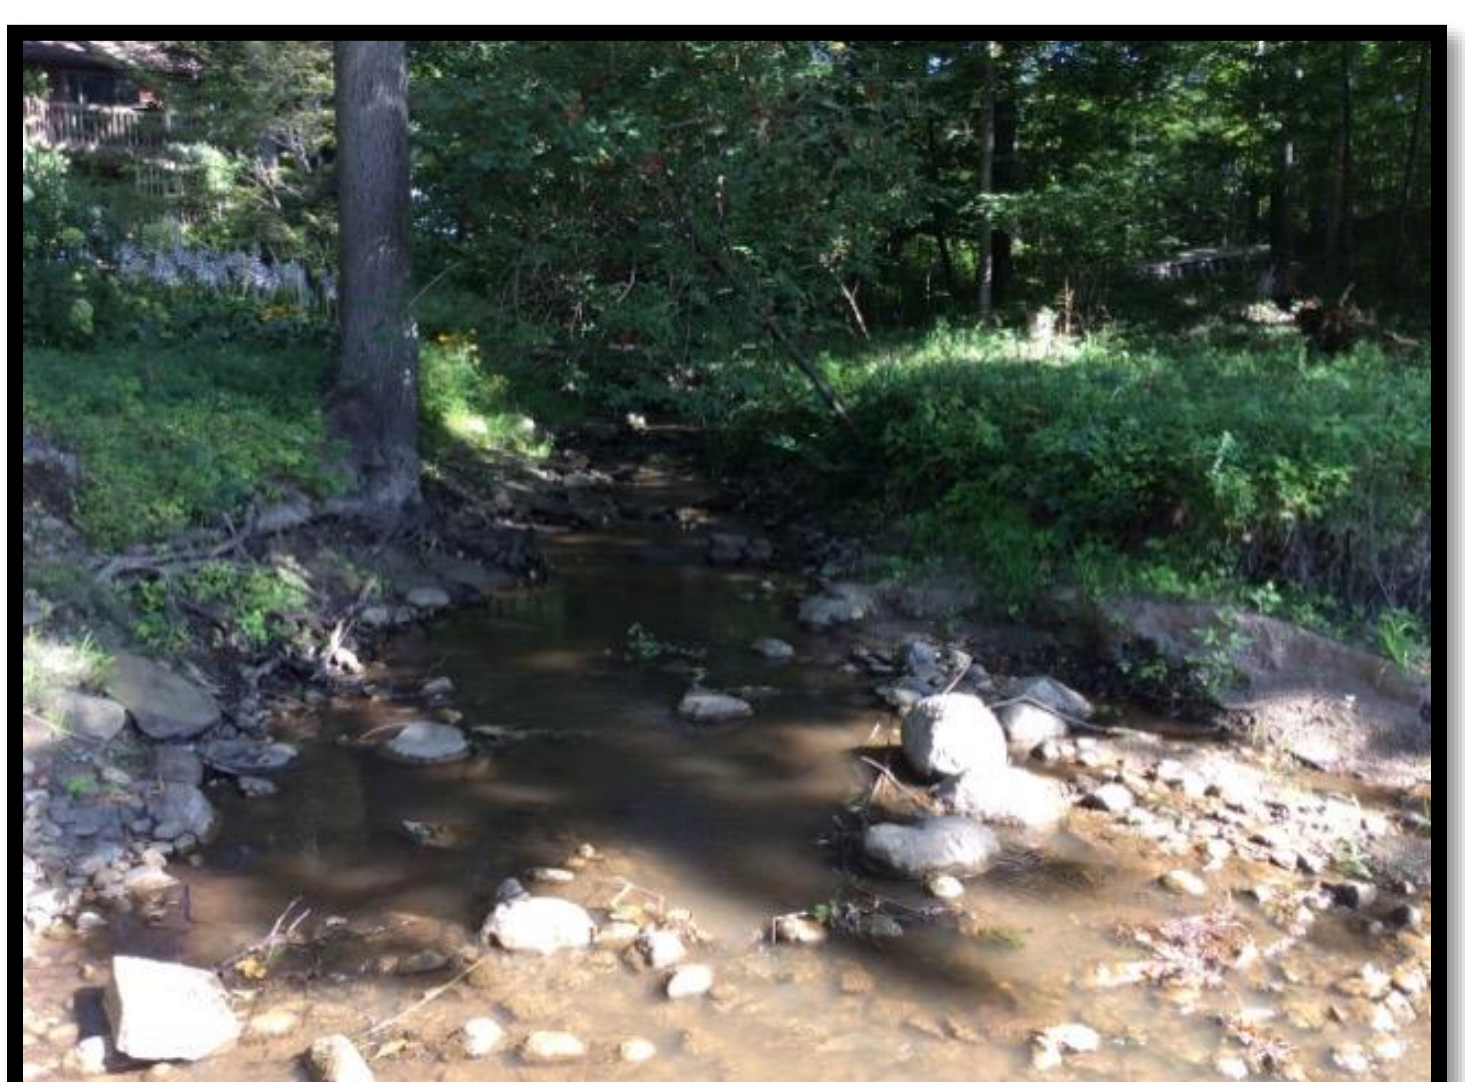
Discharge Point Details	**POINT NUMBER**	**G39-02**
	DRAIN NAME	**FOLLOW UP - GROVENBURG DRAIN DRAINAGE DISTRICT, COUNTRY VIEW ESTATES BRANCH DRAIN**
	LAND USE/AREA	RESIDIENTIAL - SINGLE
	NO. OF DAYS SINCE RUN OFF	2
	RISE X SPAN (IN)	-
	MATERIAL/TYPE	-
	VEGETATION CONDITION	-
	OUTFALL DAMAGE	-
	FLOW DEPTH (IN)	0
	FLOW PRESENT (Y/N)	YES
	SUBMERGED (Y/N)	N/A
Observations	**COLOR**	NONE
	DEPOSITS/STAINS	NONE
	FLOATABLES	NONE
	TURBIDITY	NONE
	ODOR	NONE
	NOTES	Open drain with natural flow. No irregular water quality observations. No follow up.
IDEP Parameters	**AMMONIA (mg/L)**	0
	pH	0
	SURFACTANT (mg/L LAS)	0
	TEMPERATURE (F)	0
	TURBIDITY (NTU)	0
	SPECIFIC CONDUCTIVITY (mS/cm)	-
Data Collection Detail	**STAFF**	ERS/KRZ
	GPS	+42.619926, -84.593810, +10.000000
	TIMESTAMP

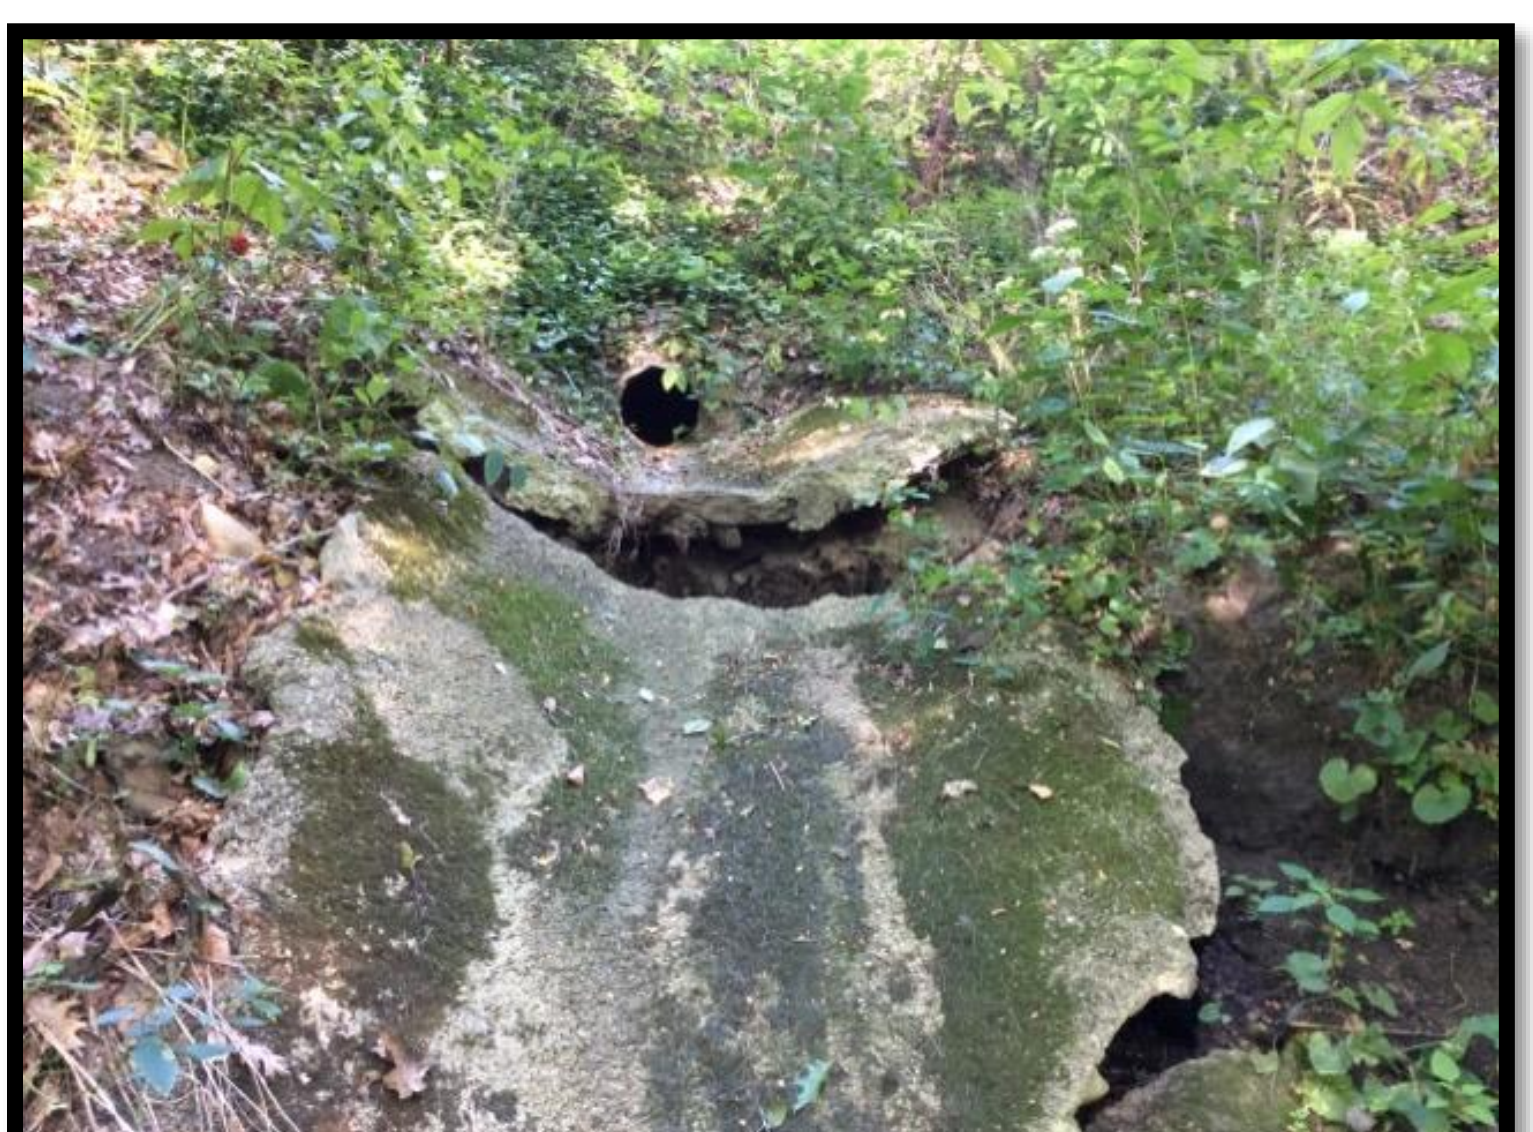
Discharge Point Details	**POINT NUMBER**	**H19-00**
	DRAIN NAME	**HEATHER HAVEN BRANCH OF GROVENBURG AND MENGER DRAIN**
	LAND USE/AREA	RESIDENTIAL - MULTI
	NO. OF DAYS SINCE RUN OFF	2
	RISE X SPAN (IN)	10
	MATERIAL/TYPE	ROUND CMP
	VEGETATION CONDITION	NORMAL
	OUTFALL DAMAGE	CONCRETE CRACKING
	FLOW DEPTH (IN)	0
	FLOW PRESENT (Y/N)	NO
	SUBMERGED (Y/N)	NO
Observations	**COLOR**	NONE
	DEPOSITS/STAINS	NONE
	FLOATABLES	NONE
	TURBIDITY	NONE
	ODOR	NONE
	NOTES	Outfall to Grovenburg drain from nearby community. Drain number doesn't match ID number.
IDEP Parameters	**AMMONIA (mg/L)**	-
	pH	-
	SURFACTANT (mg/L LAS)	-
	TEMPERATURE (F)	-
	TURBIDITY (NTU)	-
	SPECIFIC CONDUCTIVITY (mS/cm)	-
Data Collection Detail	**STAFF**	ERS/KRZ
	GPS	+42.620458, -84.593634, +10.000000
	TIMESTAMP	09/06/2017 10:42:15

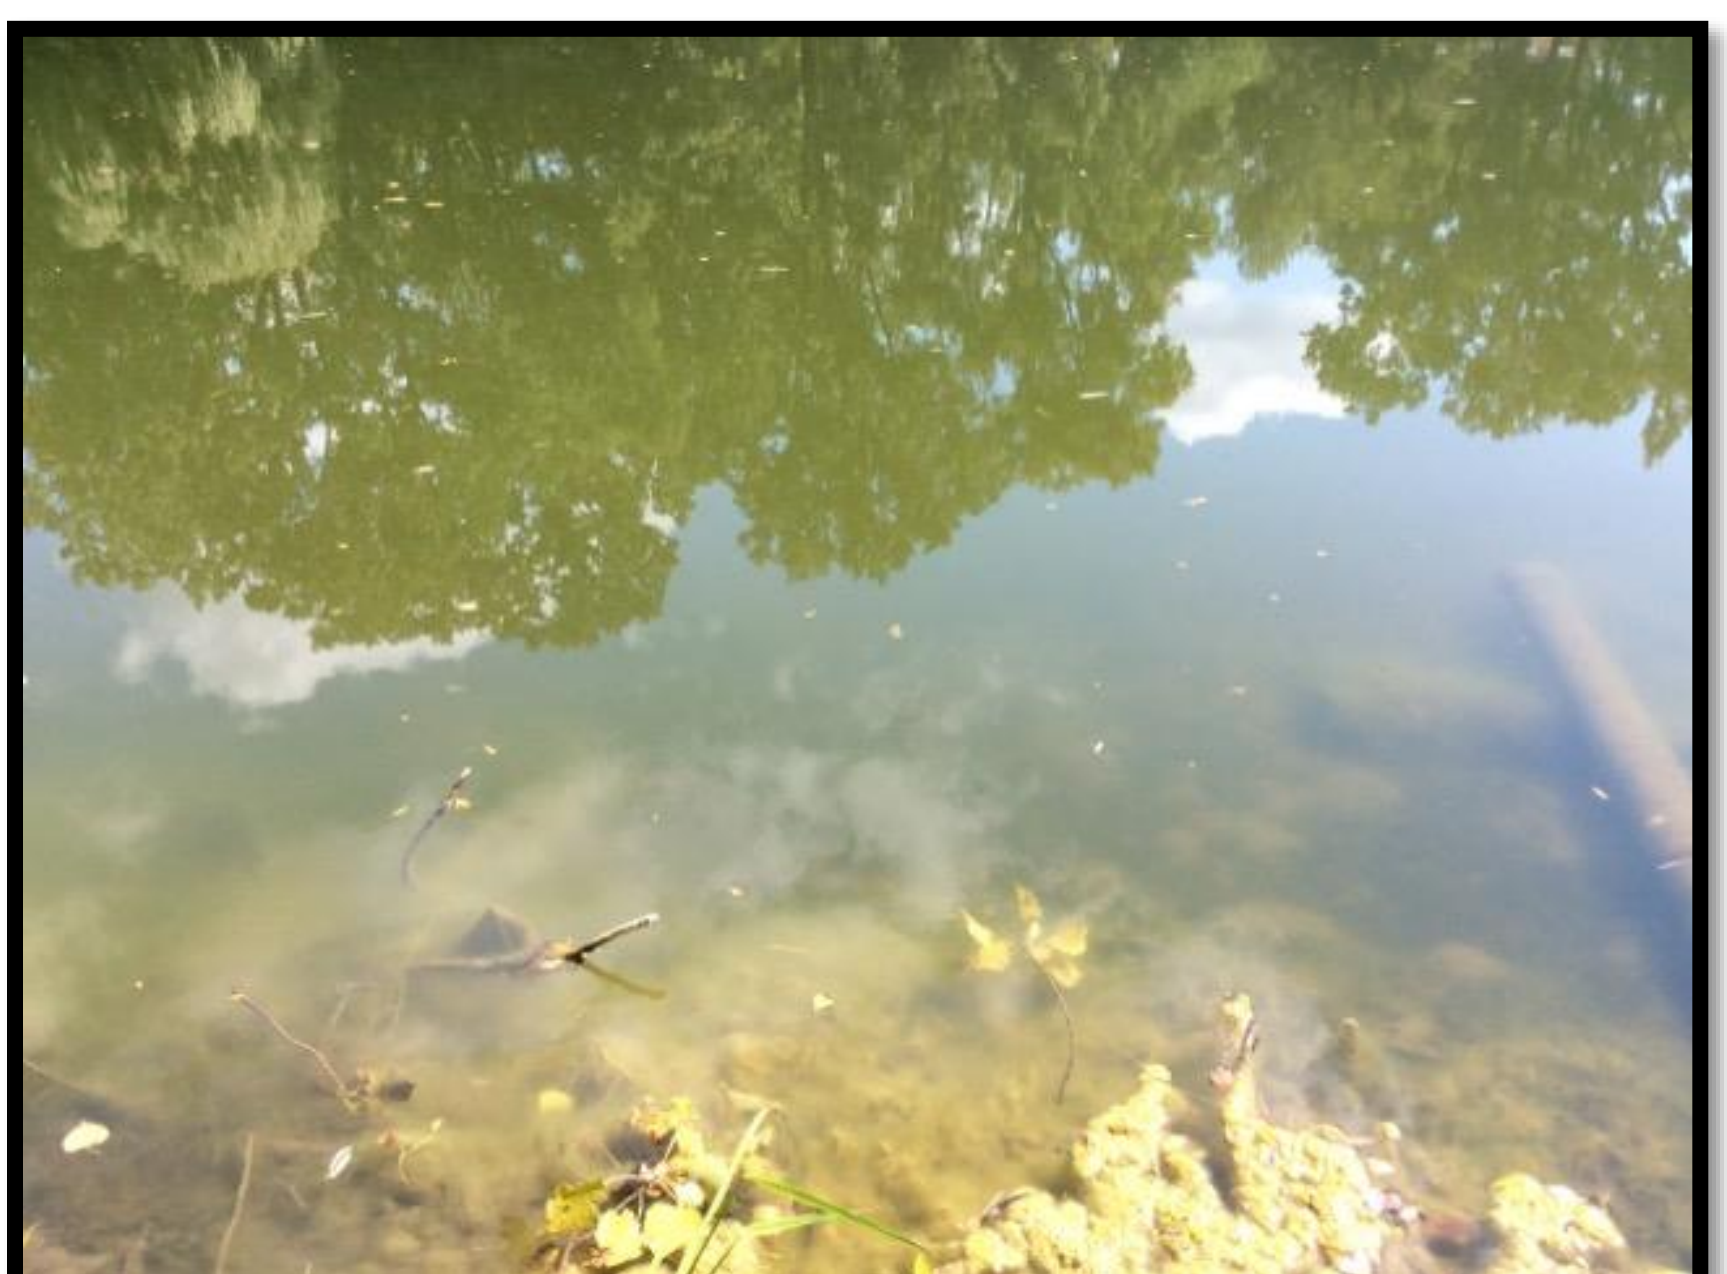
Discharge Point Details	**POINT NUMBER**	**I06-02**
	DRAIN NAME	**INDIAN LAKES NO. 2 DRAIN**
	LAND USE/AREA	RESIDIENTIAL - SINGLE
	NO. OF DAYS SINCE RUN OFF	2
	RISE X SPAN (IN)	24
	MATERIAL/TYPE	ROUND CMP
	VEGETATION CONDITION	INHIBITATED GROWTH
	OUTFALL DAMAGE	METAL CORROSION
	FLOW DEPTH (IN)	0
	FLOW PRESENT (Y/N)	NO
	SUBMERGED (Y/N)	YES
Observations	**COLOR**	NONE
	DEPOSITS/STAINS	NONE
	FLOATABLES	NONE
	TURBIDITY	NONE
	ODOR	NONE
	NOTES	End of pipe is extremely corroded.
IDEP Parameters	**AMMONIA (mg/L)**	0
	pH	0
	SURFACTANT (mg/L LAS)	0
	TEMPERATURE (F)	0
	TURBIDITY (NTU)	0
	SPECIFIC CONDUCTIVITY (mS/cm)	0
Data Collection Detail	**STAFF**	ERS/KRZ
	GPS	+42.722507, -84.446091, +10.000000
	TIMESTAMP	09/14/2017 13:34:30

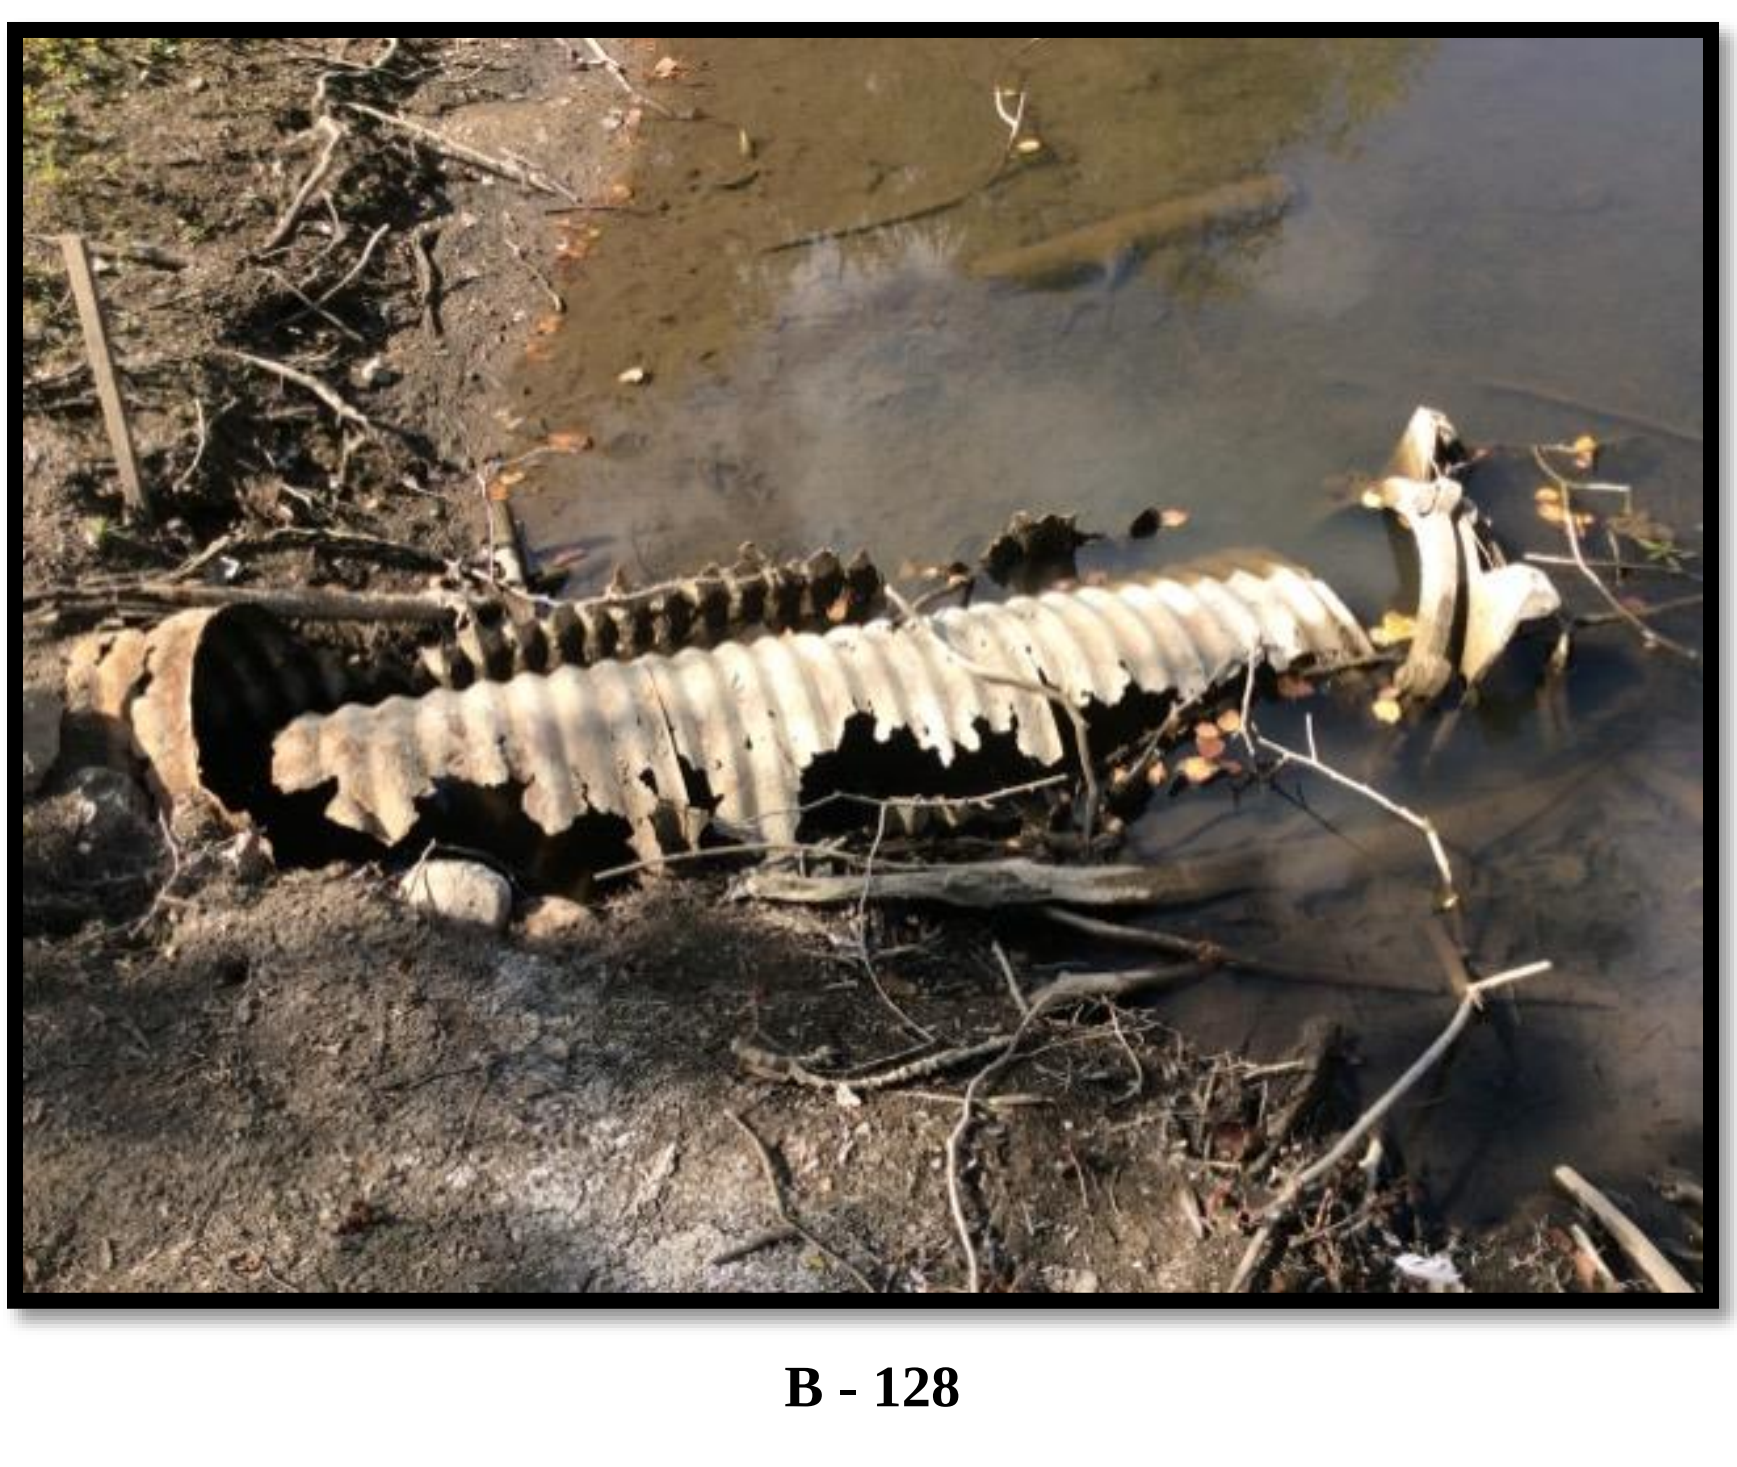
Discharge Point Details	POINT NUMBER	**I06-05**
	DRAIN NAME	**INDIAN LAKES, MAUMEE BRANCH DRAIN**
	LAND USE/AREA	WOODED AREA
	NO. OF DAYS SINCE RUN OFF	2
	RISE X SPAN (IN)	8
	MATERIAL/TYPE	clay
	VEGETATION CONDITION	NORMAL
	OUTFALL DAMAGE	FES SEPARATED
	FLOW DEPTH (IN)	0
	FLOW PRESENT (Y/N)	NO
	SUBMERGED (Y/N)	NO
Observations	COLOR	NONE
	DEPOSITS/STAINS	NONE
	FLOATABLES	NONE
	TURBIDITY	NONE
	ODOR	NONE
	NOTES	Clay pipe filled with dirt. Appears that an animal has dug it out and is living in it.
IDEP Parameters	AMMONIA (mg/L)	0
	pH	0
	SURFACTANT (mg/L LAS)	0
	TEMPERATURE (F)	0
	TURBIDITY (NTU)	0
	SPECIFIC CONDUCTIVITY (mS/cm)	0
Data Collection Detail	STAFF	ERS/KRZ
	GPS	+42.712368, -84.442580, +10.000000
	TIMESTAMP	09/14/2017 13:13:16

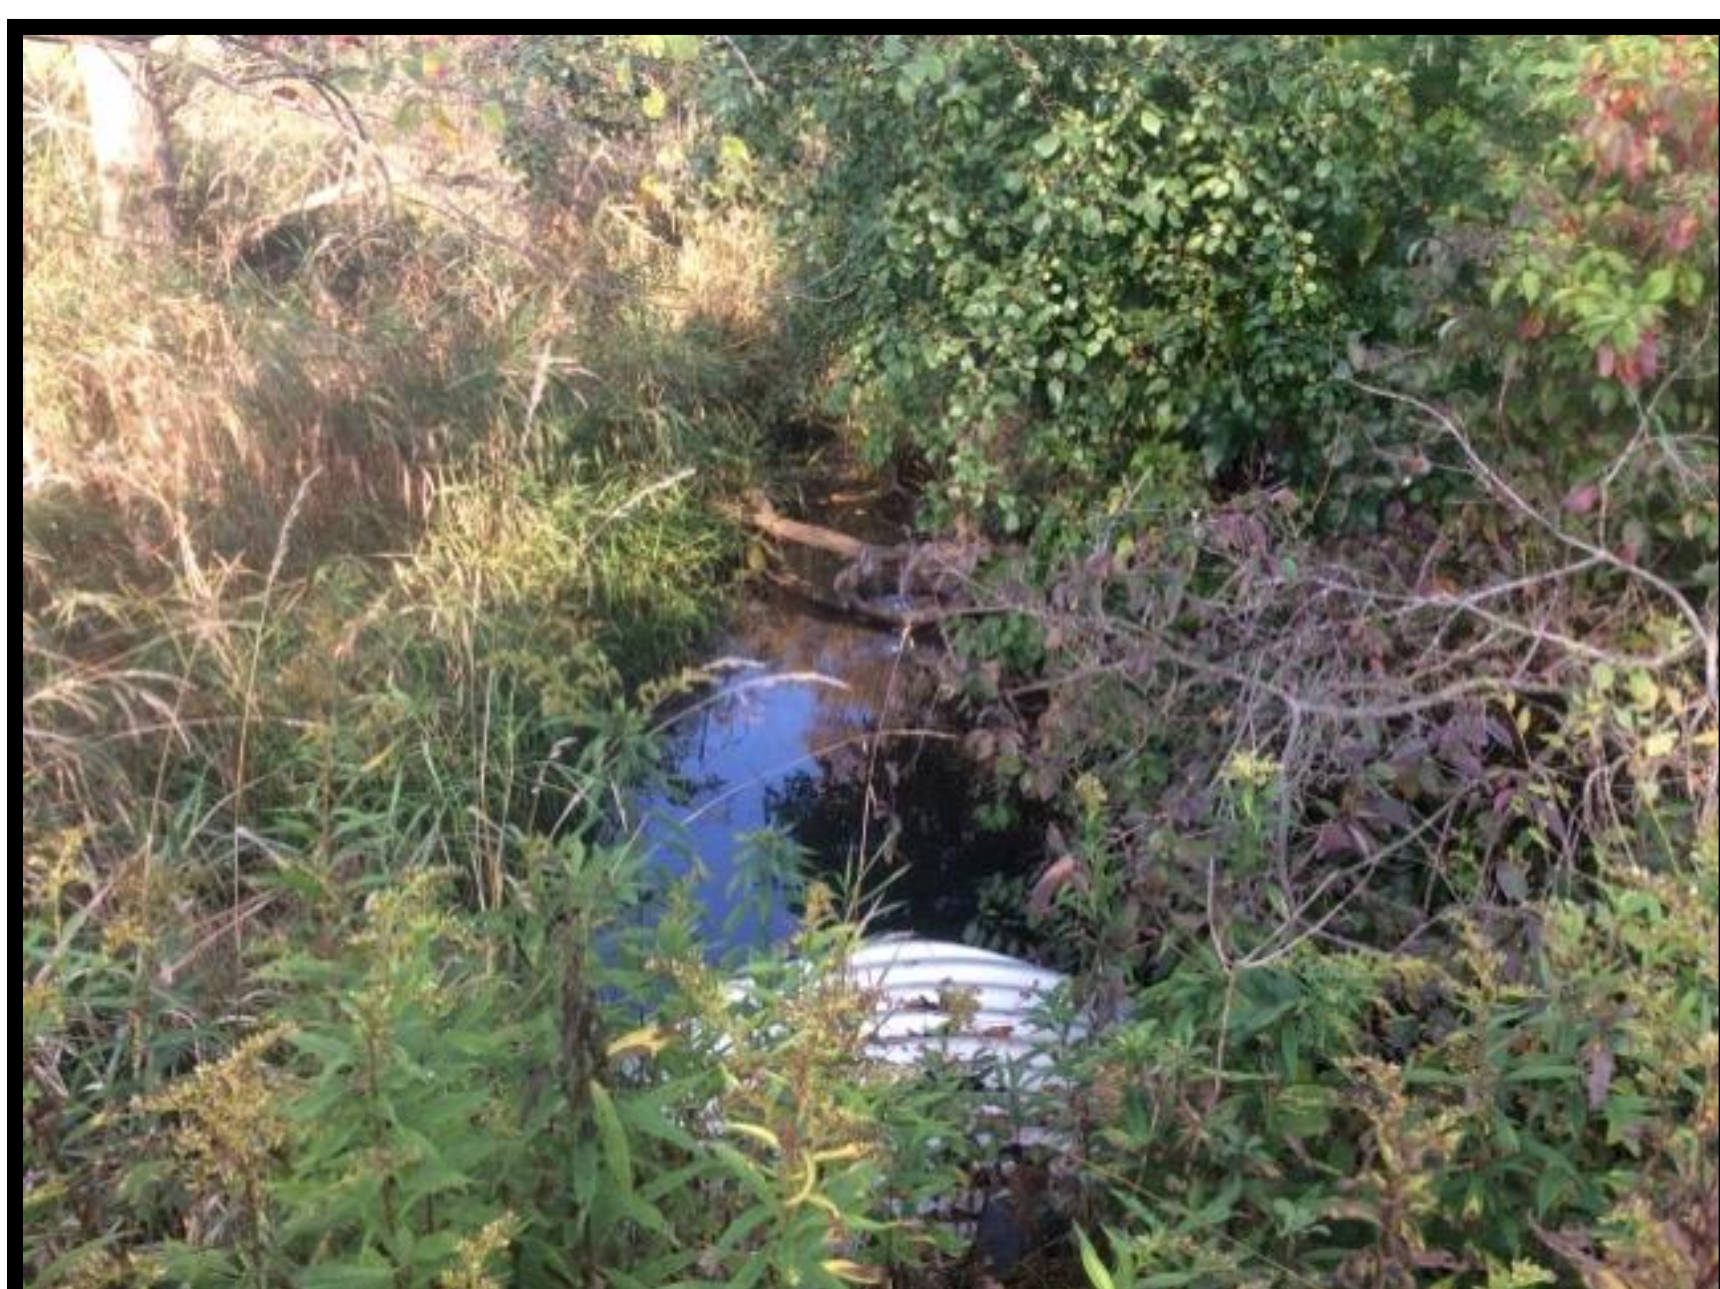
Discharge Point Details	POINT NUMBER	**J16-00**
	DRAIN NAME	**JULIE HICKS DRAIN**
	LAND USE/AREA	AGRICULTURAL
	NO. OF DAYS SINCE RUN OFF	2
	RISE X SPAN (IN)	12
	MATERIAL/TYPE	DUAL WALL HDPE
	VEGETATION CONDITION	NORMAL
	OUTFALL DAMAGE	NONE
	FLOW DEPTH (IN)	0
	FLOW PRESENT (Y/N)	NO
	SUBMERGED (Y/N)	YES
Observations	COLOR	NONE
	DEPOSITS/STAINS	NONE
	FLOATABLES	NONE
	TURBIDITY	NONE
	ODOR	NONE
	NOTES	Pipe coming from north has no flow. There is a small pipe (2") coming from the southeast that is flowing. Standing water in structure.
IDEP Parameters	AMMONIA (mg/L)	0
	pH	0
	SURFACTANT (mg/L LAS)	0
	TEMPERATURE (F)	0
	TURBIDITY (NTU)	0
	SPECIFIC CONDUCTIVITY (mS/cm)	0
Data Collection Detail	STAFF	ERS/KRZ
	GPS	+42.625697, -84.602532, +10.000000
	TIMESTAMP	09/12/2017 09:41:40

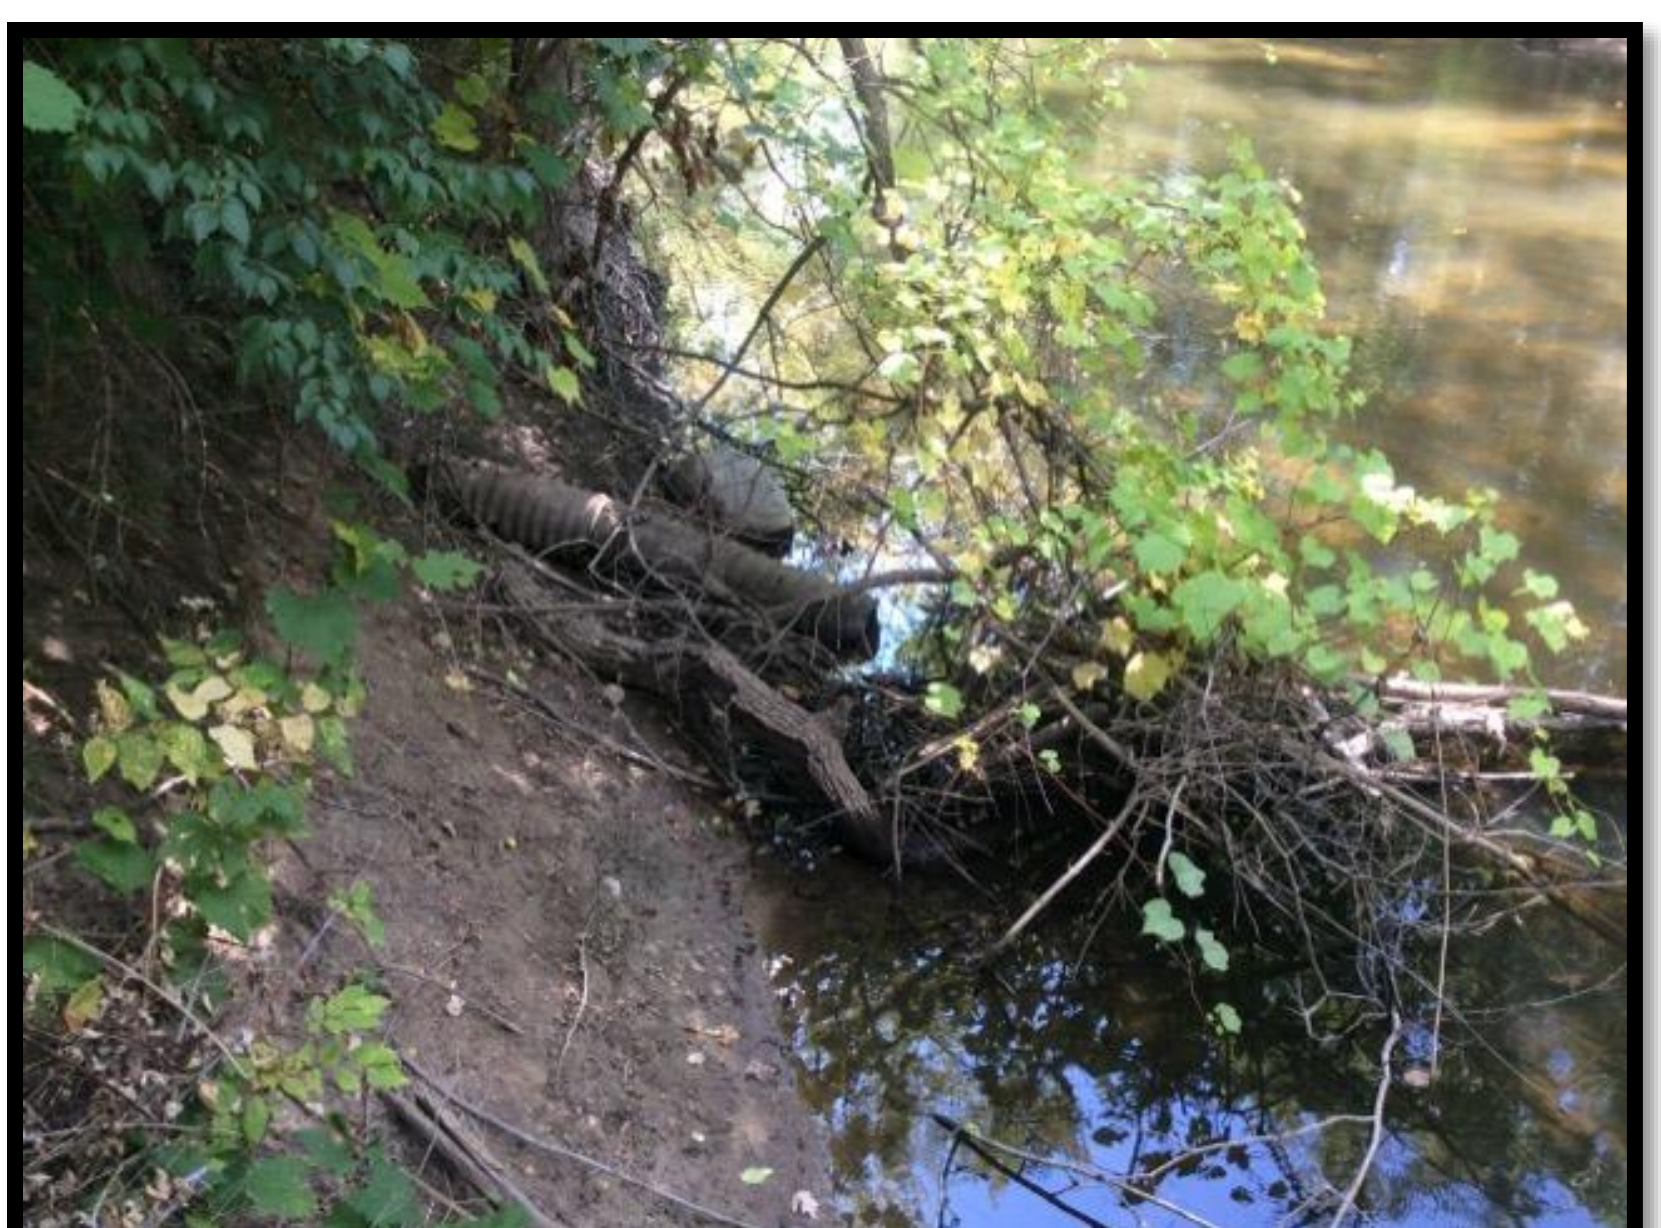
Discharge Point Details	**POINT NUMBER**	**K05-00**
	DRAIN NAME	**KIERSTEAD DRAIN**
	LAND USE/AREA	WOODED AREA
	NO. OF DAYS SINCE RUN OFF	2
	RISE X SPAN (IN)	46
	MATERIAL/TYPE	ROUND CONCRETE
	VEGETATION CONDITION	NORMAL
	OUTFALL DAMAGE	NONE
	FLOW DEPTH (IN)	0
	FLOW PRESENT (Y/N)	NO
	SUBMERGED (Y/N)	NO
Observations	**COLOR**	NONE
	DEPOSITS/STAINS	NONE
	FLOATABLES	NONE
	TURBIDITY	NONE
	ODOR	NONE
	NOTES	Outfall in good condition. Minimal standing water.
IDEP Parameters	**AMMONIA (mg/L)**	0
	pH	0
	SURFACTANT (mg/L LAS)	0
	TEMPERATURE (F)	0
	TURBIDITY (NTU)	0
	SPECIFIC CONDUCTIVITY (mS/cm)	0
Data Collection Detail	**STAFF**	ERS/KRZ
	GPS	+42.739958, -84.443216, +10.000000
	TIMESTAMP	09/13/2017 13:08:46

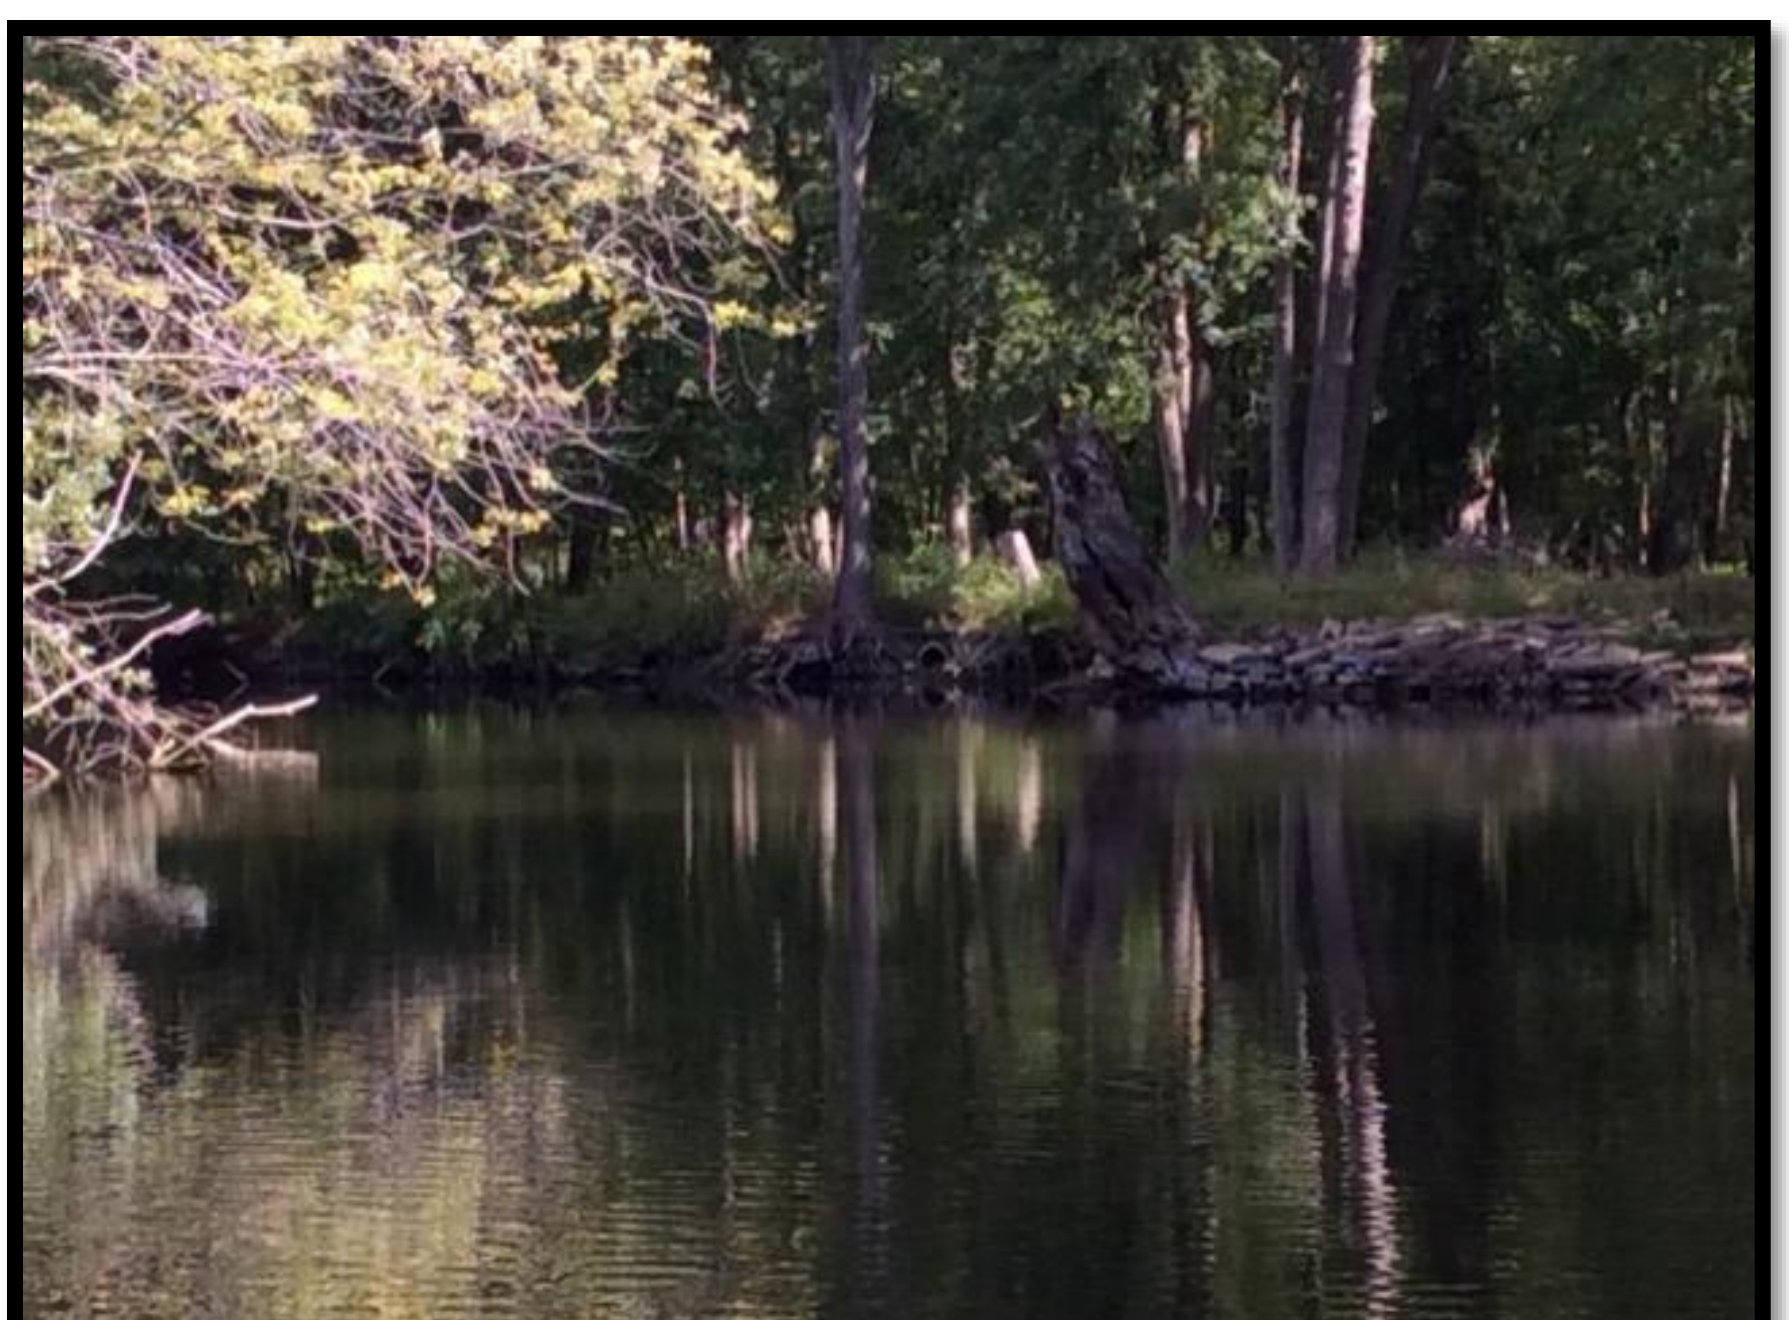
Discharge Point Details	POINT NUMBER	K11-00
	DRAIN NAME	KINAWA VIEW DRAIN
	LAND USE/AREA	RESIDIENTIAL - SINGLE
	NO. OF DAYS SINCE RUN OFF	2
	RISE X SPAN (IN)	48
	MATERIAL/TYPE	ROUND CONCRETE
	VEGETATION CONDITION	NORMAL
	OUTFALL DAMAGE	NONE
	FLOW DEPTH (IN)	0
	FLOW PRESENT (Y/N)	NO
	SUBMERGED (Y/N)	NO
Observations	COLOR	NONE
	DEPOSITS/STAINS	NONE
	FLOATABLES	NONE
	TURBIDITY	NONE
	ODOR	NONE
	NOTES	Slight flow.
IDEP Parameters	AMMONIA (mg/L)	0
	pH	0
	SURFACTANT (mg/L LAS)	0
	TEMPERATURE (F)	0
	TURBIDITY (NTU)	0
	SPECIFIC CONDUCTIVITY (mS/cm)	0
Data Collection Detail	STAFF	ERS/KRZ
	GPS	+42.699257, -84.415566, +10.000000
	TIMESTAMP	09/26/2017 10:40:55
