Schedule of Compliance Submittal - Basic

Site name:
Ingham CDC MS4

INGHAM COUNTY DRAINS MS4 PROGRESS REPORT

APRIL 1, 2021

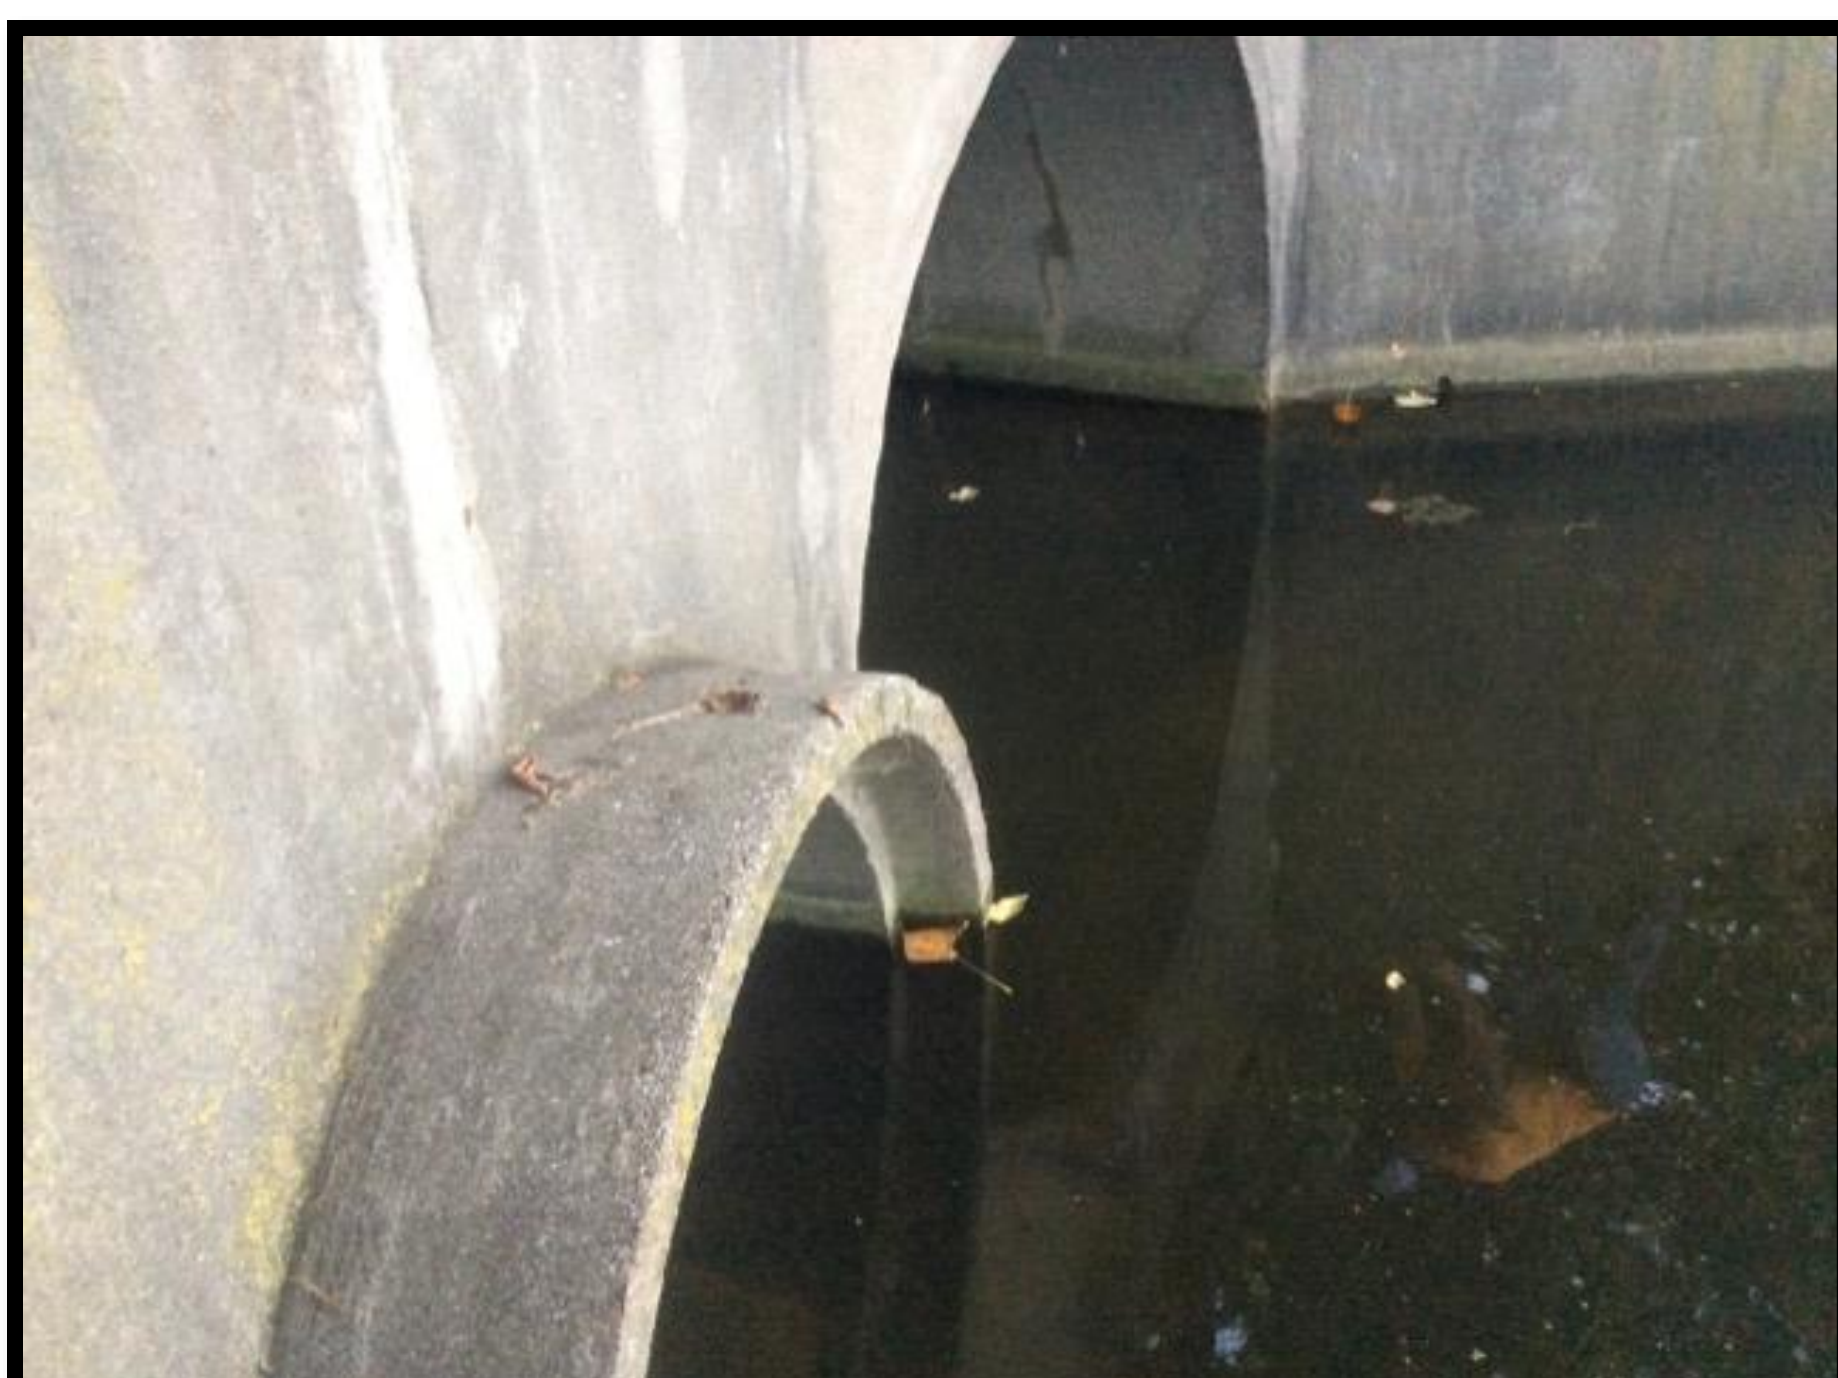
Discharge Point Details	**POINT NUMBER**	**L36-00**
	DRAIN NAME	**LANSING TOWNSHIP NO. 2**
	LAND USE/AREA	COMMERCIAL BUSSINESS
	NO. OF DAYS SINCE RUN OFF	2
	RISE X SPAN (IN)	15
	MATERIAL/TYPE	DUAL WALL HDPE
	VEGETATION CONDITION	NORMAL
	OUTFALL DAMAGE	NONE
	FLOW DEPTH (IN)	0
	FLOW PRESENT (Y/N)	NO
	SUBMERGED (Y/N)	NO
Observations	**COLOR**	NONE
	DEPOSITS/STAINS	NONE
	FLOATABLES	NONE
	TURBIDITY	NONE
	ODOR	NONE
	NOTES	No flow, no follow up.
IDEP Parameters	**AMMONIA (mg/L)**	0
	pH	0
	SURFACTANT (mg/L LAS)	0
	TEMPERATURE (F)	0
	TURBIDITY (NTU)	0
	SPECIFIC CONDUCTIVITY (mS/cm)	0
Data Collection Detail	**STAFF**	ERS/KRZ
	GPS	+42.718114, -84.597301, +10.000000
	TIMESTAMP	09/21/2017 15:01:30

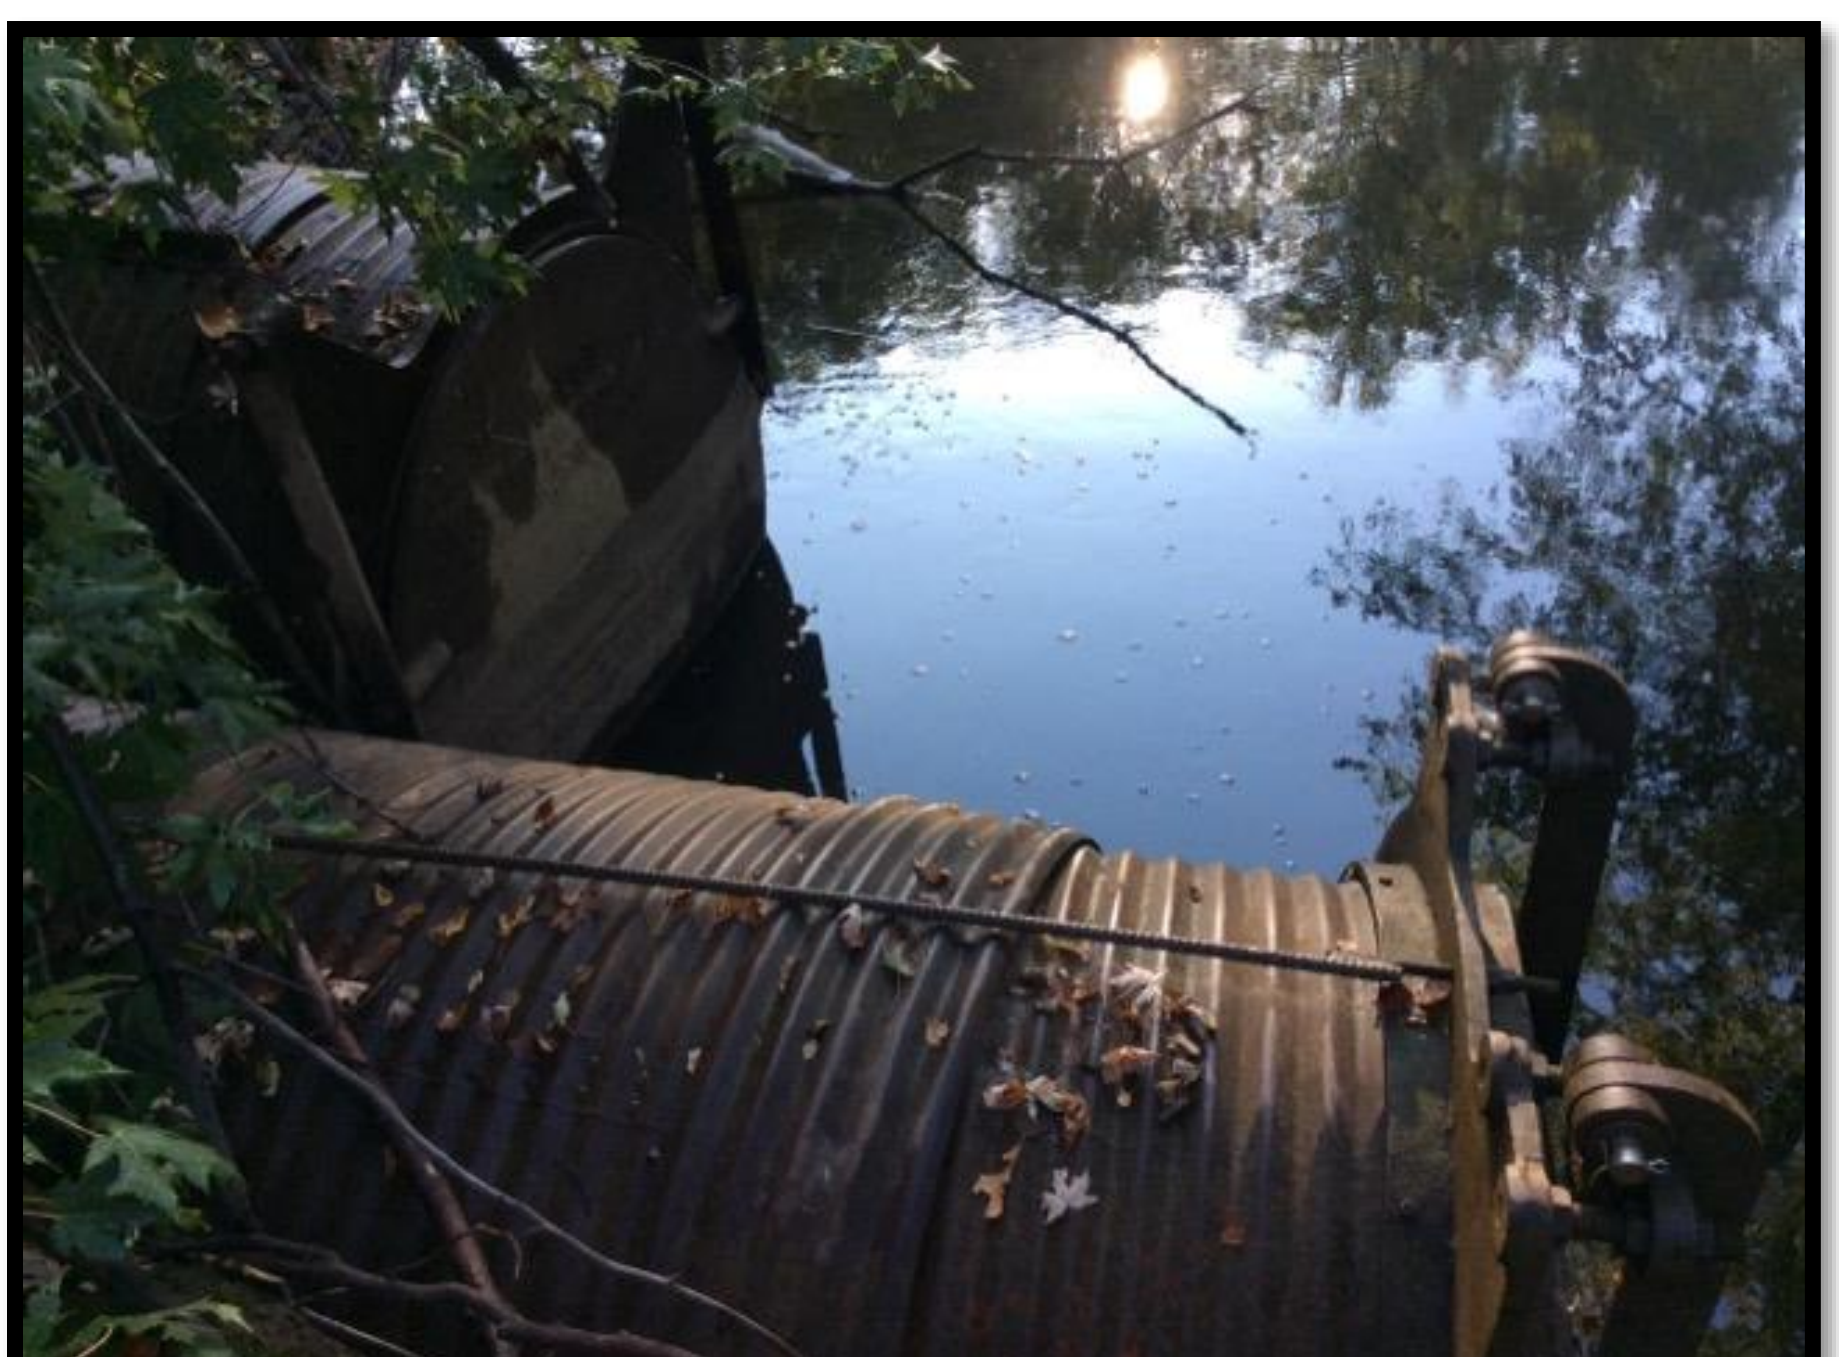
Discharge Point Details	POINT NUMBER	**M14-00**
	DRAIN NAME	**MERIDIAN HILLS DRAIN**
	LAND USE/AREA	RESIDIENTIAL - SINGLE
	NO. OF DAYS SINCE RUN OFF	2
	RISE X SPAN (IN)	NA
	MATERIAL/TYPE	wetland
	VEGETATION CONDITION	NORMAL
	OUTFALL DAMAGE	NONE
	FLOW DEPTH (IN)	0
	FLOW PRESENT (Y/N)	N/A
	SUBMERGED (Y/N)	N/A
Observations	COLOR	NONE
	DEPOSITS/STAINS	NONE
	FLOATABLES	NONE
	TURBIDITY	NONE
	ODOR	NONE
	NOTES	No outfall observed, may be covered by building debris/concrete. Wetland present.
IDEP Parameters	AMMONIA (mg/L)	0
	pH	0
	SURFACTANT (mg/L LAS)	0
	TEMPERATURE (F)	0
	TURBIDITY (NTU)	0
	SPECIFIC CONDUCTIVITY (mS/cm)	0
Data Collection Detail	STAFF	ERS/KRZ
	GPS	+42.741573, -84.410494, +10.000000
	TIMESTAMP	09/14/2017 10:06:02

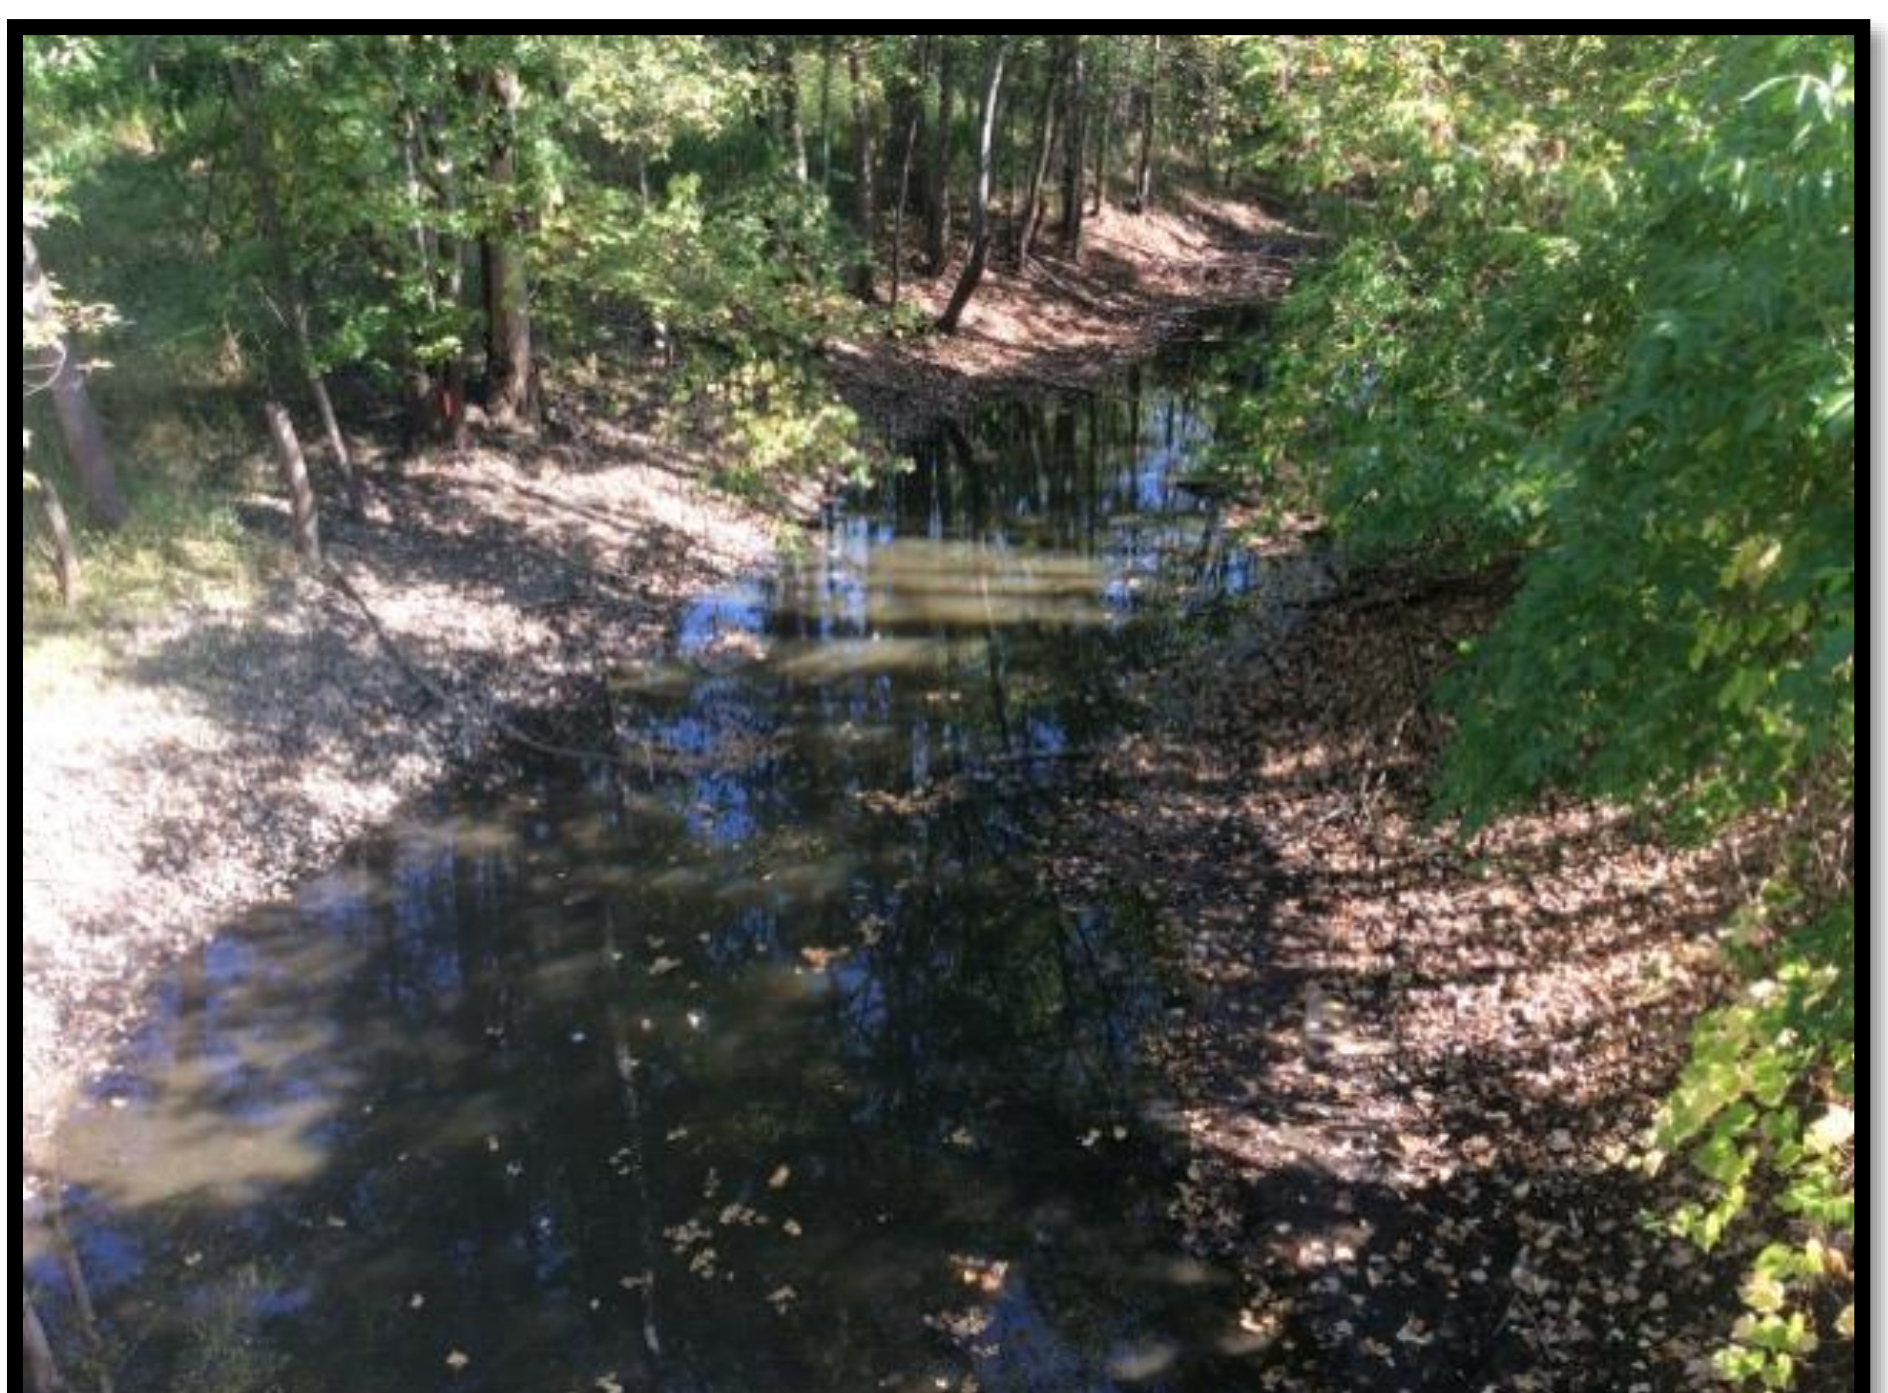
Discharge Point Details	POINT NUMBER	**M18-03**
	DRAIN NAME	**MUD LAKE OUTLET, OLD ENGLISH ESTATES BRANCH DRAIN**
	LAND USE/AREA	RESIDIENTIAL - SINGLE
	NO. OF DAYS SINCE RUN OFF	2
	RISE X SPAN (IN)	18
	MATERIAL/TYPE	DUAL WALL HDPE
	VEGETATION CONDITION	NORMAL
	OUTFALL DAMAGE	NONE
	FLOW DEPTH (IN)	0
	FLOW PRESENT (Y/N)	NO
	SUBMERGED (Y/N)	NO
Observations	COLOR	NONE
	DEPOSITS/STAINS	NONE
	FLOATABLES	NONE
	TURBIDITY	NONE
	ODOR	NONE
	NOTES	sight erosion around outfall
IDEP Parameters	AMMONIA (mg/L)	0
	pH	0
	SURFACTANT (mg/L LAS)	0
	TEMPERATURE (F)	0
	TURBIDITY (NTU)	0
	SPECIFIC CONDUCTIVITY (mS/cm)	0
Data Collection Detail	STAFF	ERS/KRZ
	GPS	+42.734316, -84.401501, +10.000000
	TIMESTAMP	09/14/2017 10:26:02

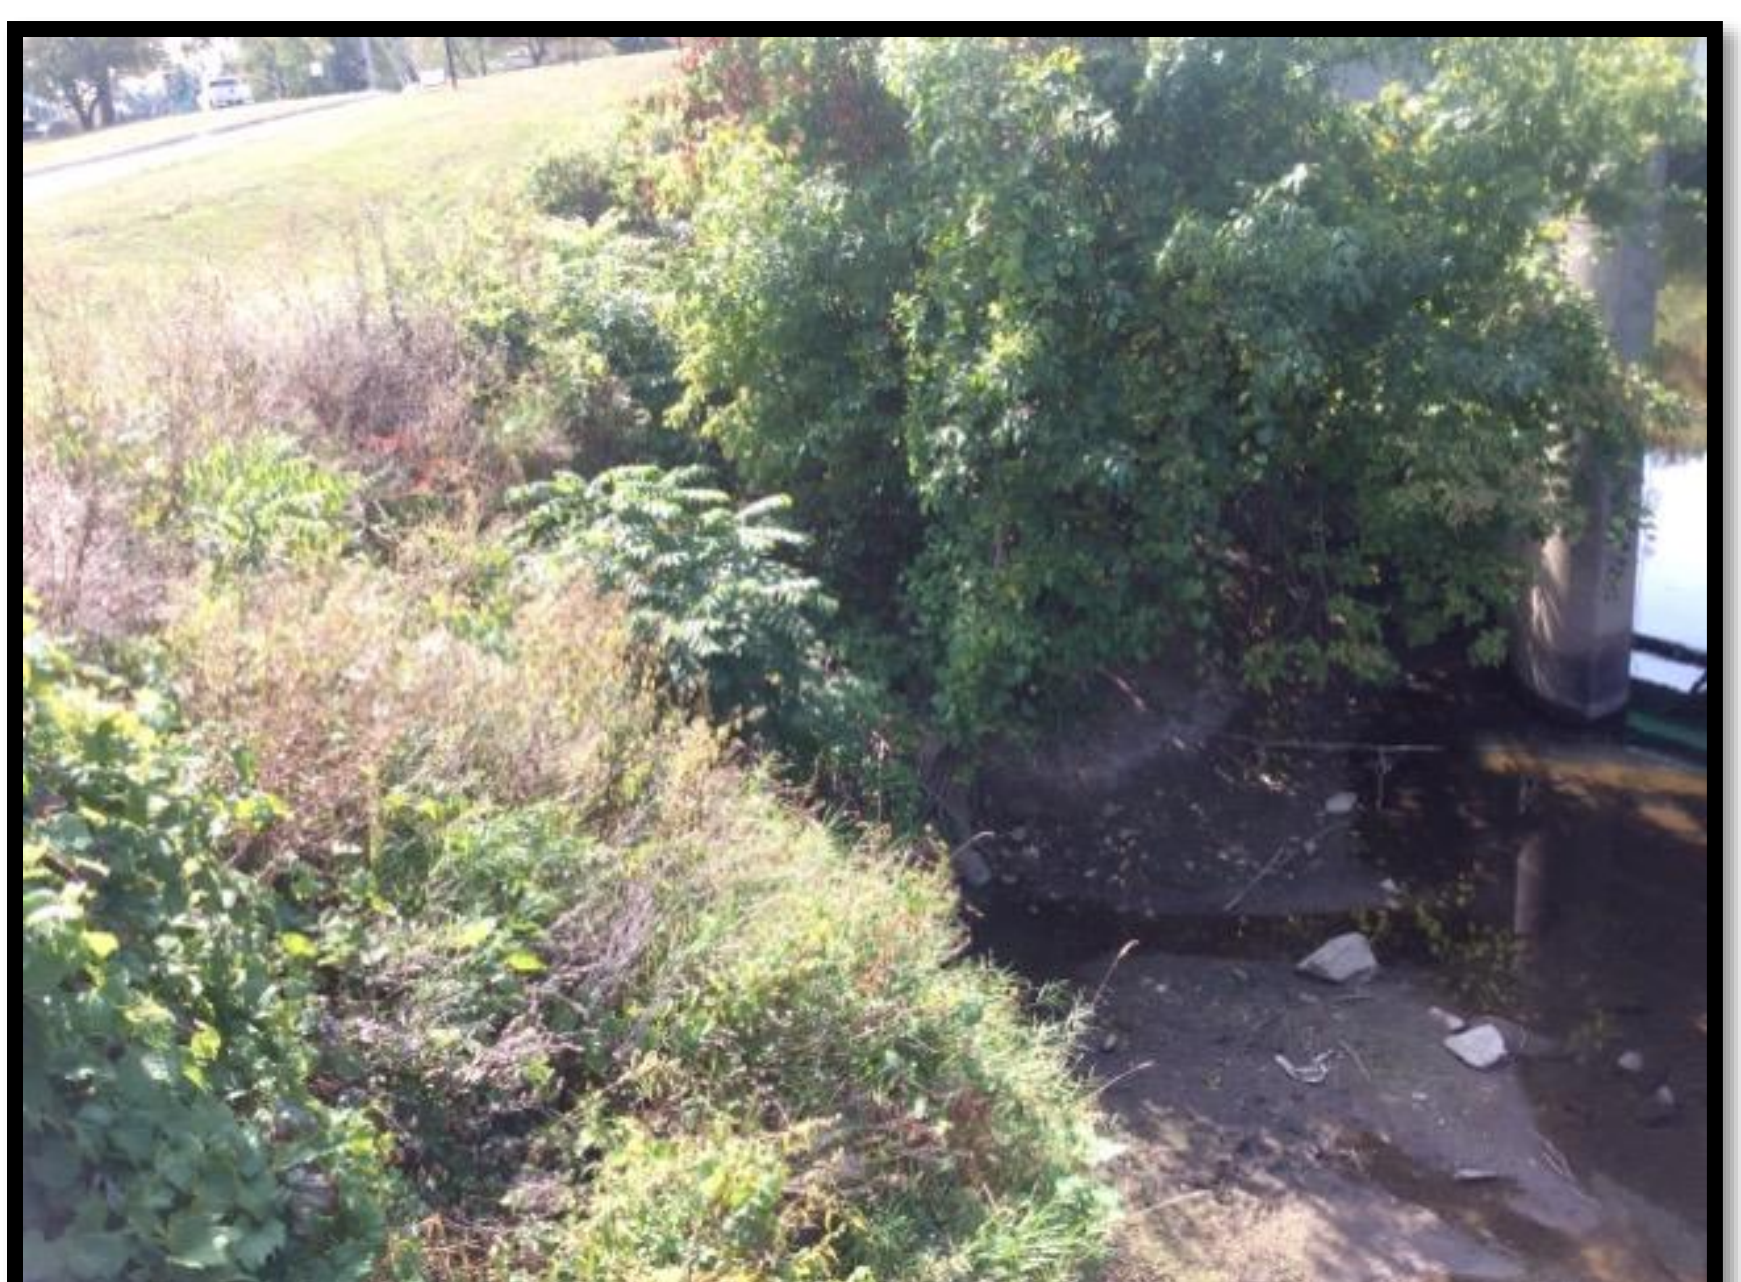
Discharge Point Details	**POINT NUMBER**	**N13-00**
	DRAIN NAME	**NORTHWIND DRAIN**
	LAND USE/AREA	COMMERCIAL BUSSINESS
	NO. OF DAYS SINCE RUN OFF	2
	RISE X SPAN (IN)	24
	MATERIAL/TYPE	ROUND CMP
	VEGETATION CONDITION	NORMAL
	OUTFALL DAMAGE	NONE
	FLOW DEPTH (IN)	0
	FLOW PRESENT (Y/N)	NO
	SUBMERGED (Y/N)	NO
Observations	**COLOR**	NONE
	DEPOSITS/STAINS	NONE
	FLOATABLES	NONE
	TURBIDITY	NONE
	ODOR	NONE
	NOTES	Pipe is partially submerged.
IDEP Parameters	**AMMONIA (mg/L)**	0
	pH	0
	SURFACTANT (mg/L LAS)	0
	TEMPERATURE (F)	0
	TURBIDITY (NTU)	0
	SPECIFIC CONDUCTIVITY (mS/cm)	0
Data Collection Detail	**STAFF**	ERS/KRZ
	GPS	+42.723696, -84.454330, +10.000000
	TIMESTAMP	09/26/2017 11:30:23

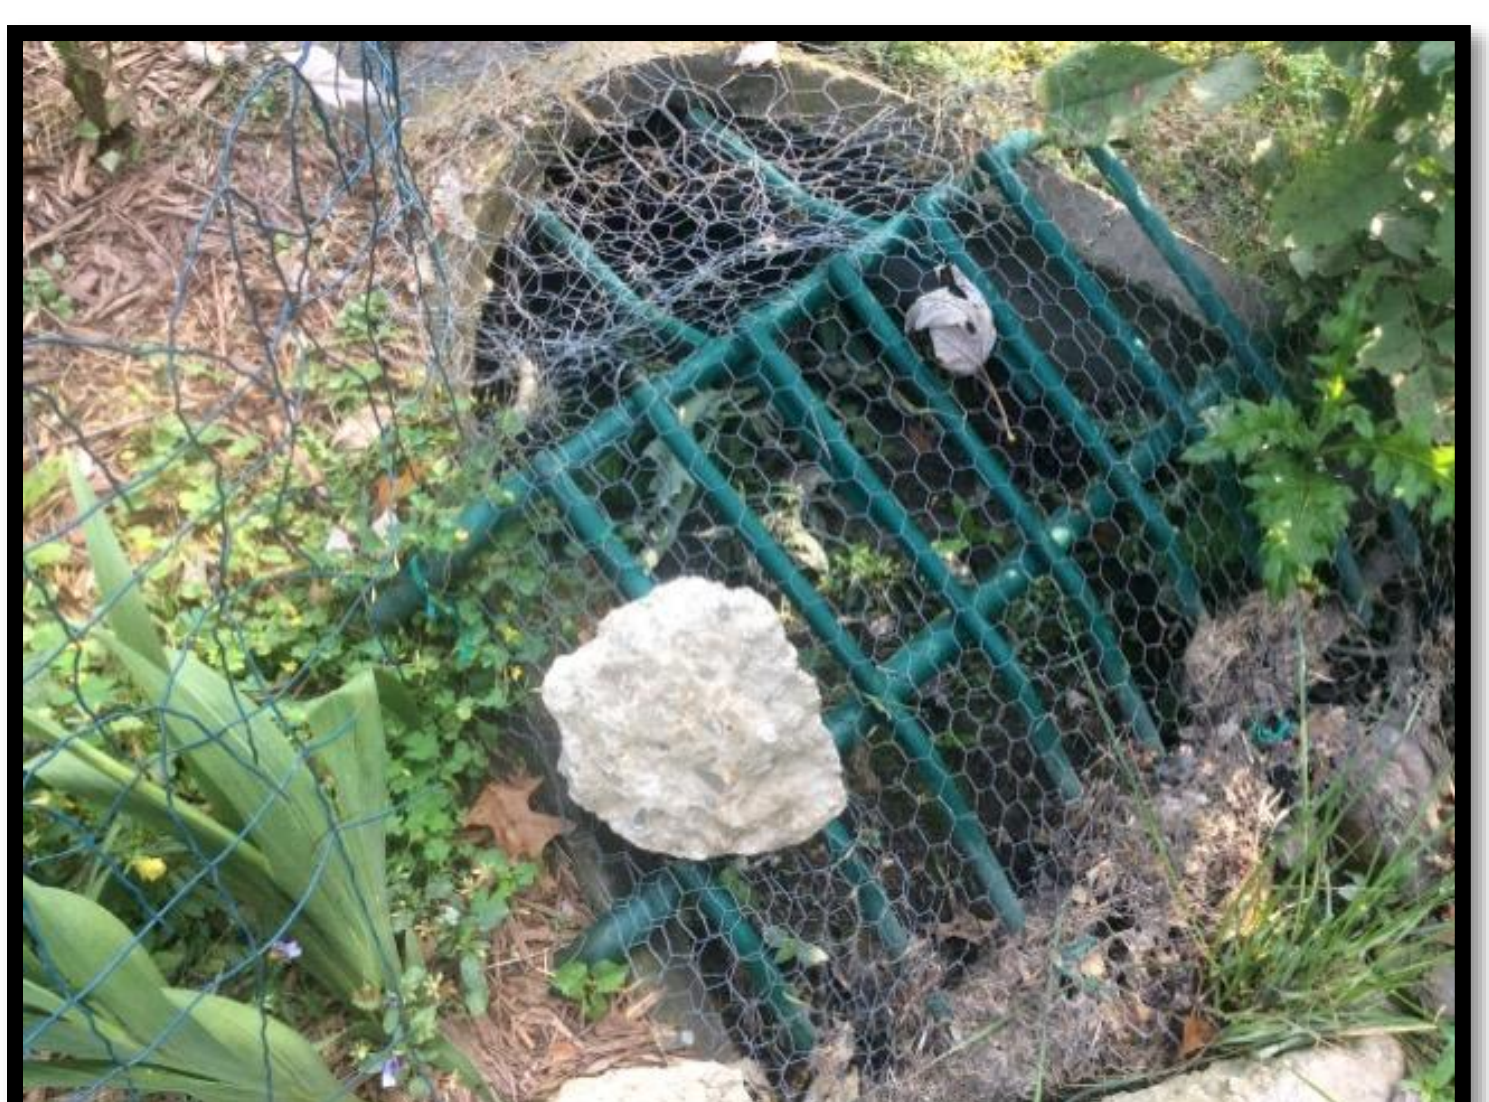
Discharge Point Details	**POINT NUMBER**	**P24-11**
	DRAIN NAME	**PINE LAKE OUTLET DRAIN DRAINAGE DISTRICT, NORTHPORT BRANCH DRAIN**
	LAND USE/AREA	RESIDIENTIAL - SINGLE
	NO. OF DAYS SINCE RUN OFF	2
	RISE X SPAN (IN)	15
	MATERIAL/TYPE	ROUND CONCRETE
	VEGETATION CONDITION	NORMAL
	OUTFALL DAMAGE	NONE
	FLOW DEPTH (IN)	0
	FLOW PRESENT (Y/N)	NO
	SUBMERGED (Y/N)	NO
Observations	**COLOR**	NONE
	DEPOSITS/STAINS	NONE
	FLOATABLES	NONE
	TURBIDITY	NONE
	ODOR	NONE
	NOTES	Outfalls into a backyard where the land owner has made a rain garden.
IDEP Parameters	**AMMONIA (mg/L)**	0
	pH	0
	SURFACTANT (mg/L LAS)	0
	TEMPERATURE (F)	0
	TURBIDITY (NTU)	0
	SPECIFIC CONDUCTIVITY (mS/cm)	0
Data Collection Detail	**STAFF**	ERS/KRZ
	GPS	+42.768189, -84.409863, +10.000000
	TIMESTAMP	09/21/2017 11:18:57

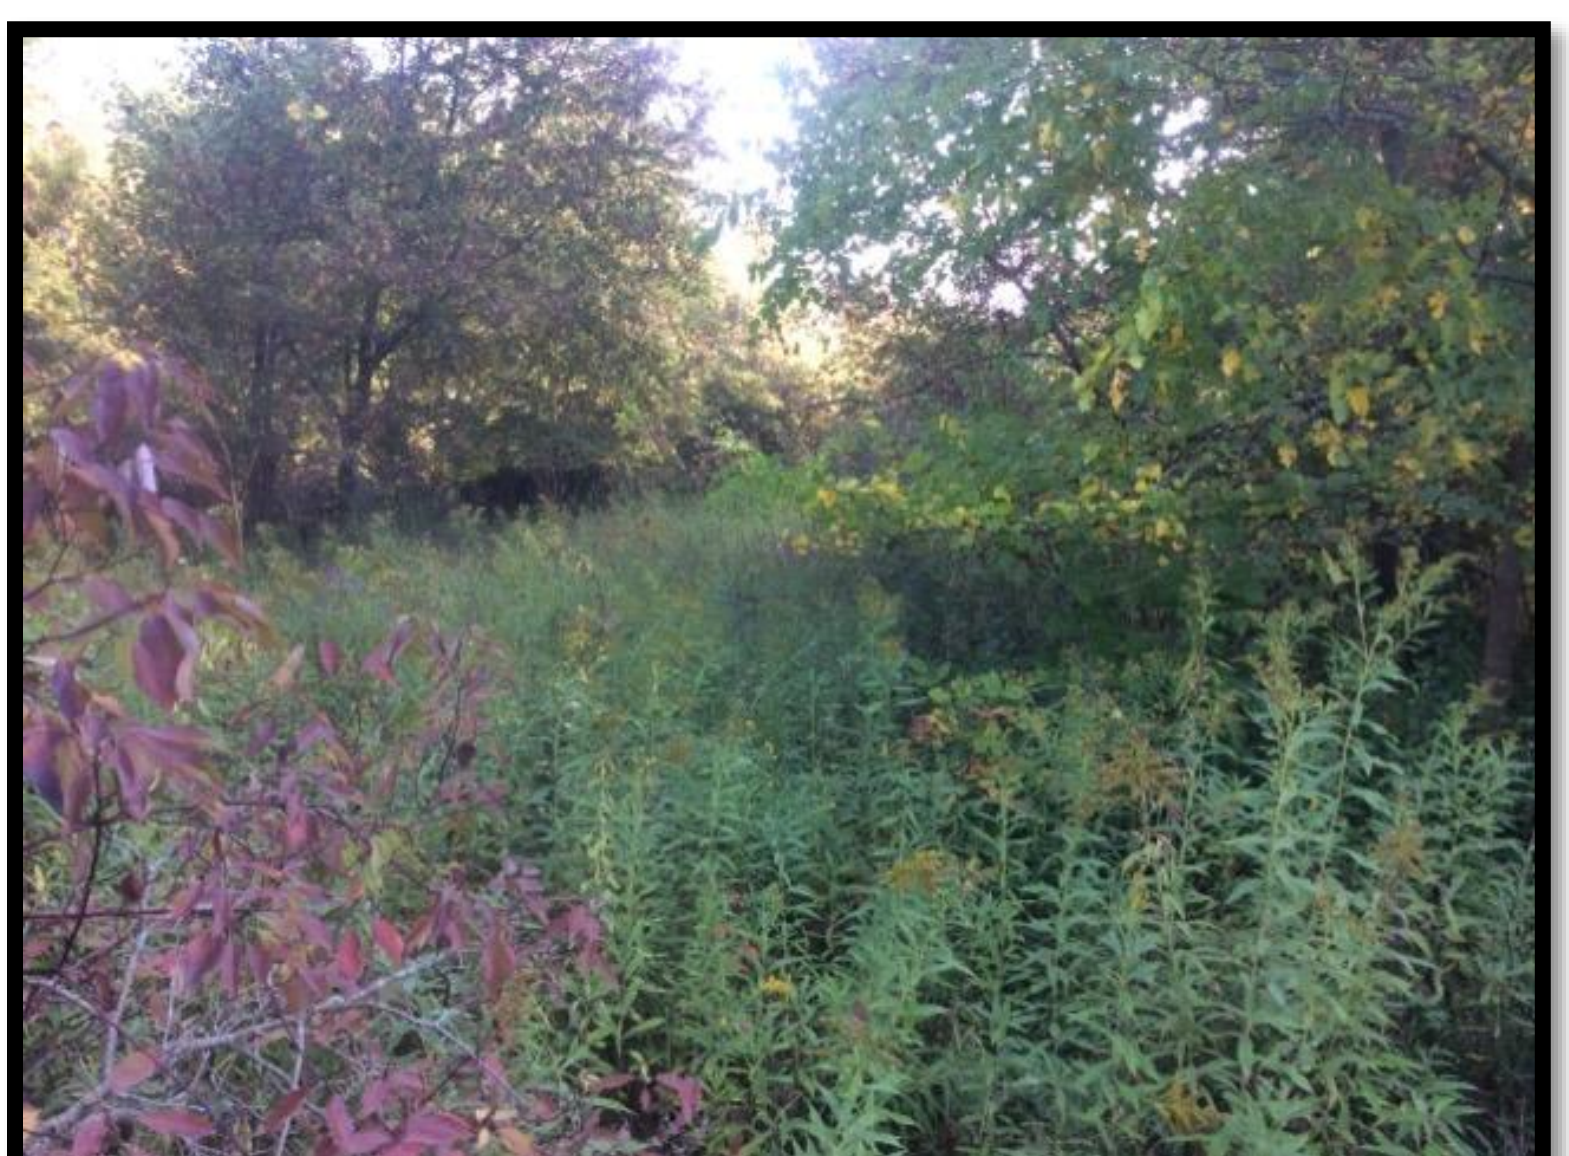
Discharge Point Details	POINT NUMBER	**P26-00**
	DRAIN NAME	**PONDEROSA DRAIN**
	LAND USE/AREA	INDUSTRIAL
	NO. OF DAYS SINCE RUN OFF	2
	RISE X SPAN (IN)	NA
	MATERIAL/TYPE	NA
	VEGETATION CONDITION	NORMAL
	OUTFALL DAMAGE	NONE
	FLOW DEPTH (IN)	0
	FLOW PRESENT (Y/N)	NO
	SUBMERGED (Y/N)	NO
Observations	COLOR	NONE
	DEPOSITS/STAINS	NONE
	FLOATABLES	NONE
	TURBIDITY	NONE
	ODOR	NONE
	NOTES	Open drain with a dry bottom. Erosion control material surrounding drain.
IDEP Parameters	AMMONIA (mg/L)	0
	pH	0
	SURFACTANT (mg/L LAS)	0
	TEMPERATURE (F)	0
	TURBIDITY (NTU)	0
	SPECIFIC CONDUCTIVITY (mS/cm)	0
Data Collection Detail	STAFF	ERS/KRZ
	GPS	+42.676765, -84.521952, +10.000000
	TIMESTAMP	09/07/2017 09:46:20

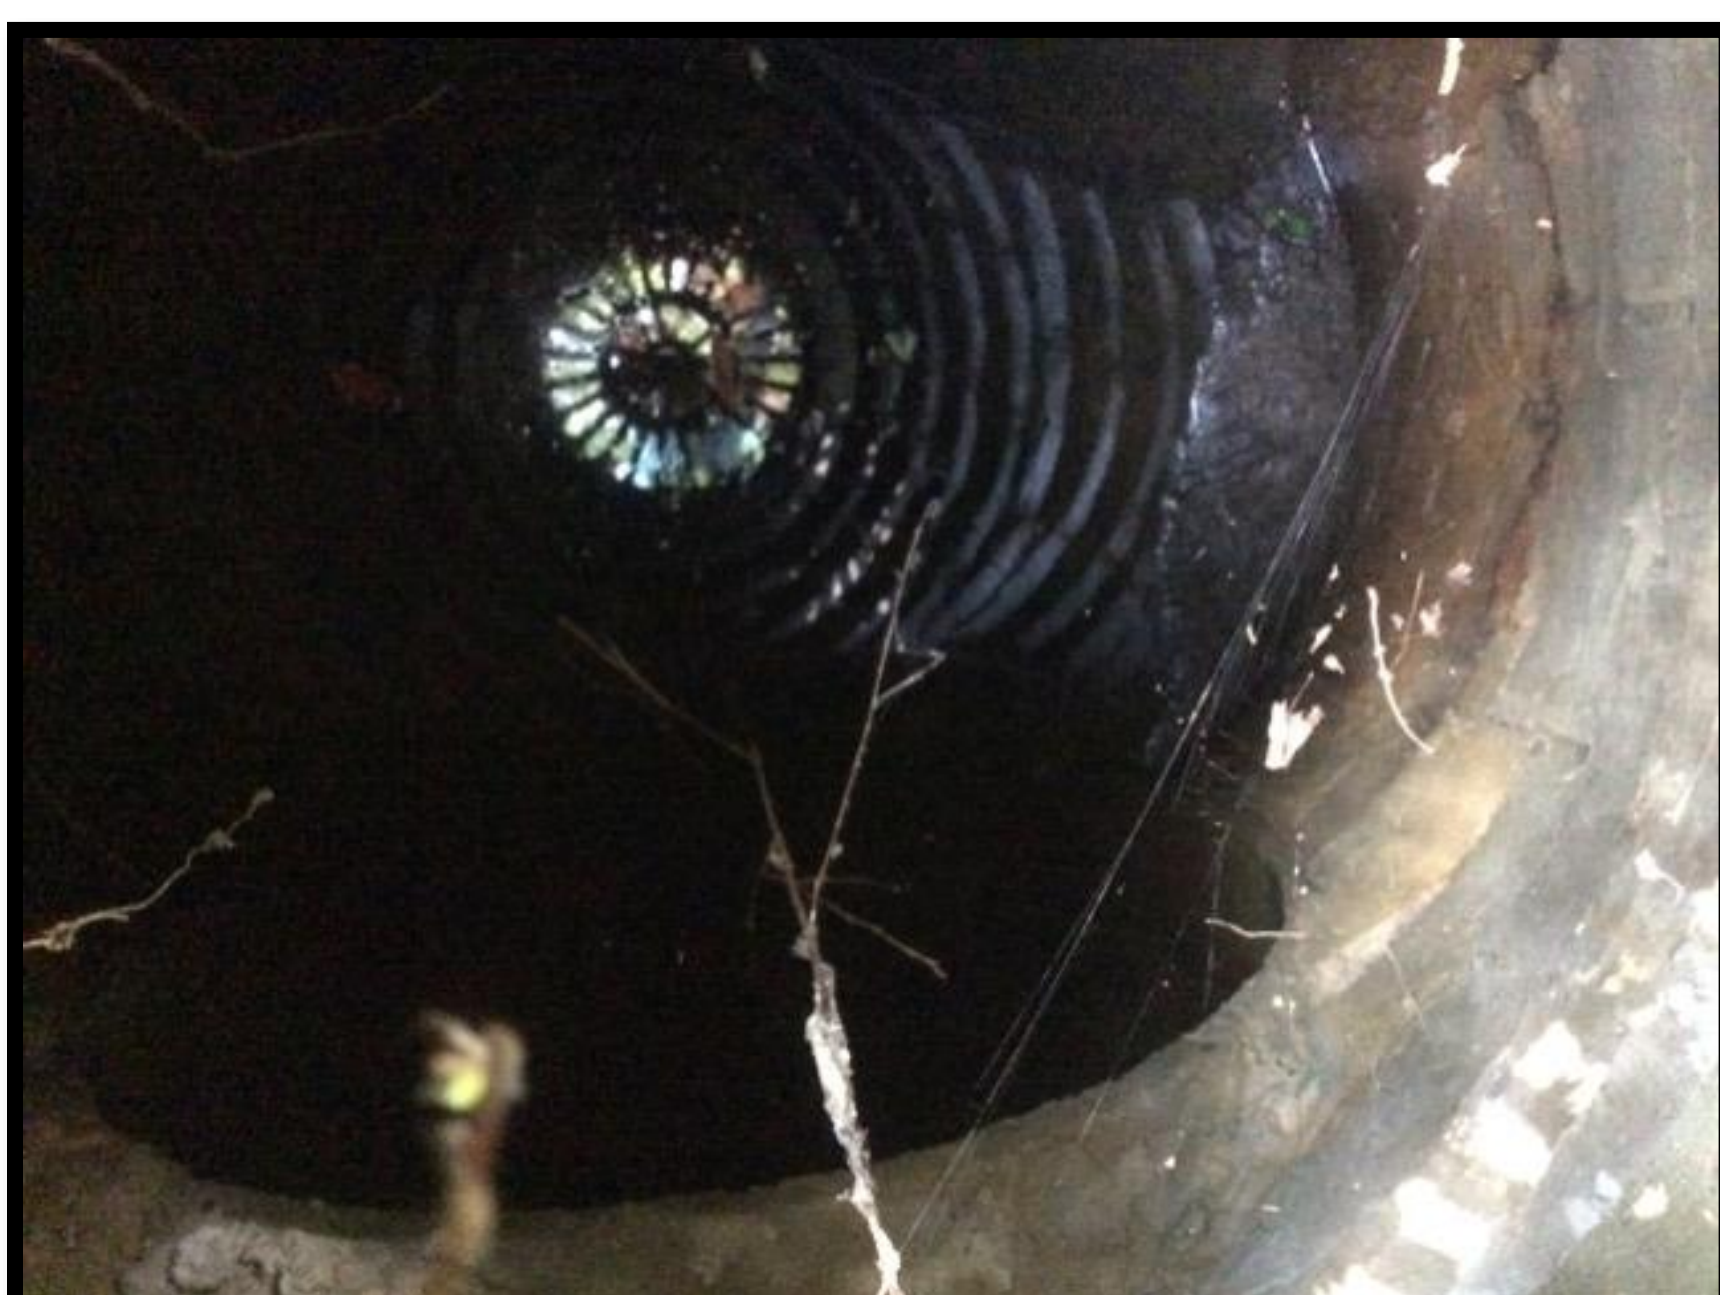
Discharge Point Details	**POINT NUMBER**	**R04-00**
	DRAIN NAME	**REDMAN DRAIN**
	LAND USE/AREA	AGRICULTURAL
	NO. OF DAYS SINCE RUN OFF	6
	RISE X SPAN (IN)	18
	MATERIAL/TYPE	CMPA
	VEGETATION CONDITION	NORMAL
	OUTFALL DAMAGE	NONE
	FLOW DEPTH (IN)	0.5
	FLOW PRESENT (Y/N)	YES
	SUBMERGED (Y/N)	NO
Observations	**COLOR**	NONE
	DEPOSITS/STAINS	SEDIMENT
	FLOATABLES	NONE
	TURBIDITY	NONE
	ODOR	NONE
	NOTES	-
IDEP Parameters	**AMMONIA (mg/L)**	-
	pH	-
	SURFACTANT (mg/L LAS)	-
	TEMPERATURE (F)	-
	TURBIDITY (NTU)	-
	SPECIFIC CONDUCTIVITY (mS/cm)	-
Data Collection Detail	**STAFF**	ANGIE
	GPS	42.522271,-84.405820 (+/-10m)
	TIMESTAMP	09/12/2012 14:59:59

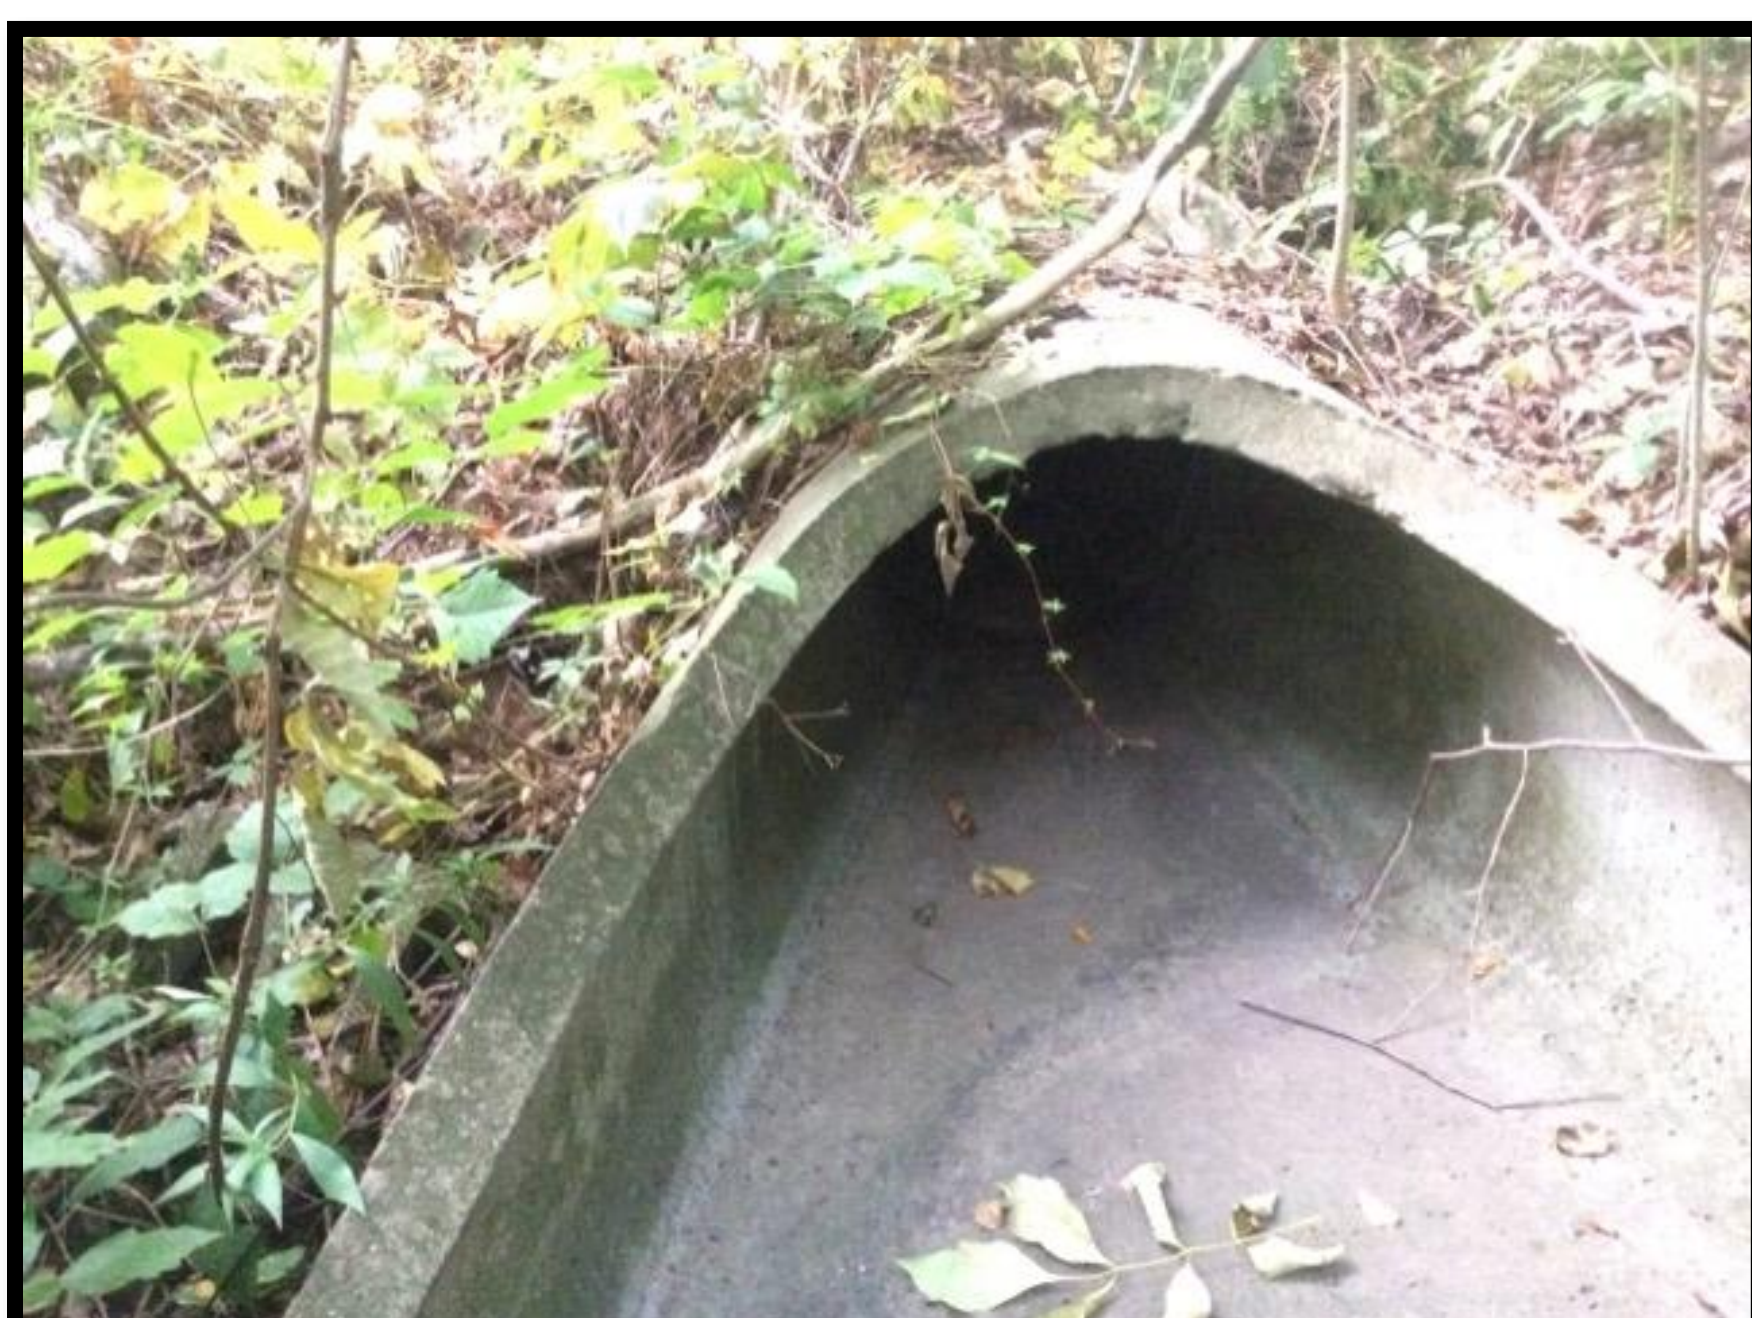
Discharge Point Details	**POINT NUMBER**	**R07-14**
	DRAIN NAME	**REMY-CHANDLER #5 DRAIN DRAINAGE DISTRICT, WHITEHILLS LAKES BRANCH #5 DRAIN**
	LAND USE/AREA	RESIDIENTIAL - SINGLE
	NO. OF DAYS SINCE RUN OFF	2
	RISE X SPAN (IN)	NA
	MATERIAL/TYPE	NA
	VEGETATION CONDITION	NORMAL
	OUTFALL DAMAGE	NONE
	FLOW DEPTH (IN)	0
	FLOW PRESENT (Y/N)	N/A
	SUBMERGED (Y/N)	N/A
Observations	**COLOR**	NONE
	DEPOSITS/STAINS	NONE
	FLOATABLES	NONE
	TURBIDITY	NONE
	ODOR	NONE
	NOTES	No outlet point observed. Wetland observed instead.
IDEP Parameters	**AMMONIA (mg/L)**	0
	pH	0
	SURFACTANT (mg/L LAS)	0
	TEMPERATURE (F)	0
	TURBIDITY (NTU)	0
	SPECIFIC CONDUCTIVITY (mS/cm)	0
Data Collection Detail	**STAFF**	ERS/KRZ
	GPS	+42.768939, -84.442559, +10.000000
	TIMESTAMP	09/14/2017 09:00:52

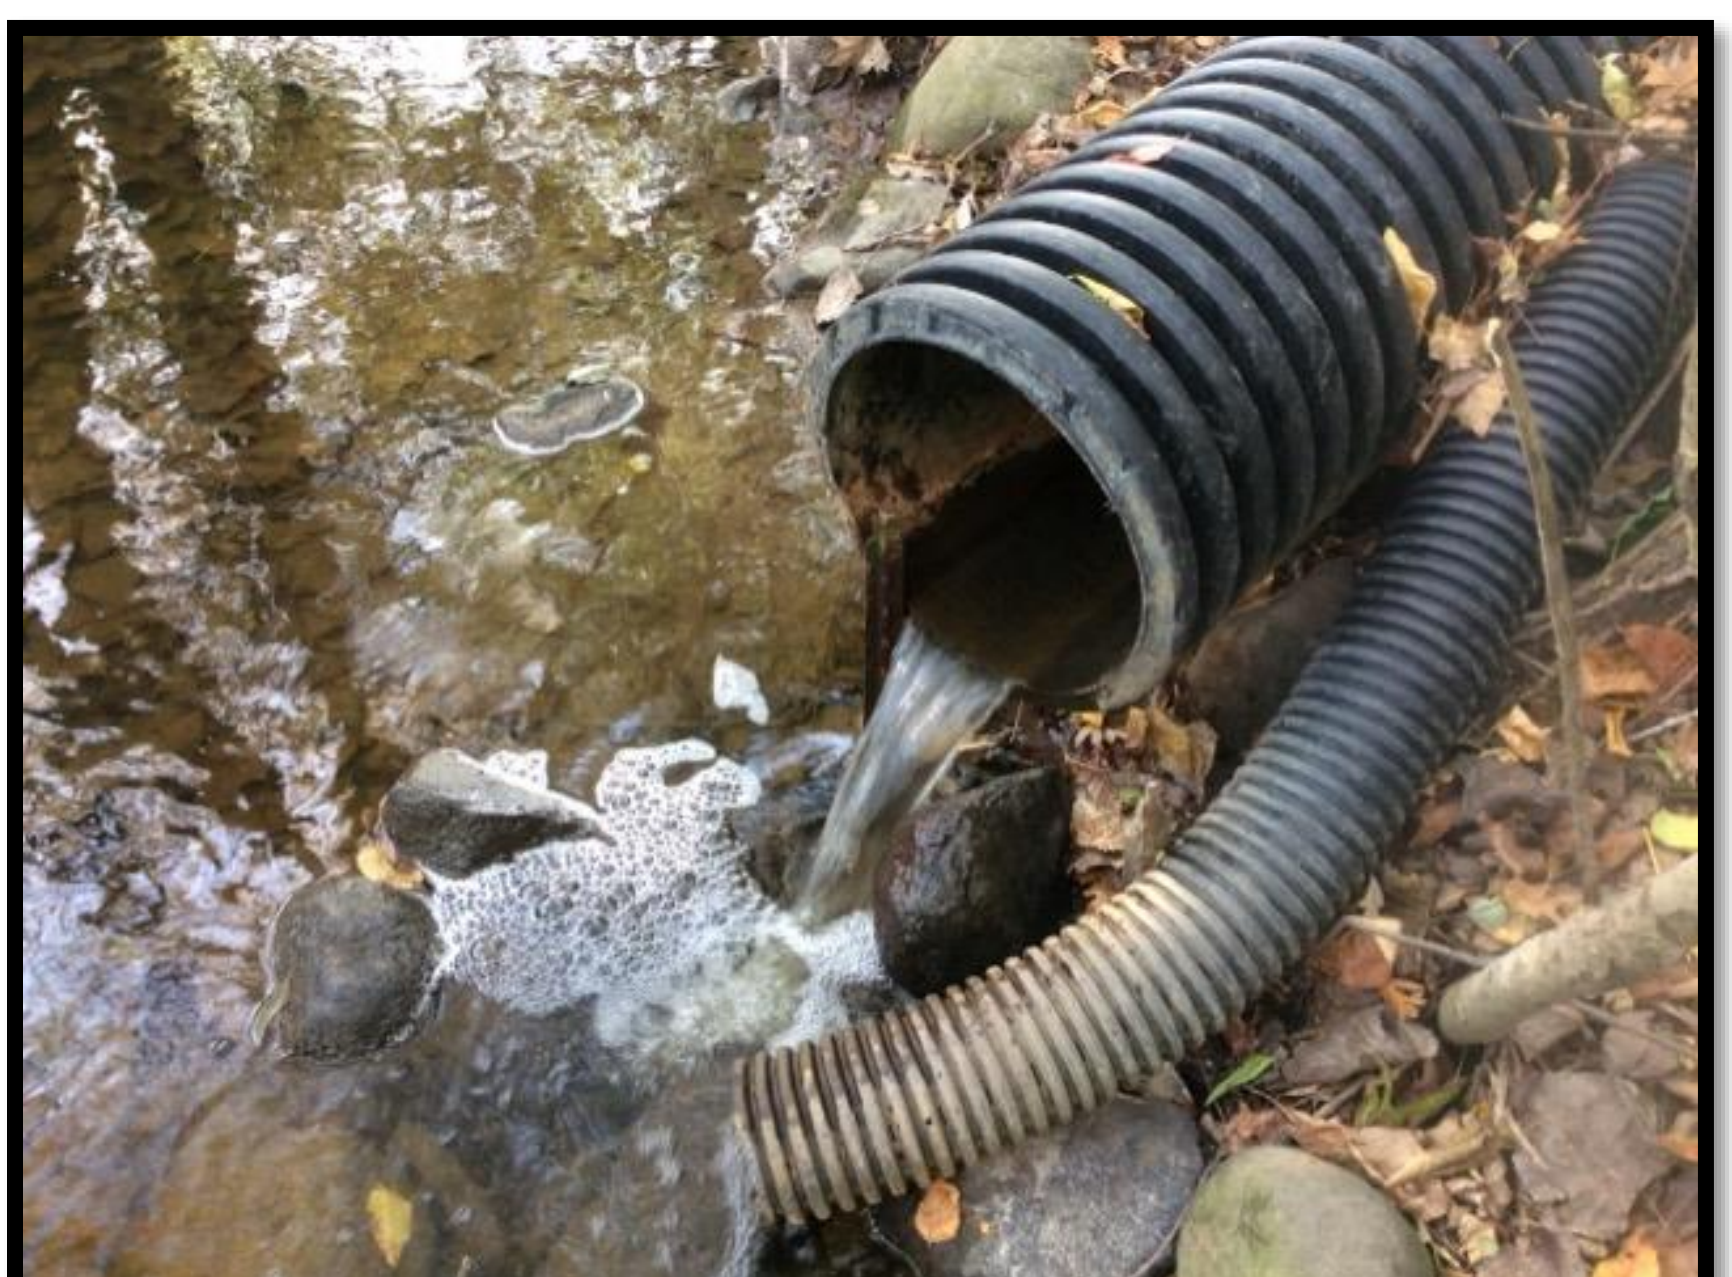
Discharge Point Details	**POINT NUMBER**	**R18-00**
	DRAIN NAME	**ROSSITER DRAIN**
	LAND USE/AREA	AGRICULTURAL
	NO. OF DAYS SINCE RUN OFF	2
	RISE X SPAN (IN)	12
	MATERIAL/TYPE	DUAL WALL HDPE
	VEGETATION CONDITION	NORMAL
	OUTFALL DAMAGE	NONE
	FLOW DEPTH (IN)	0.5
	FLOW PRESENT (Y/N)	YES
	SUBMERGED (Y/N)	NO
Observations	**COLOR**	NONE
	DEPOSITS/STAINS	NONE
	FLOATABLES	NONE
	TURBIDITY	NONE
	ODOR	NONE
	NOTES	no smells, clear flow
IDEP Parameters	**AMMONIA (mg/L)**	0
	pH	0
	SURFACTANT (mg/L LAS)	0
	TEMPERATURE (F)	0
	TURBIDITY (NTU)	0
	SPECIFIC CONDUCTIVITY (mS/cm)	0
Data Collection Detail	**STAFF**	ERS/KRZ
	GPS	+42.671253, -84.455323, +10.000000
	TIMESTAMP	10/19/2017 09:24:54
