Schedule of Compliance Submittal - Basic

Site name:
Ingham CDC MS4

INGHAM COUNTY DRAINS MS4 PROGRESS REPORT

APRIL 1, 2021

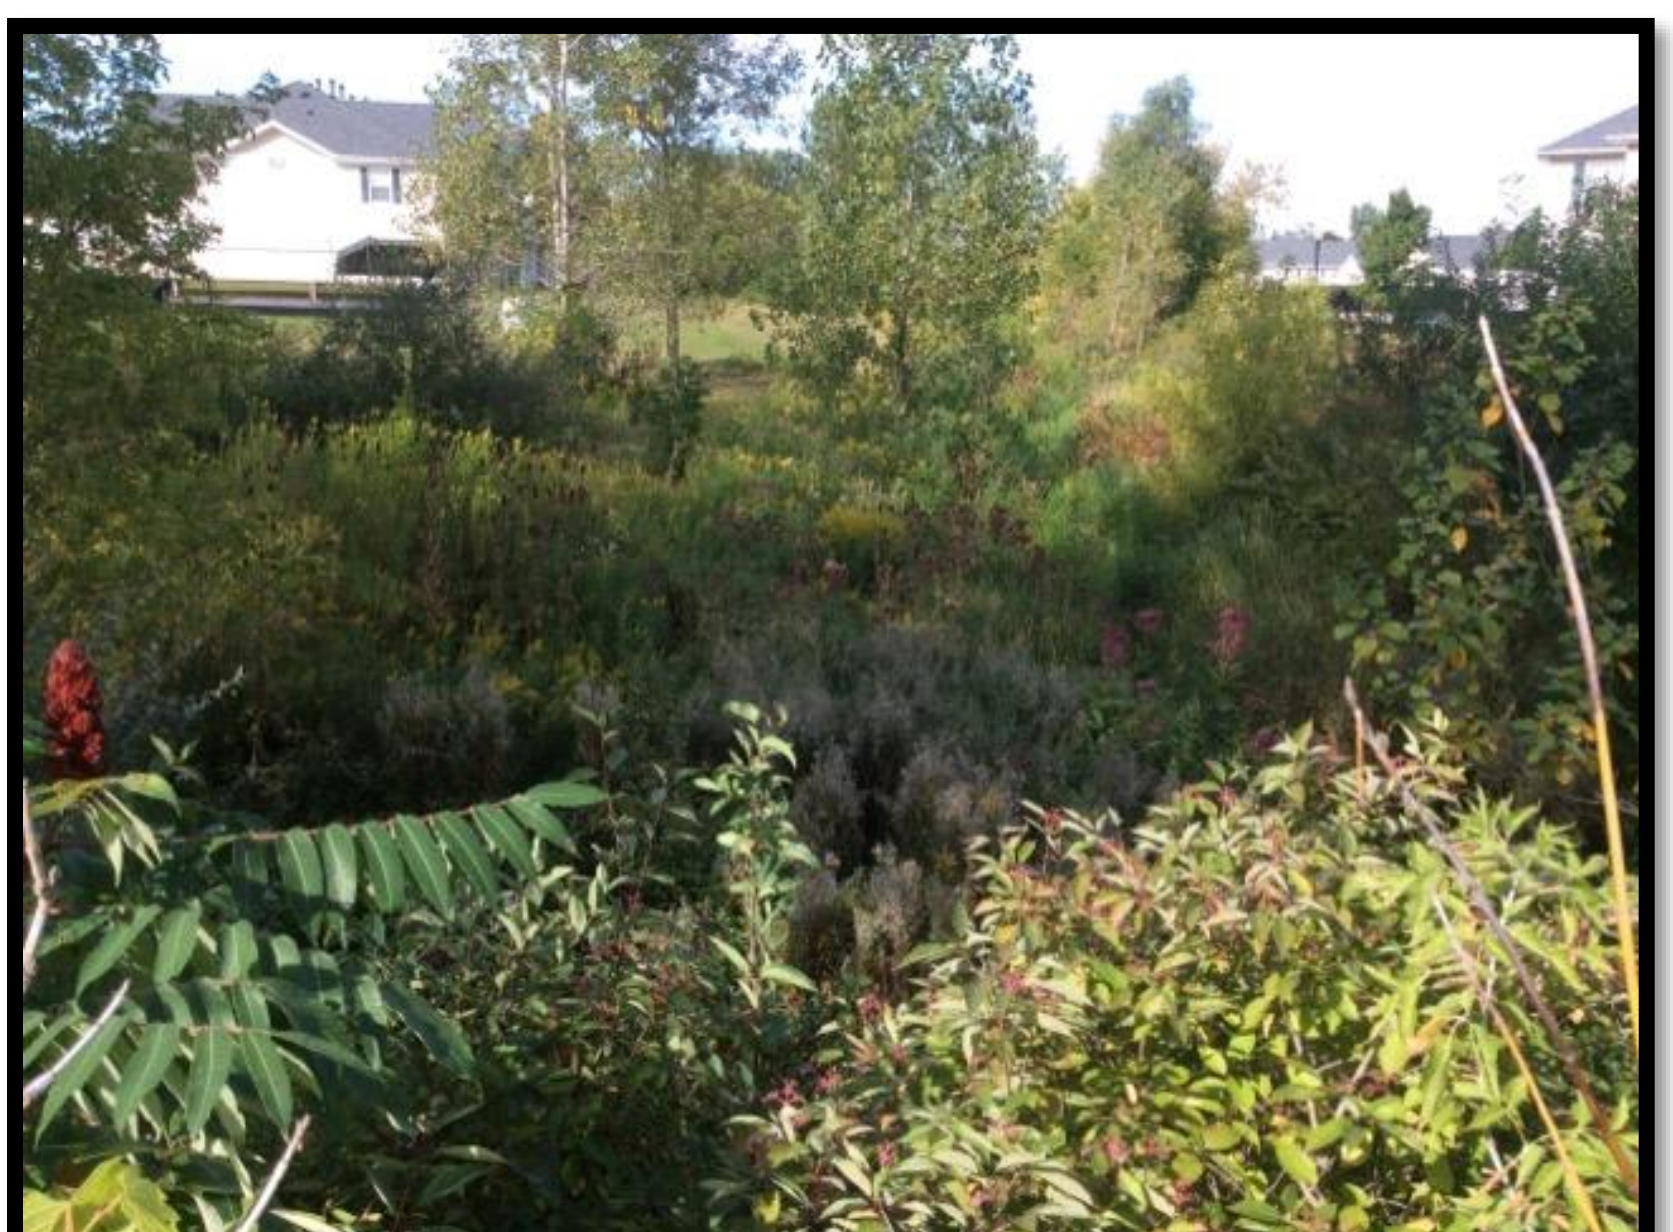
Discharge Point Details	**POINT NUMBER**	**S32-00**
	DRAIN NAME	**SUMMITT STREET DRAIN**
	LAND USE/AREA	INDUSTRIAL
	NO. OF DAYS SINCE RUN OFF	2
	RISE X SPAN (IN)	24
	MATERIAL/TYPE	ROUND CONCRETE
	VEGETATION CONDITION	NORMAL
	OUTFALL DAMAGE	NONE
	FLOW DEPTH (IN)	0
	FLOW PRESENT (Y/N)	NO
	SUBMERGED (Y/N)	N/A
Observations	**COLOR**	NONE
	DEPOSITS/STAINS	NONE
	FLOATABLES	NONE
	TURBIDITY	NONE
	ODOR	NONE
	NOTES	Outfall into a detention pond. Detention pond has a bit of biofilm on the surface.
IDEP Parameters	**AMMONIA (mg/L)**	0
	pH	0
	SURFACTANT (mg/L LAS)	0
	TEMPERATURE (F)	0
	TURBIDITY (NTU)	0
	SPECIFIC CONDUCTIVITY (mS/cm)	0
Data Collection Detail	**STAFF**	ERS/KRZ
	GPS	-
	TIMESTAMP	09/11/2017 13:04:12

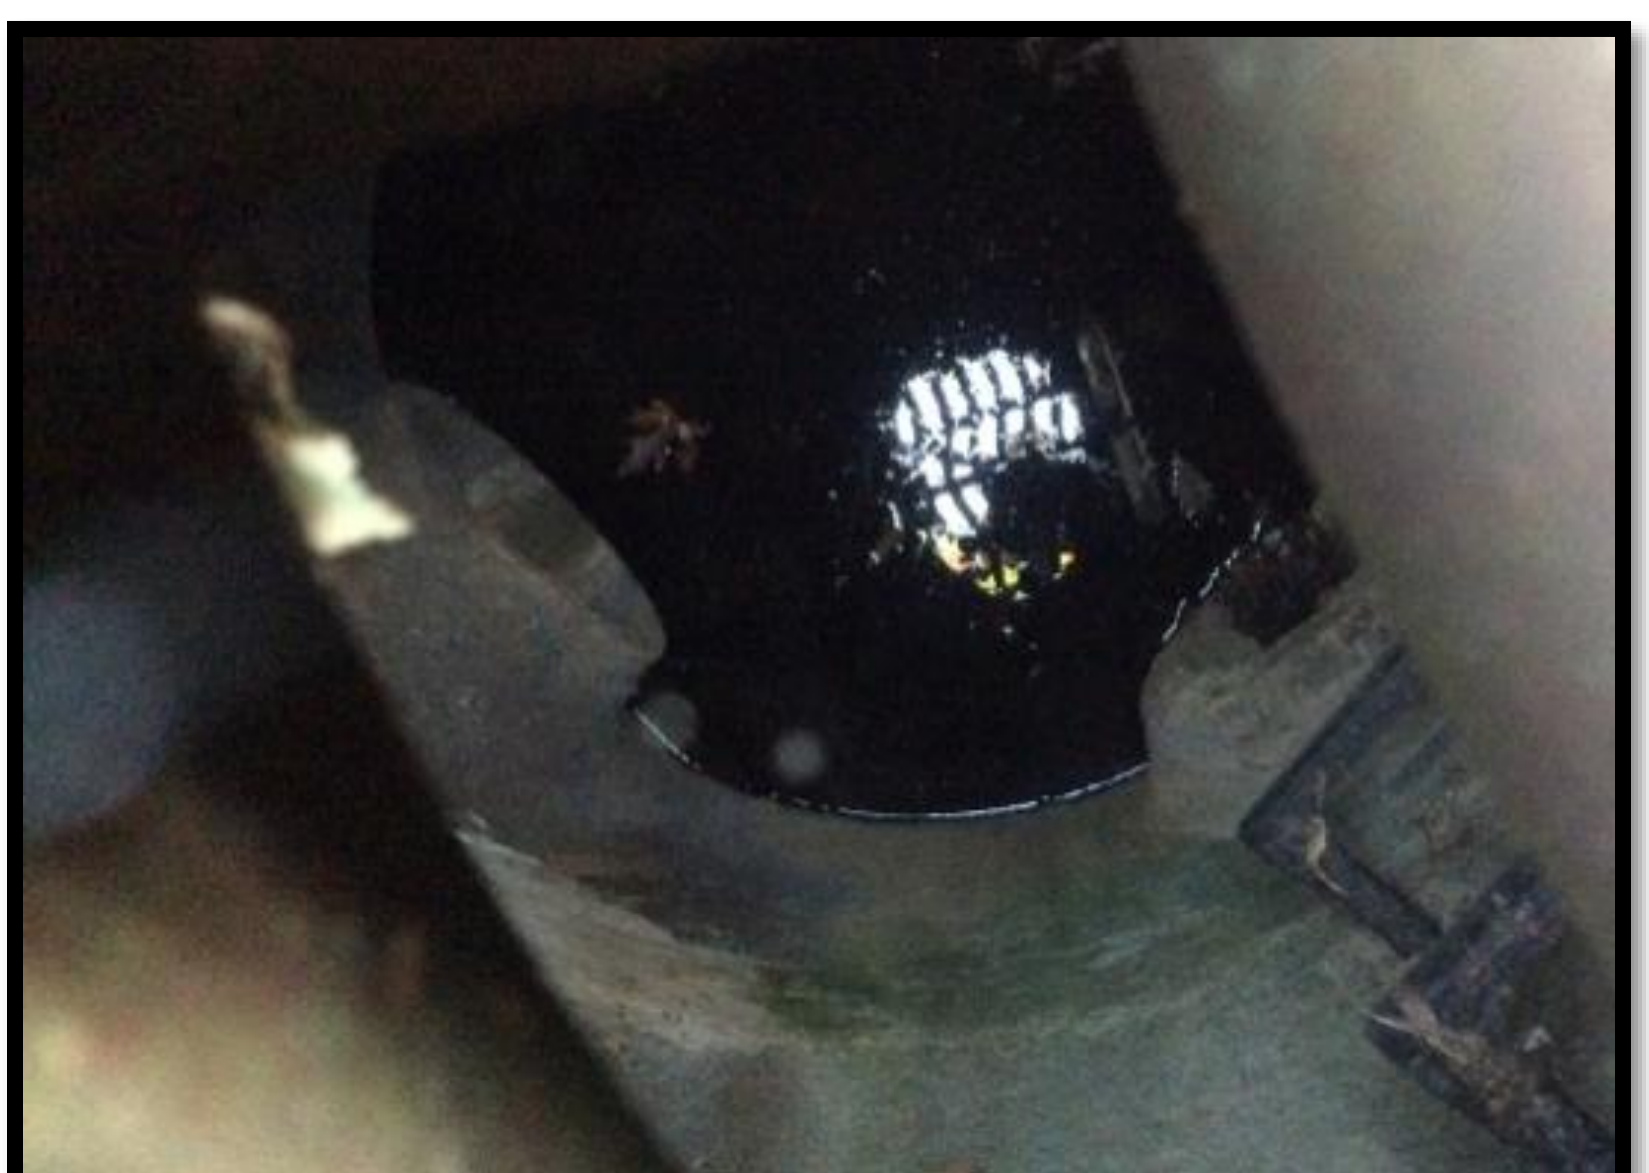
Discharge Point Details	POINT NUMBER	T14-00
	DRAIN NAME	TOBIAS DRAIN
	LAND USE/AREA	RESIDENTIAL - MULTI
	NO. OF DAYS SINCE RUN OFF	2
	RISE X SPAN (IN)	24
	MATERIAL/TYPE	DUAL WALL HDPE
	VEGETATION CONDITION	NORMAL
	OUTFALL DAMAGE	NONE
	FLOW DEPTH (IN)	0
	FLOW PRESENT (Y/N)	NO
	SUBMERGED (Y/N)	NO
Observations	COLOR	NONE
	DEPOSITS/STAINS	NONE
	FLOATABLES	NONE
	TURBIDITY	NONE
	ODOR	NONE
	NOTES	Standing water in bottom of structure.
IDEP Parameters	AMMONIA (mg/L)	0
	pH	0
	SURFACTANT (mg/L LAS)	0
	TEMPERATURE (F)	0
	TURBIDITY (NTU)	0
	SPECIFIC CONDUCTIVITY (mS/cm)	0
Data Collection Detail	STAFF	ERS/KRZ
	GPS	+42.675599, -84.287364, +10.000000
	TIMESTAMP	09/13/2017 07:37:42

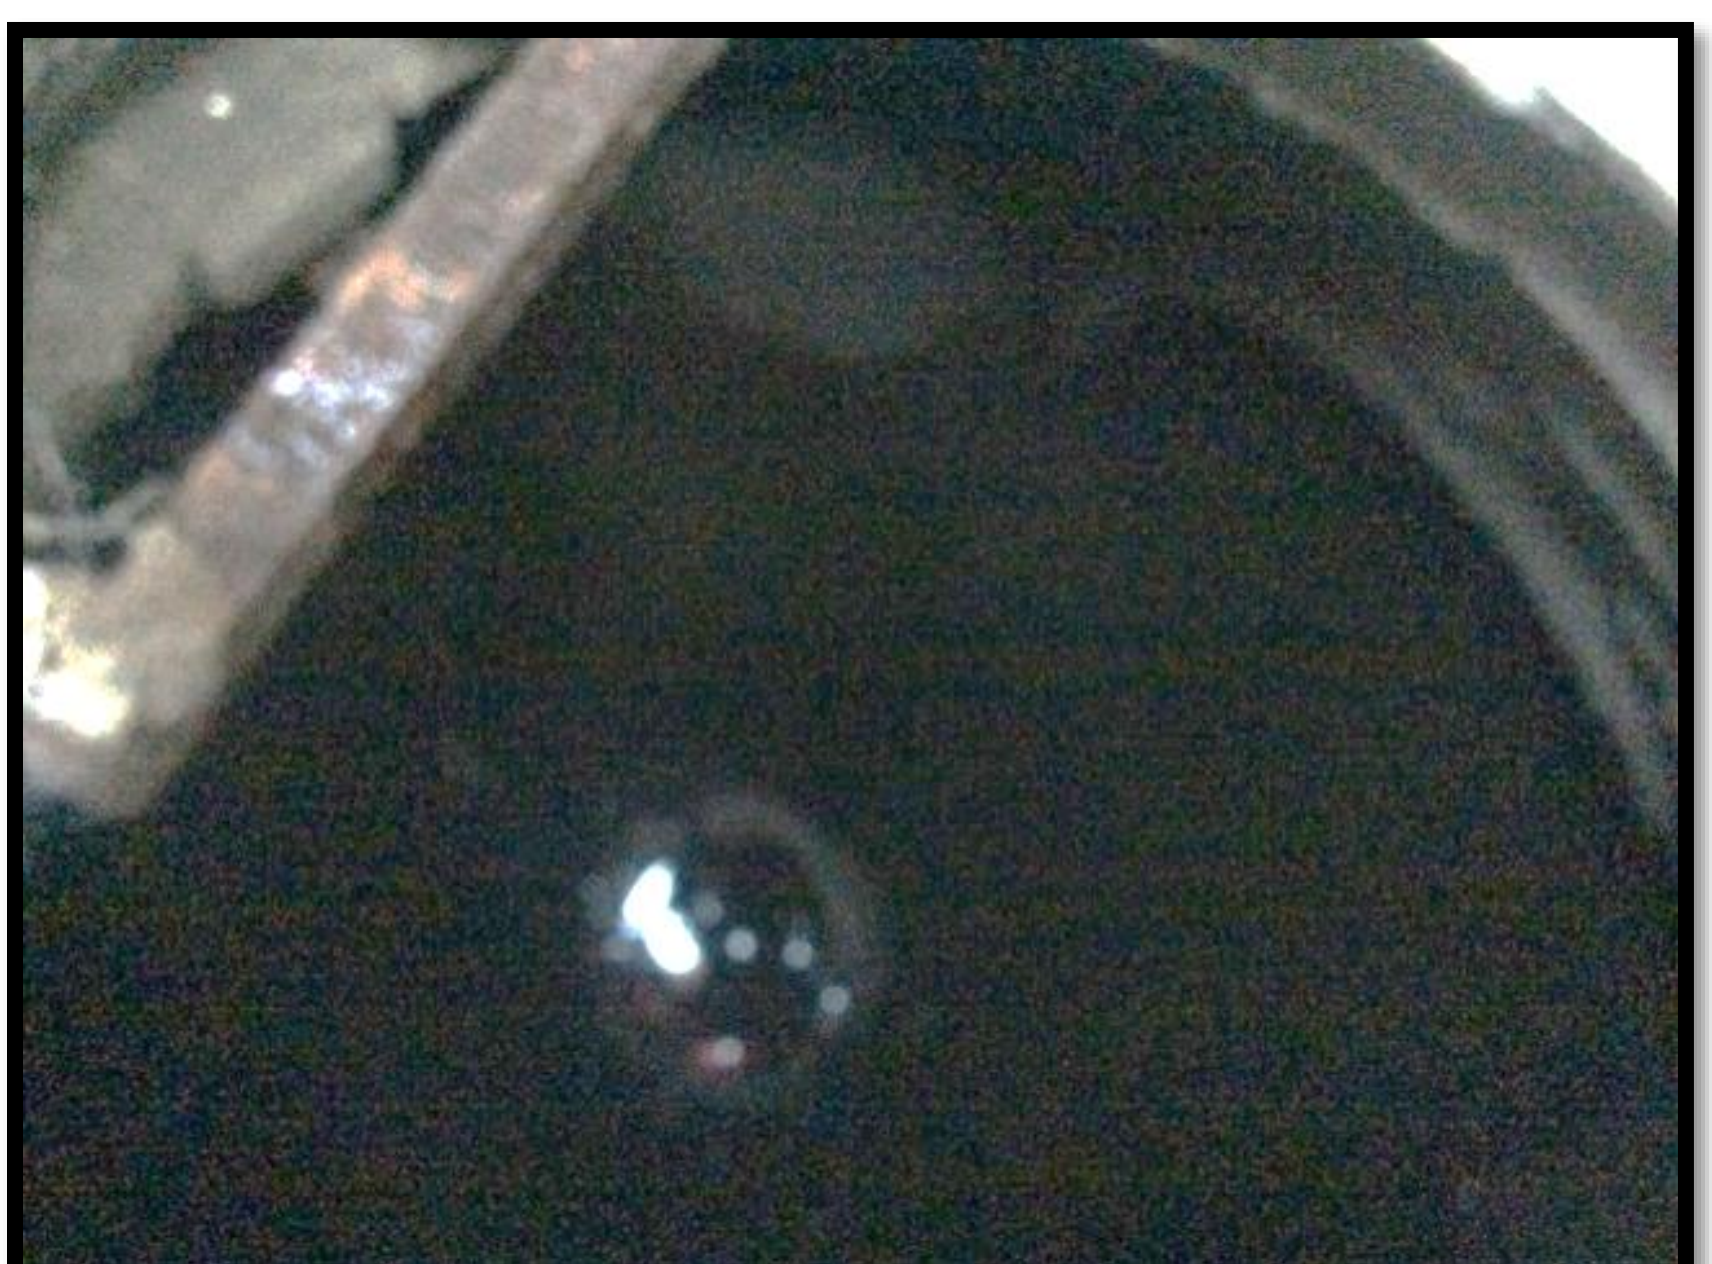
Discharge Point Details	POINT NUMBER	**U05-00**
	DRAIN NAME	**URBANDALE DRAIN**
	LAND USE/AREA	COMMERCIAL BUSSINESS
	NO. OF DAYS SINCE RUN OFF	2
	RISE X SPAN (IN)	36
	MATERIAL/TYPE	ROUND CONCRETE
	VEGETATION CONDITION	NORMAL
	OUTFALL DAMAGE	NONE
	FLOW DEPTH (IN)	0
	FLOW PRESENT (Y/N)	NO
	SUBMERGED (Y/N)	NO
Observations	COLOR	NONE
	DEPOSITS/STAINS	NONE
	FLOATABLES	NONE
	TURBIDITY	NONE
	ODOR	NONE
	NOTES	Standing water in structure. Hard to see pipe.
IDEP Parameters	AMMONIA (mg/L)	0
	pH	0
	SURFACTANT (mg/L LAS)	0
	TEMPERATURE (F)	0
	TURBIDITY (NTU)	0
	SPECIFIC CONDUCTIVITY (mS/cm)	0
Data Collection Detail	STAFF	ERS/KRZ
	GPS	+42.725616, -84.512859, +10.000000
	TIMESTAMP	09/29/2017 08:49:45

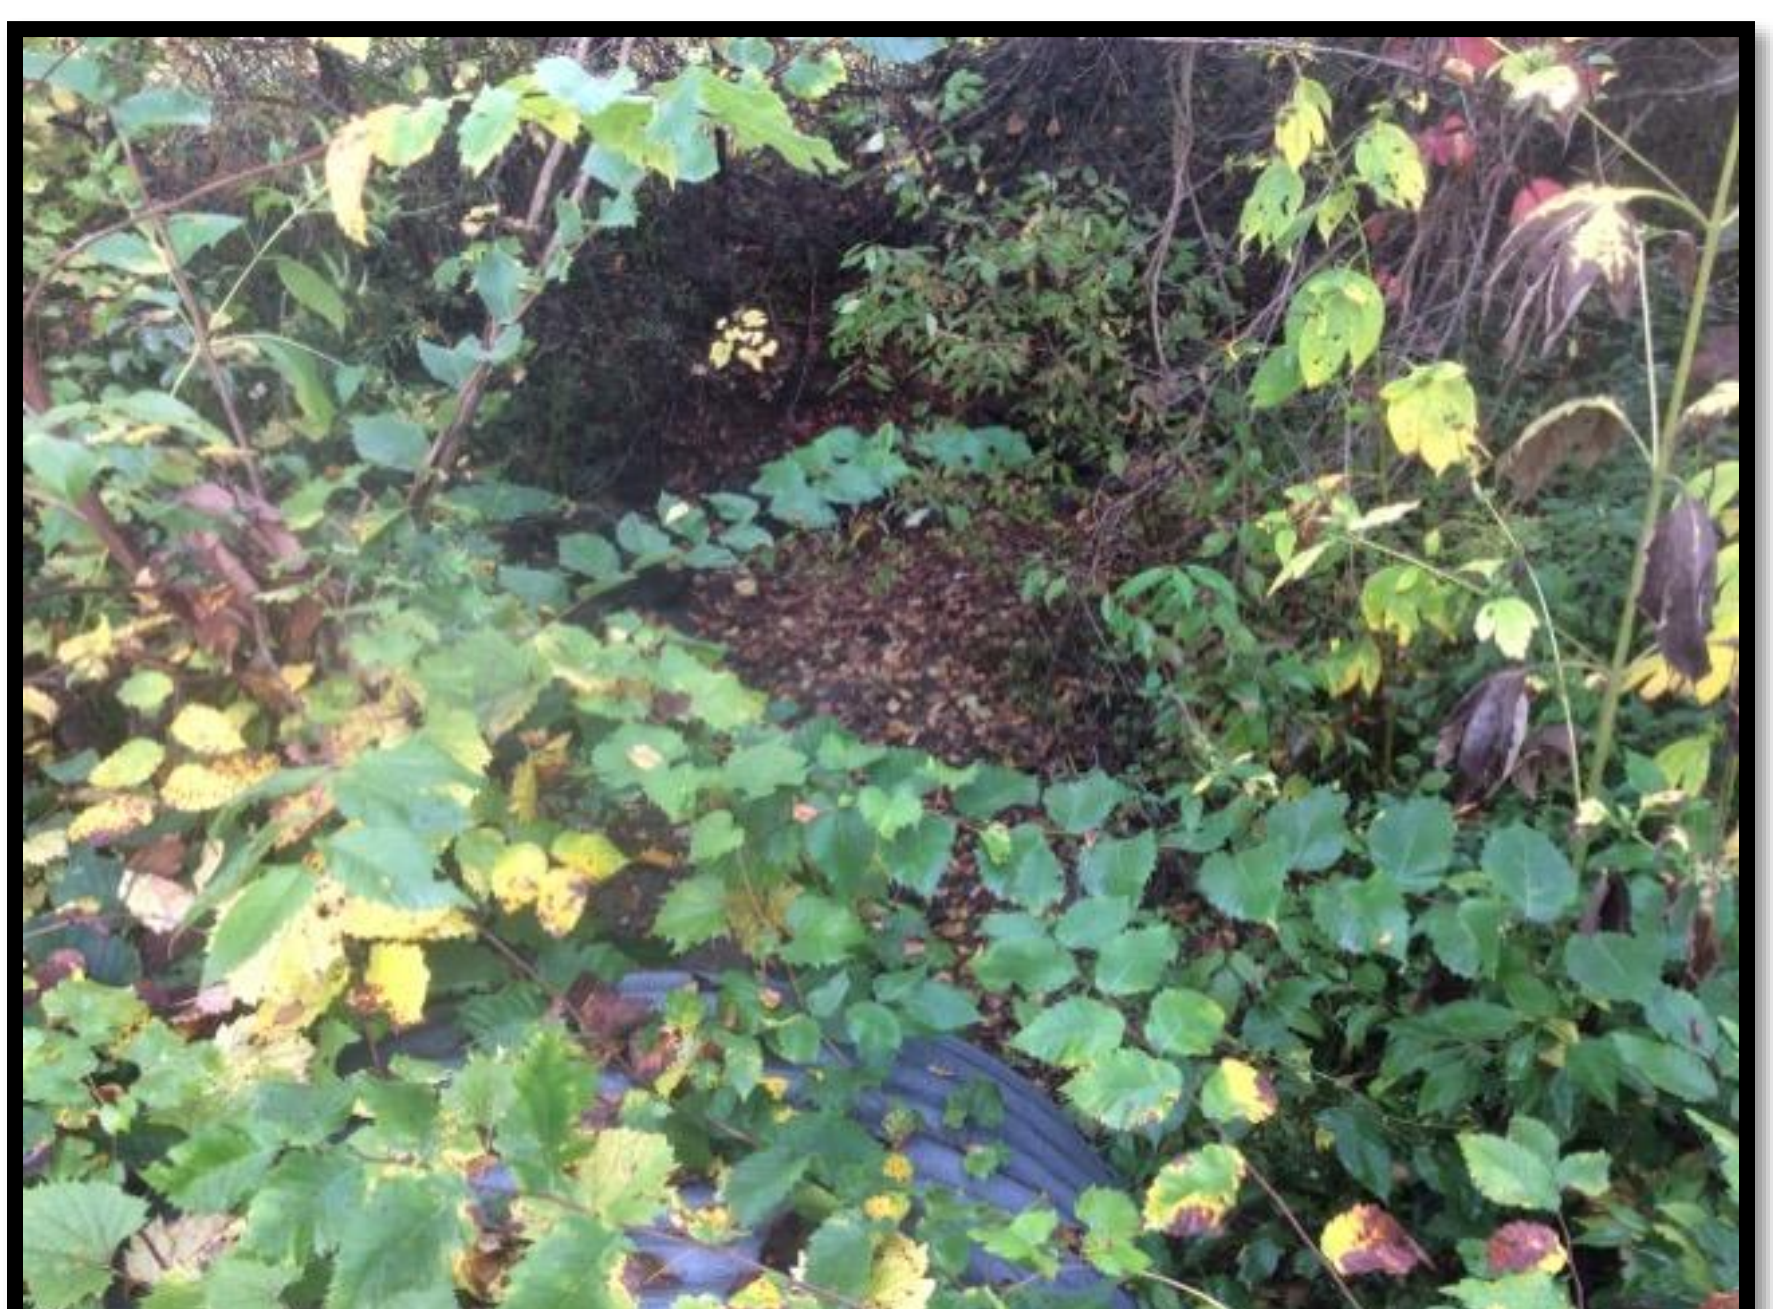
Discharge Point Details	POINT NUMBER	**W01-00**
	DRAIN NAME	**WAUBANAKIN DRAIN**
	LAND USE/AREA	AGRICULTURAL
	NO. OF DAYS SINCE RUN OFF	2
	RISE X SPAN (IN)	48
	MATERIAL/TYPE	ROUND CMP
	VEGETATION CONDITION	NORMAL
	OUTFALL DAMAGE	NONE
	FLOW DEPTH (IN)	0
	FLOW PRESENT (Y/N)	NO
	SUBMERGED (Y/N)	NO
Observations	COLOR	NONE
	DEPOSITS/STAINS	NONE
	FLOATABLES	NONE
	TURBIDITY	NONE
	ODOR	NONE
	NOTES	Dry open drain.
IDEP Parameters	AMMONIA (mg/L)	0
	pH	0
	SURFACTANT (mg/L LAS)	0
	TEMPERATURE (F)	0
	TURBIDITY (NTU)	0
	SPECIFIC CONDUCTIVITY (mS/cm)	0
Data Collection Detail	STAFF	ERS/KRZ
	GPS	+42.618843, -84.383652, +5.000000
	TIMESTAMP	09/20/2017 08:55:03

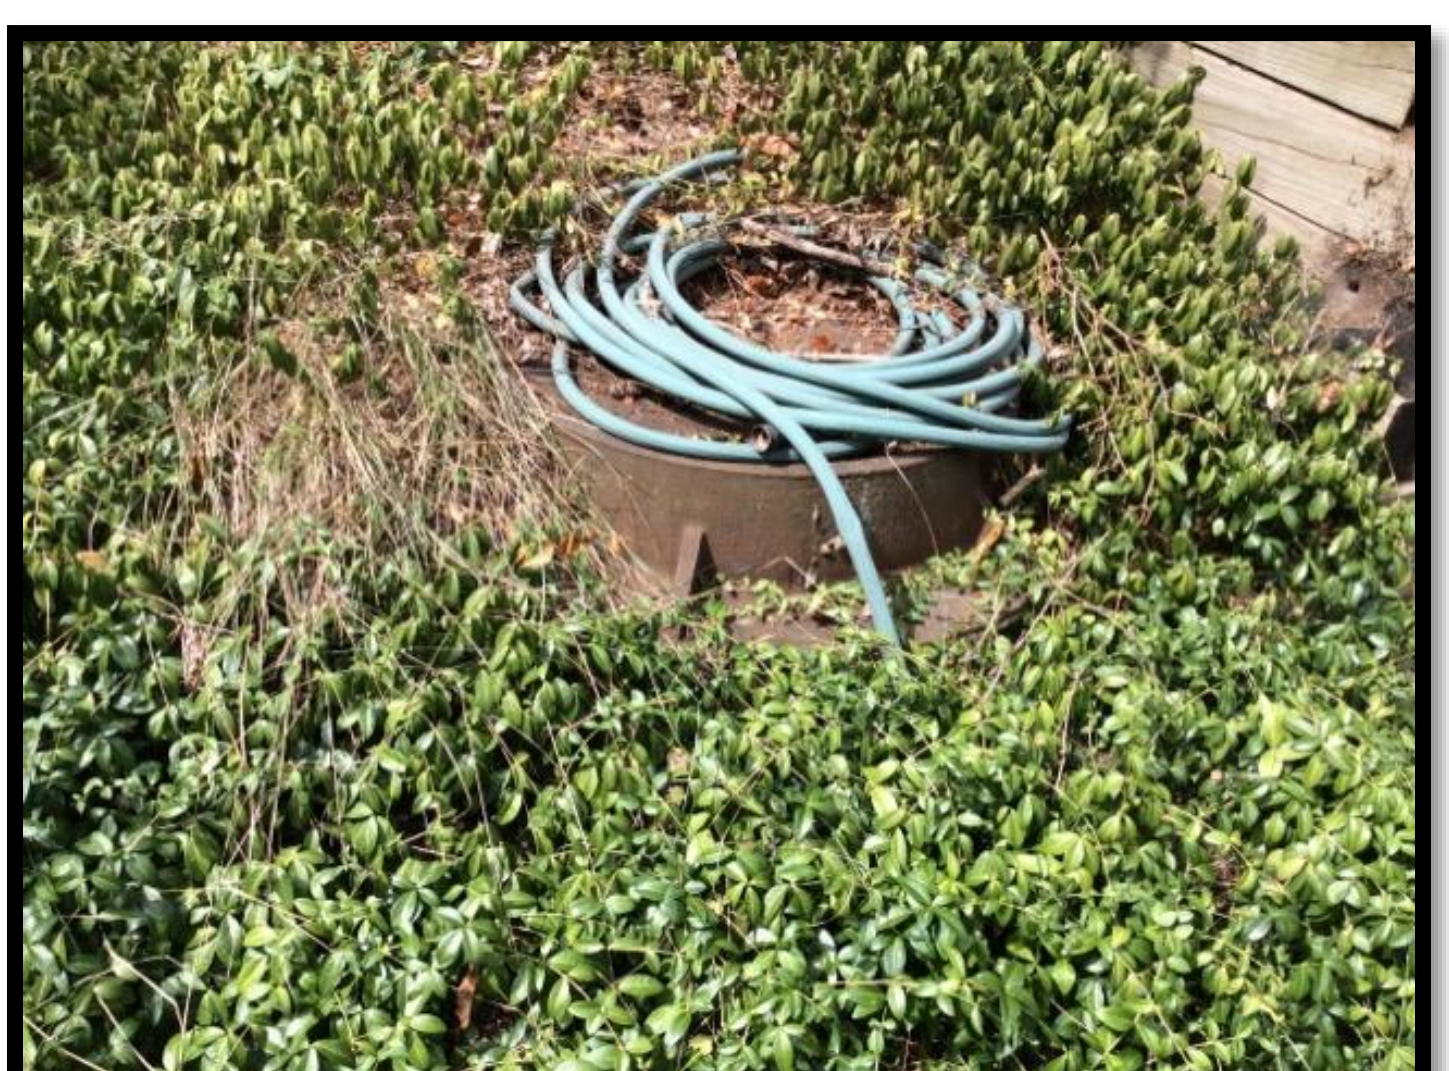
Discharge Point Details	POINT NUMBER	**W22-00**
	DRAIN NAME	**FOLLOW UP - WILLOW CREEK DRAIN**
	LAND USE/AREA	RESIDIENTIAL - SINGLE
	NO. OF DAYS SINCE RUN OFF	2
	RISE X SPAN (IN)	N/A
	MATERIAL/TYPE	N/A
	VEGETATION CONDITION	NORMAL
	OUTFALL DAMAGE	NONE
	FLOW DEPTH (IN)	0
	FLOW PRESENT (Y/N)	N/A
	SUBMERGED (Y/N)	N/A
Observations	COLOR	NONE
	DEPOSITS/STAINS	NONE
	FLOATABLES	NONE
	TURBIDITY	NONE
	ODOR	NONE
	NOTES	No structure present, no follow up. Structure in picture was a sanitary pipe that was in close proximity to where the storm outfall was supposed to be, according to Collector map.
IDEP Parameters	AMMONIA (mg/L)	0
	pH	0
	SURFACTANT (mg/L LAS)	0
	TEMPERATURE (F)	0
	TURBIDITY (NTU)	0
	SPECIFIC CONDUCTIVITY (mS/cm)	0
Data Collection Detail	STAFF	ERS/KRZ
	GPS	+42.572949, -84.444192, +10.000000
	TIMESTAMP	09/06/2017 13:40:12

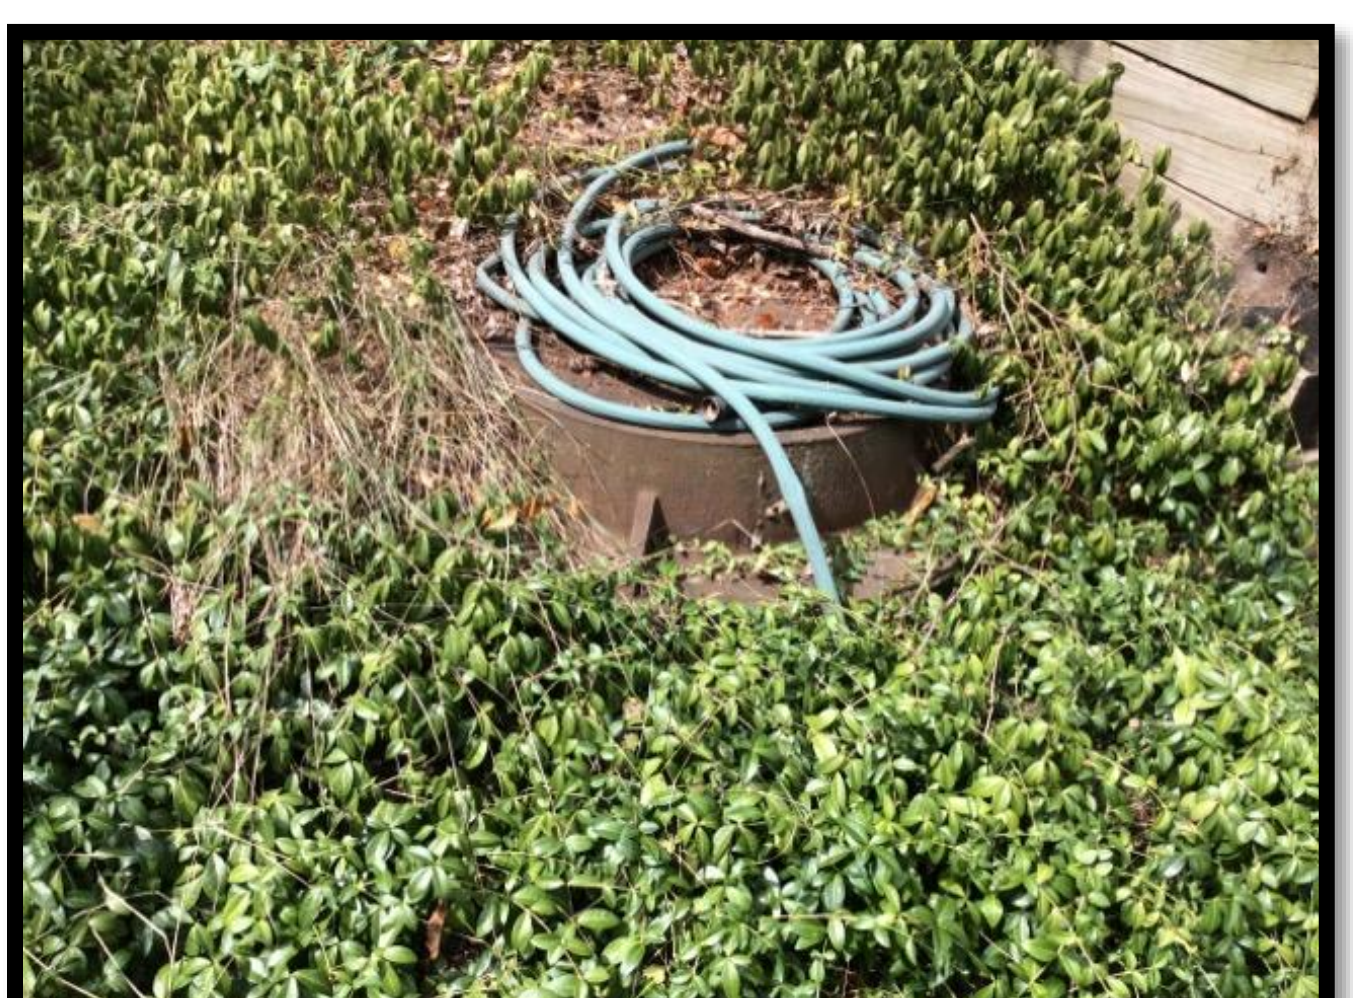
Discharge Point Details	POINT NUMBER	**W22-00**
	DRAIN NAME	**WILLOW CREEK DRAIN**
	LAND USE/AREA	RESIDENTIAL - MULTI
	NO. OF DAYS SINCE RUN OFF	2
	RISE X SPAN (IN)	-
	MATERIAL/TYPE	ROUND CONCRETE
	VEGETATION CONDITION	NORMAL
	OUTFALL DAMAGE	NONE
	FLOW DEPTH (IN)	1
	FLOW PRESENT (Y/N)	YES
	SUBMERGED (Y/N)	NO
Observations	COLOR	NONE
	DEPOSITS/STAINS	NONE
	FLOATABLES	NONE
	TURBIDITY	NONE
	ODOR	NONE
	NOTES	No structure present, no follow up. Structure in picture was a sanitary pipe that was in close proximity to where the storm outfall was supposed to be, according to Collector map. Water flow in structure was audible. Outlet pipe to creek could not be found.
IDEP Parameters	AMMONIA (mg/L)	0
	pH	0
	SURFACTANT (mg/L LAS)	0
	TEMPERATURE (F)	0
	TURBIDITY (NTU)	0
	SPECIFIC CONDUCTIVITY (mS/cm)	0
Data Collection Detail	STAFF	ERS/KRZ
	GPS	+42.572677, -84.444525, +10.000000
	TIMESTAMP	09/29/2017 10:23:11

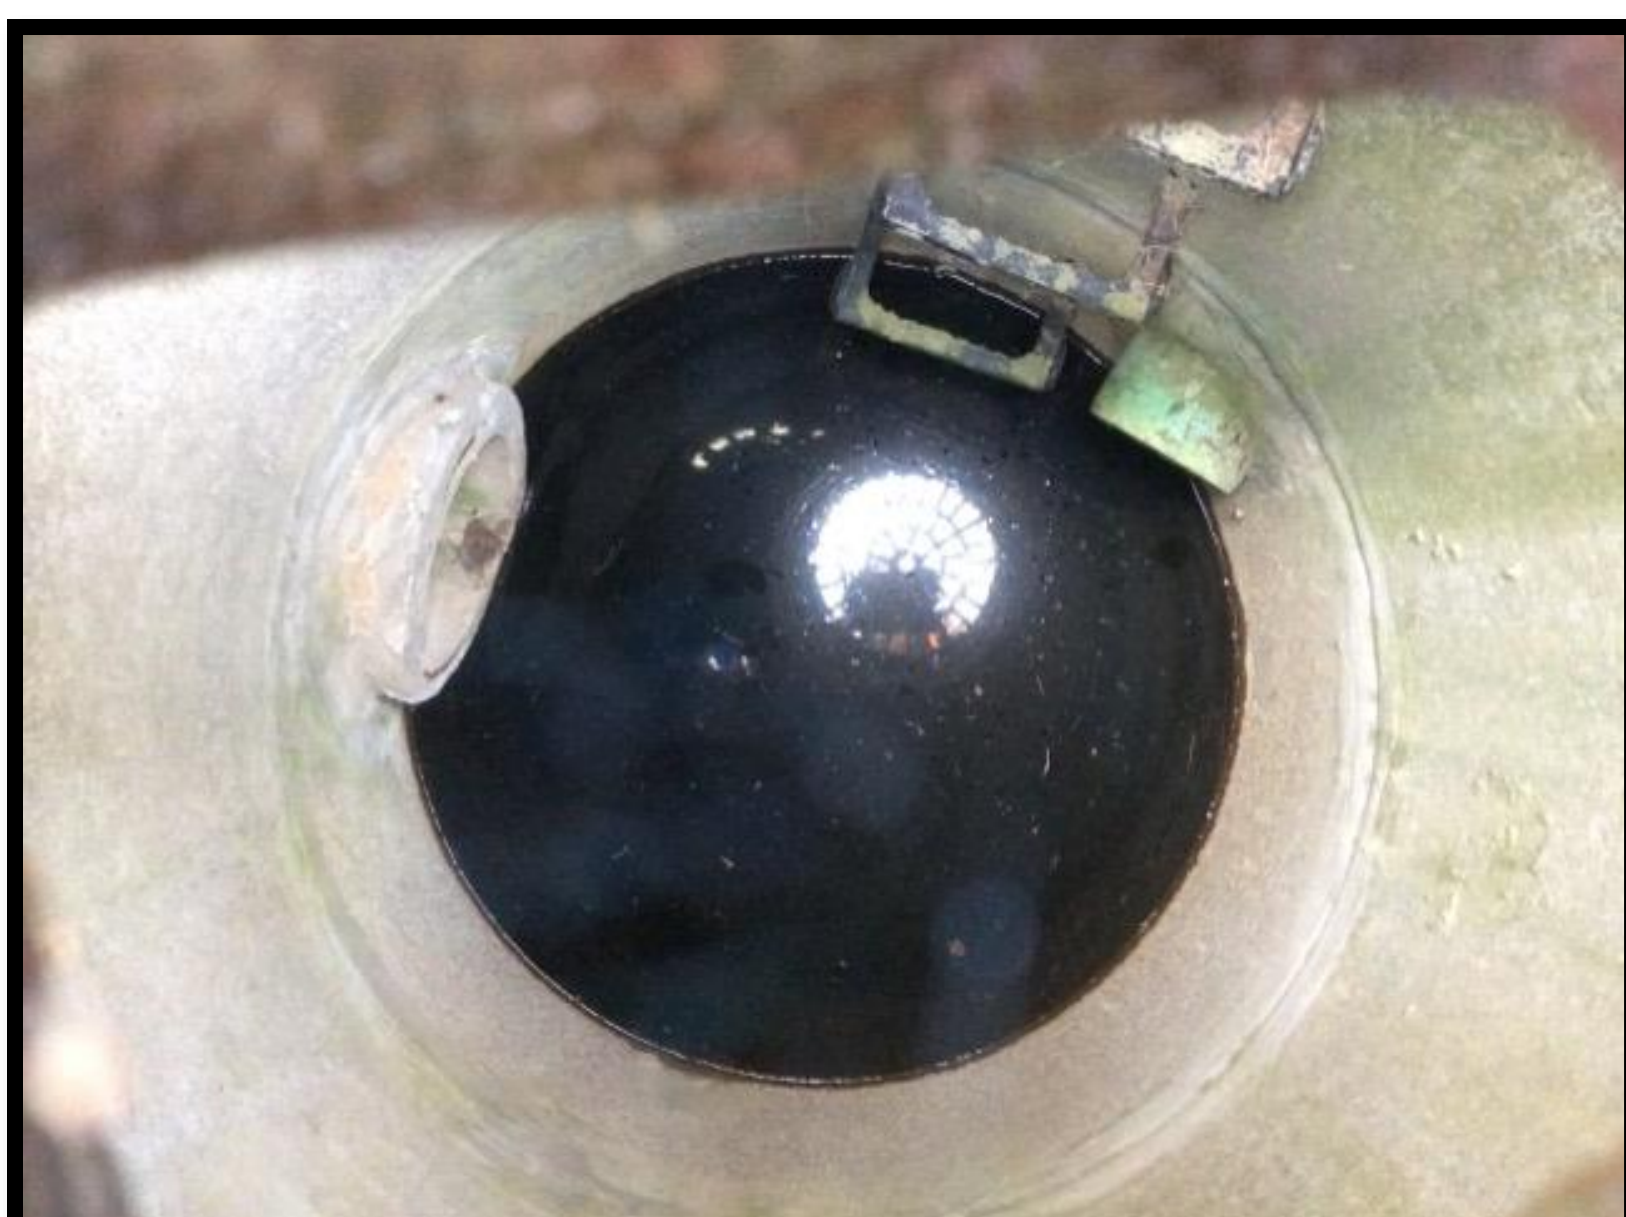
Discharge Point Details	POINT NUMBER	**W69-00**
	DRAIN NAME	**WOODED VALLEY DRAIN**
	LAND USE/AREA	RESIDENTIAL - MULTI
	NO. OF DAYS SINCE RUN OFF	2
	RISE X SPAN (IN)	12
	MATERIAL/TYPE	ROUND CONCRETE
	VEGETATION CONDITION	NORMAL
	OUTFALL DAMAGE	NONE
	FLOW DEPTH (IN)	0
	FLOW PRESENT (Y/N)	NO
	SUBMERGED (Y/N)	N/A
Observations	COLOR	NONE
	DEPOSITS/STAINS	NONE
	FLOATABLES	NONE
	TURBIDITY	NONE
	ODOR	NONE
	NOTES	One pipe comes into the junction from the northeast and the other leaves to the west. No flow, water present in bottom.
IDEP Parameters	AMMONIA (mg/L)	0
	pH	0
	SURFACTANT (mg/L LAS)	0
	TEMPERATURE (F)	0
	TURBIDITY (NTU)	0
	SPECIFIC CONDUCTIVITY (mS/cm)	0
Data Collection Detail	STAFF	ERS/KRZ
	GPS	+42.654774, -84.514471, +10.000000
	TIMESTAMP	09/07/2017 11:03:22

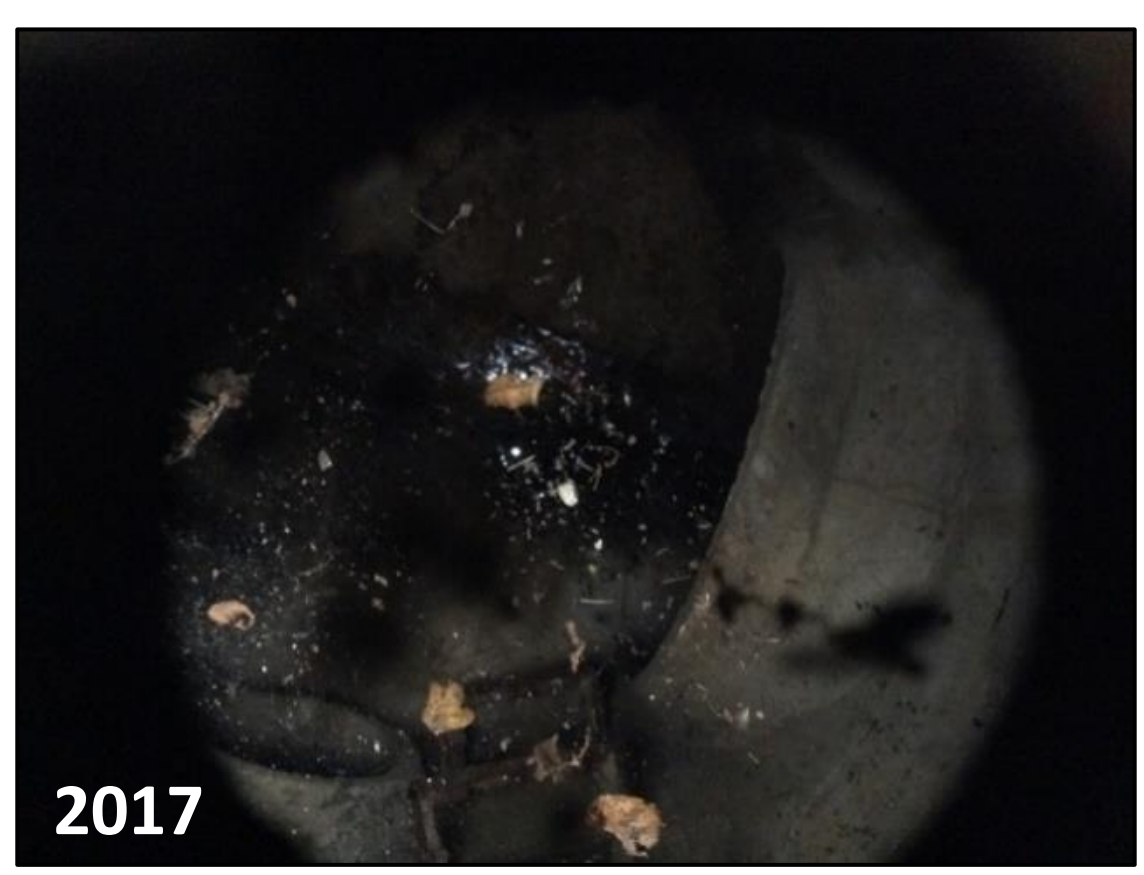
Discharge Point Details	**POINT NUMBER**	**M24-00**
	DRAIN NAME	**MAPLE SHADE DRAIN**
	LAND USE/AREA	AGRICULTURAL
	NO. OF DAYS SINCE RUN OFF	2
	RISE X SPAN (IN)	24
	MATERIAL/TYPE	ROUND CONCRETE
	VEGETATION CONDITION	NORMAL
	OUTFALL DAMAGE	NONE
	FLOW DEPTH (IN)	0
	FLOW PRESENT (Y/N)	NO
	SUBMERGED (Y/N)	NO
Observations	**COLOR**	NONE
	DEPOSITS/STAINS	NONE
	FLOATABLES	NONE
	TURBIDITY	NONE
	ODOR	NONE
	2020 NOTES	-
	2017 NOTES	Last junction before the outfall. The outfall opens up into a large wetland/meadow area.
IDEP Parameters	**AMMONIA (mg/L)**	-
	pH	-
	SURFACTANT (mg/L LAS)	-
	TEMPERATURE (F)	-
	TURBIDITY (NTU)	-
	SPECIFIC CONDUCTIVITY (mS/cm)	-
	E. COLI (MPN/100 mL)	-
Data Collection Detail	**STAFF**	EM/TD
	GPS	+42.713876, -84.300688, +10.000000
	TIMESTAMP	8/25/2020 12:49

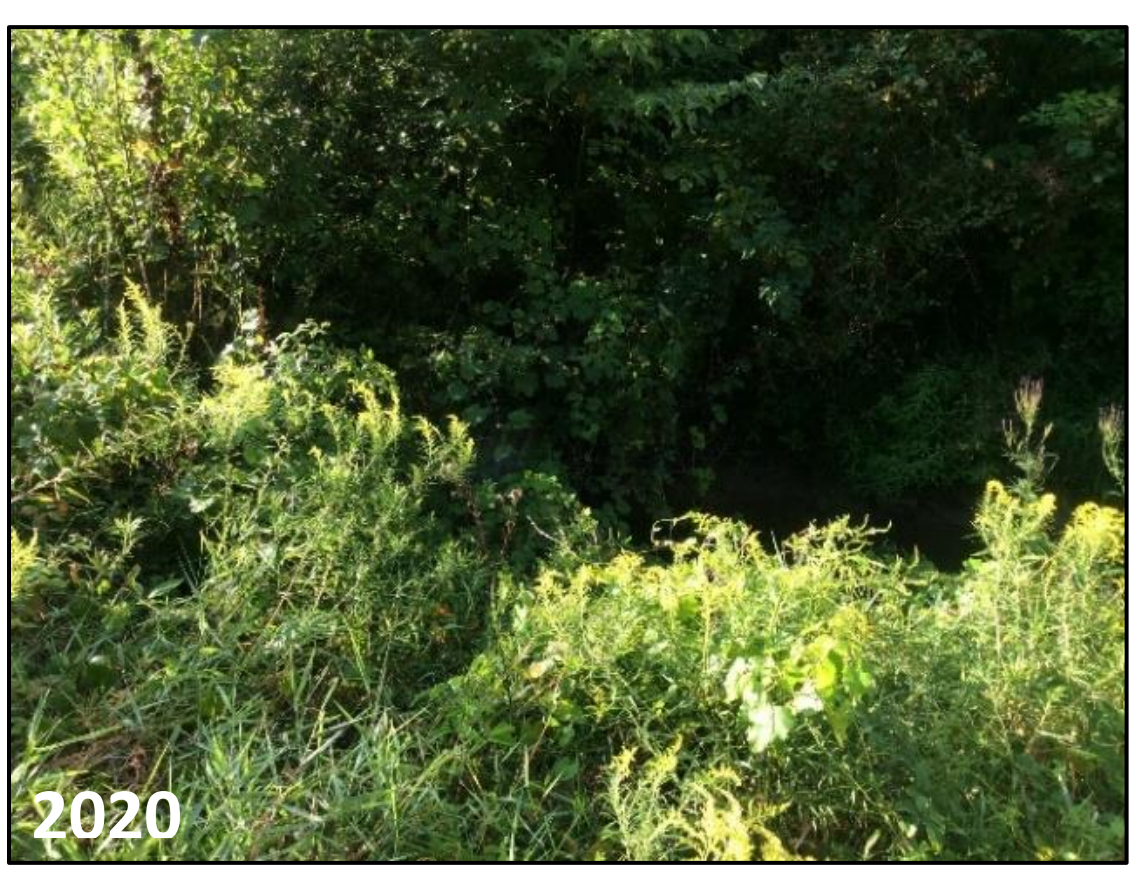
Discharge Point Details	**POINT NUMBER**	**M52-00**
	DRAIN NAME	**MCKEON DRAIN**
	LAND USE/AREA	WOODED AREA
	NO. OF DAYS SINCE RUN OFF	2
	RISE X SPAN (IN)	40
	MATERIAL/TYPE	ROUND CMP
	VEGETATION CONDITION	NORMAL
	OUTFALL DAMAGE	NONE
	FLOW DEPTH (IN)	0
	FLOW PRESENT (Y/N)	NO
	SUBMERGED (Y/N)	NO
Observations	**COLOR**	NONE
	DEPOSITS/STAINS	NONE
	FLOATABLES	NONE
	TURBIDITY	NONE
	ODOR	NONE
	2020 NOTES	Opens into open drain, standing water. Water is clear.
	2017 NOTES	Drain opens into an open drain. Standing water, clear.
IDEP Parameters	**AMMONIA (mg/L)**	-
	pH	-
	SURFACTANT (mg/L LAS)	-
	TEMPERATURE (F)	-
	TURBIDITY (NTU)	-
	SPECIFIC CONDUCTIVITY (mS/cm)	-
	E. COLI (MPN/100 mL)	-
Data Collection Detail	**STAFF**	EM/TD
	GPS	+42.769571, -84.351989, +10.000000
	TIMESTAMP	8/21/2020 8:44
